Correlation between microhardness and wear resistance of dental alloys against monolithic zirconia

PURPOSE. The aim of this study is to compare the hardness according to the conditions of metal alloys. Moreover, the correlation between the cast crown hardness before and after wear testing and the degree of wear for each dental alloy was assessed. **MATERIALS AND METHODS.** Cast crowns of three metal alloys (Co-Cr, gold, and Ni-Cr alloys) opposing smooth-surface monolithic zirconia were used. The Vickers microhardness of the ingot (which did not undergo wear testing) and the cast crown before and after wear testing were measured for each alloy. Two-way ANOVA and Scheffé tests were used to compare the measured hardness values. Moreover, the Pearson correlation coefficient was used to evaluate the relationship between the surface hardness and the wear of the cast crown ($\alpha=.05$). **RESULTS.** There was no significant difference in the hardness before and after wear testing for the gold alloy ($P>.05$); however, the hardness of the worn surface of the cast crown increased compared to that of the cast crown before the wear tests of Ni-Cr and Co-Cr alloys ($P<.05$). Furthermore, th

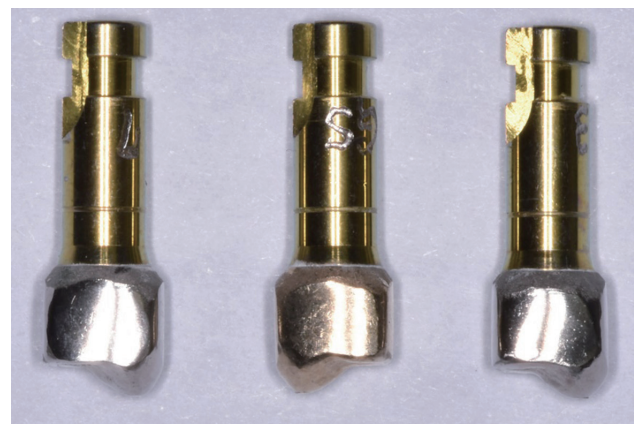
Fig. 1. Cast crown specimens (from left to right): Co-Cr, gold, and Ni-Cr alloys.

The process of fabricating cast crowns from each metal alloy, the condition of wear testing, and the method of measuring the volumetric wear of the cast crowns in our previous study²³ were as follows. A polymethyl methacrylate (PMMA) pattern that resembles the maxillary premolar was manufactured. Unlike the anatomical contours of natural teeth, the four axial walls of this PMMA pattern are flat surfaces. In addition, each of the four axial walls formed an angle of 90° to the adjacent axial walls and was parallel to the long axis direction of the crown. The reason for the difference in the shape and arrangement of the axial wall from the anatomical contour of the natural tooth was to make it possible to measure the hardness on the axial wall and the worn surface. According to the manufacturer's instructions for each metal alloy, the PMMA pattern was invested, cast, finished, and polished to produce Co-Cr, gold, and Ni-Cr alloy cast crowns (Fig. 1). 3Y-TZP powder (Zpex, Tosoh Corp., Tokyo, Japan) was pressure-molded, air-sintered, and polished to produce cylindrical monolith-
