RESEARCH Open Access

Functional outcomes following fixation of a marginal distal radius fracture with two commonly used volar locking plates: a retrospective cohort study

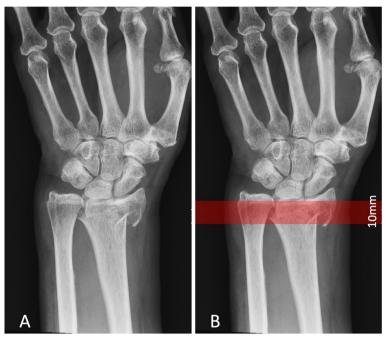
Fig. 1 Defining marginal distal radius fracture patterns. A) Pre-operation anteroposterior film of an injured wrist; B) The distal end of a fracture area lies within 10 mm of the joint line of the lunate fossa

Fracture configuration and patterns were classified radiographically by a senior orthopedic resident and rechecked by a hand surgeon. The definition of a marginal distal radius fracture pattern was assumed to be the most distal horizontal fracture line within 10 mm of the joint line of the lunate fossa, based on anteroposterior (AP) film. Simple volar or dorsal Barton fracture patterns (AO/ OTA 2R3B2/3) were excluded (Fig. 1). All pre-operation, intra-operation, and post-operation plan films, and preoperation computed tomography (CT), intra-operation arthroscopic images (if Arthroscopically assisted reduction and internal fixation was performed) were reviewed and recorded.

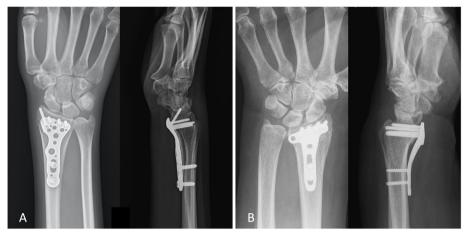
Fig. 2 A post-operative anteroposterior and lateral view of an injured wrist. A) The Acumed Acu-Loc VLP group; the implant fits the volar cortex in the lateral view; B) The Synthes 2.4 mm LCP group, note the gap between the implant and the volar cortex

Both study implants were designed for far distal or intra-articular fractures of the distal radius, and to sit distal to the watershed line, but both have with different solution approaches to avoid tendon irritation [30, 31]. The Synthes $2.4\,\mathrm{mm}$ LCP $^{\mathrm{IM}}$ Distal Radius System Juxta-articular volar plate is pre-contoured to fit the volar cortex of the distal radius. The low plate-and-screw profile, round plate edges and undercut of the plate-head facilitates intraoperative contouring of the plate, based on individual patient anatomy and fracture patterns (Fig. 2) [30].

In contrast, the Acumed Acu-Loc Wrist Plating System Volar Distal Radius Plate has a more rigid and complex pre-contoured design of the distal edge, and is based on the modern module of general population distal radius anatomy. It also comes with a round plate edge, low profile and beveled design [30, 31]]. It has been suggested this design ideally fits the watershed line (cadaver study), whereas the manufacturer states it is "designed to be placed more distal then many other volar plates" (Fig. 2) [31, 32].

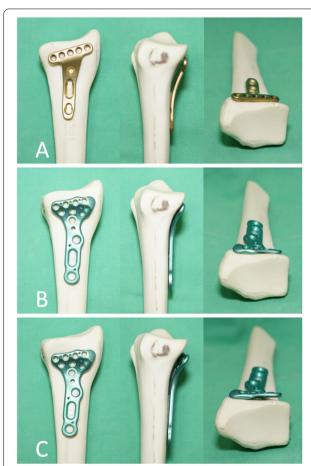
Fig. 3 A bone model of anteroposterior, lateral and axial views. A) The Synthes 2.4 mm LCP group, note the plate protrusion on the lateral and axial view; B) The Acumed Acu-Loc VLP group with designed position; C) The Acumed Acu-Loc VLP group with a more proximal position, note the plate protrusion due to plate mis-positioning

Furthermore, our bone model (Fig. 3) also indicated if the Acumed Acu-Loc VLP was not placed in its designed-for position, even with a more proximal position not crossing or sitting on the watershed line, this would result in increased prominence. Thus, if the Acumed Acu-Loc VLP is to be used, the surgeon should put the locking plate on the watershed line, even if the fracture pattern does not require marginal fragment fixation.
