Case Report

Massive Chondrolysis and Joint Destruction after Artificial Anterior Cruciate Ligament Repair

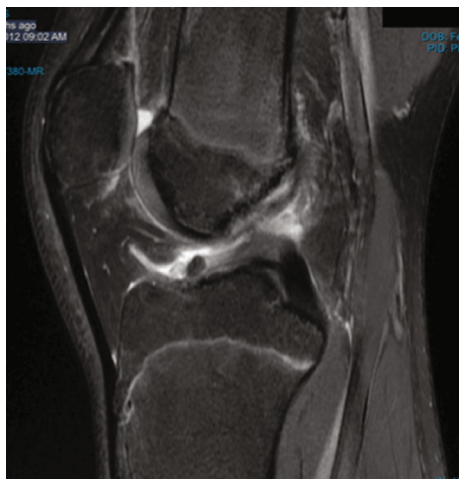
FIGURE 1: MRI demonstrating initial ACL rupture in 2012.

Mr. BP, a 16-year-old male, had a soccer injury in 2012 sustaining a left anterior cruciate ligament (ACL) and lateral meniscal tear (Figure 1). He subsequently had an ACL reconstruction performed by an orthopaedic surgeon (BM) who used the ipsilateral hamstring tendons for the ACL graft and repaired the lateral meniscus. A year later in 2014, Mr. BP sustained another injury to his left knee when dismounting from a dirt bike resulting in an intrasubstance ACL graft rupture and medial meniscus tear. He underwent a revision ACL reconstruction performed by another orthopaedic surgeon (EJ) using the contralateral (right) double hamstring tendons in addition to a Ligament Augmentation and Reconstruction System (LARS). The left medial meniscus was repaired with the omnispan meniscal repair system, and the frayed free edge was debrided conservatively to a stable margin.

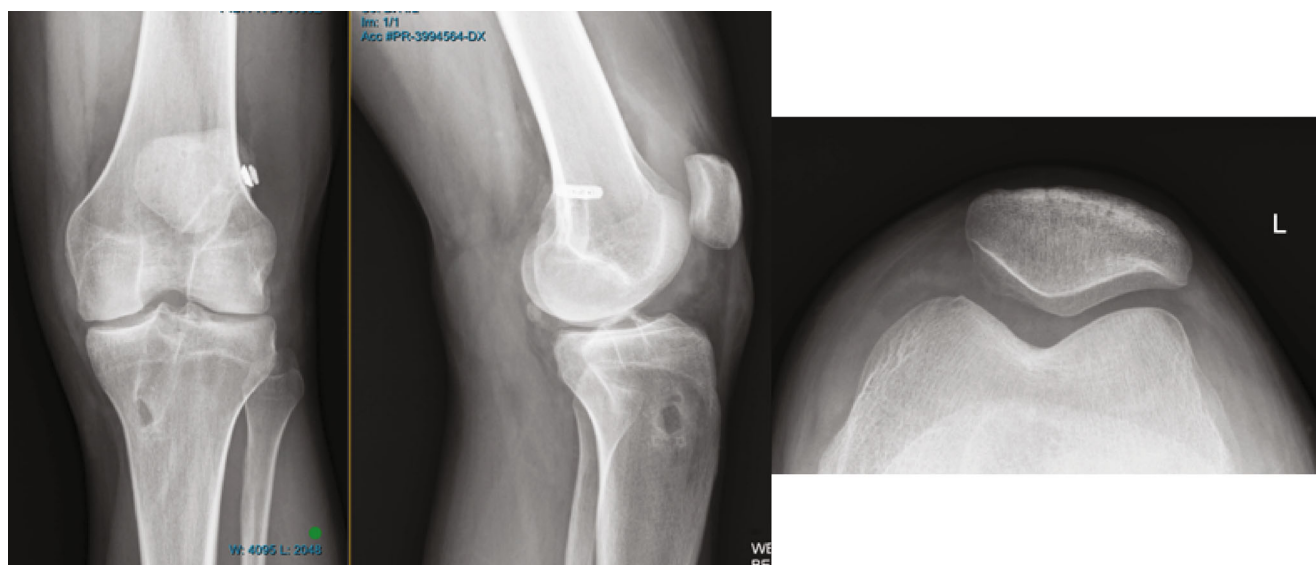
FIGURE 2: Radiograph in 2016 of BP's left knee.

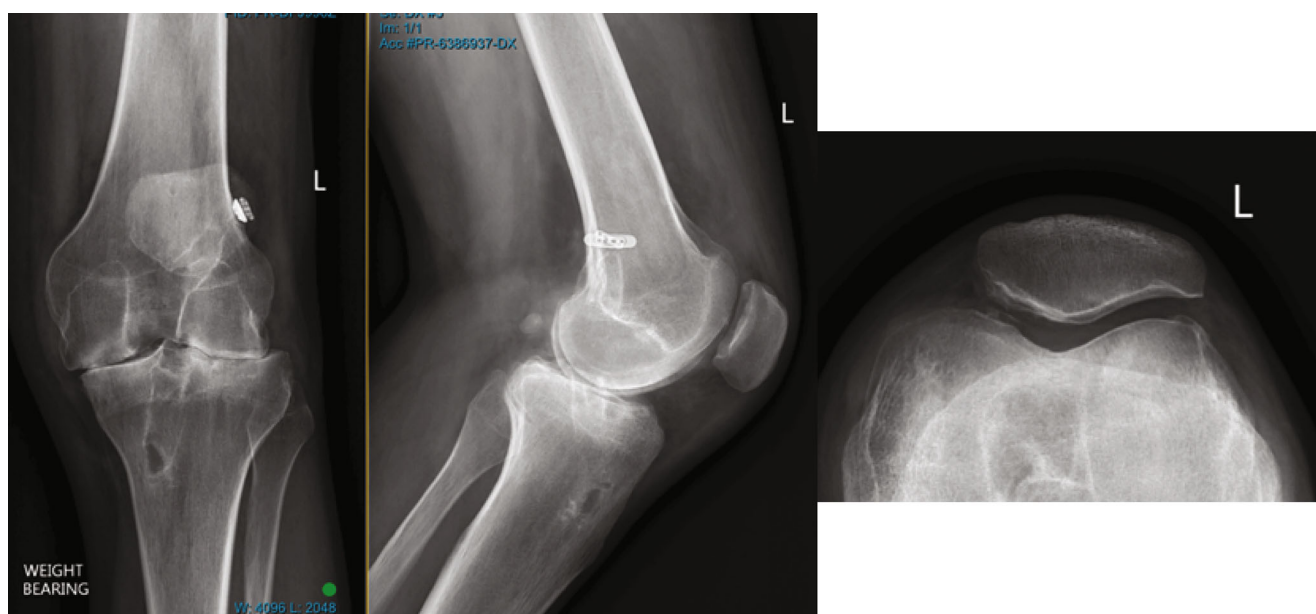
FIGURE 3: Radiograph in 2019 of BP's left knee. Note the significant interval change from 2016 images.

In March 2019, 6 years from the initial injury, Mr. BP (23 years) represented to PK for worsening pain and clunking with movement of his left knee. The pain was now both throughout the day and night and worse with work and not relieved with simple analgesia. On examination, the left quadriceps muscle was severely wasted, and the left knee had a positive pivot shift test and mild lateral ligament pseudolaxity. A radiograph at the time showed severe chondrolysis with bone-on-bone disease in a pattern across all three compartments (Figure 3).

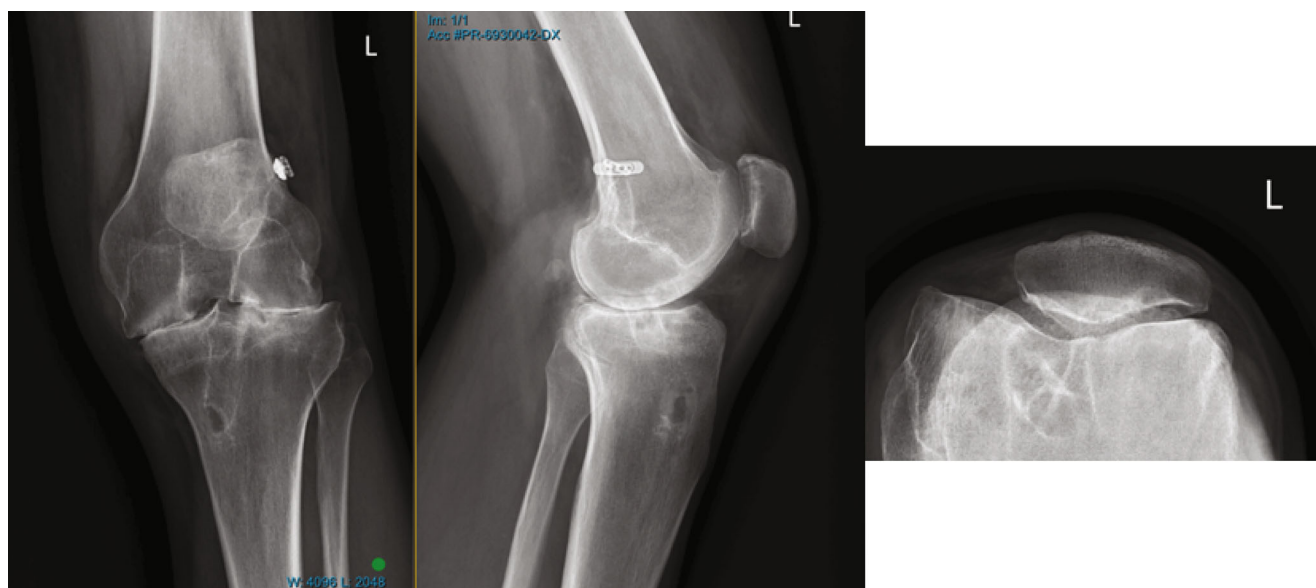
FIGURE 4: Radiograph of the left knee 7 months later in 2019.

In October 2019, Mr. BP's condition deteriorated further secondary to pain and immobility. An ultrasound guided Synvisc-One (Hylan G-F 20) injection of the left knee with 2 ml of Celestone Chronodose and 8 ml of 0.5% bupivacaine without complication. A progress radiograph (Figure 4) showed further narrowing of the medial and lateral compartments with increasing sclerosis and subarticular cysts compared to the MRI in 2018.
