Case Report

Thigh burn – A magnetic resonance imaging (MRI) related adverse event[☆]

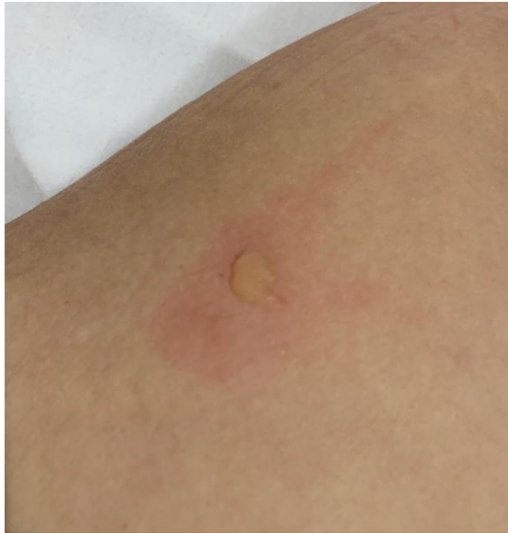
Fig. 1 – A bullous lesion on the patient’s right medial thigh (1 cm) with some mild surrounding erythema on the day of magnetic resonance imaging.

On examination, bilateral medial thigh bullous lesions were seen. They were confirmed to be at the point at which the thighs touch when the feet are brought close together and were of a consistent appearance with second-degree burns (Figs. 1 and 2). These lesions were not present prior to the MRI. The patient did not have any monitoring devices or cables on his person at the time of the MRI scan. He was wearing underwear and a hospital gown, and a spacer was placed between his lower legs, these were not touching the site of the burn. The MRI used during this imaging scan was a Philips Intera 1.5 Tesla with Torso coil. The scan went for 33 minutes and there were seven sequences.

This case raises the importance of patient positioning and avoidance of skin to skin contact in areas of high intensity in the MRI machine. Technicians and clinicians should be made aware of the potential for adverse events and patients should be encouraged to notify staff if burning sensations occur during imaging.

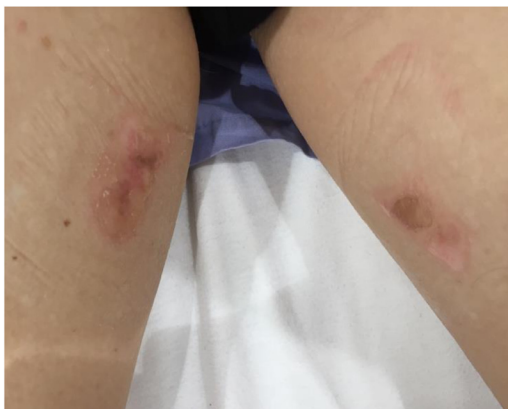
Fig. 2 – Bilateral medial thigh lesions (2 cm total) which developed after magnetic resonance imaging of the perianal region, photo taken 2 days after imaging.
