Case Report

Hook Plate Technique for Bony Mallet Thumb

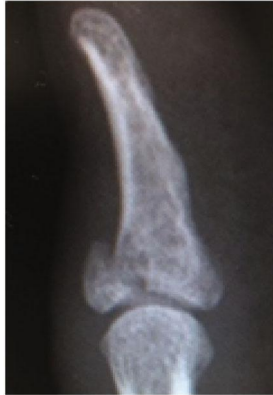
FIGURE 1: Lateral radiograph at the injury site.

IP joint were full. The IP joint was stable against radial and ulnar stress. The images of plain radiography and computed tomography showed an avulsion fracture of one-third to half of its articular surface at the base of the distal phalanx (Figure 1). Using the hook plate technique, open reduction was performed under general anesthesia 19 days after the injury (Figure 2). An incision was made along the crease on the dorsal side of the IP joint. The fracture was reduced and fixed using a hook plate adapted from a 1.5 mm micro module (KLS Martin, Germany, Figure 3(a)). One of the holes was cut, and one-third of its circumference was removed. The ends of the crescent arc were bent approximately 100° by pliers to form two sharp pointed hooks (Figure 3(b)). Two small longitudinal incisions were made at the EPL. The hook plate was slid under the nail matrix, the hooks were inserted through the slips, and the bone fragment was gripped. The screw was inserted into the plate hole to add compression to the fragment. The articular congruency and stability of the fragment in the direction of passive flexion were checked, and the wound was closed.

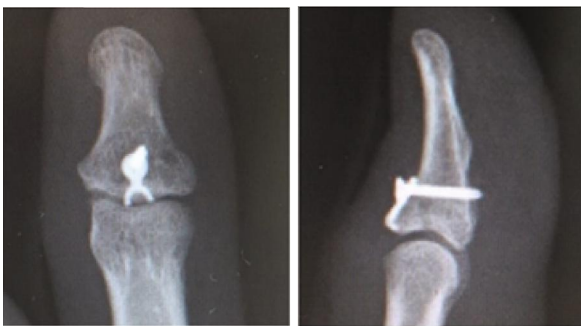
FIGURE 2: The radiograph images after reduction and fixation.

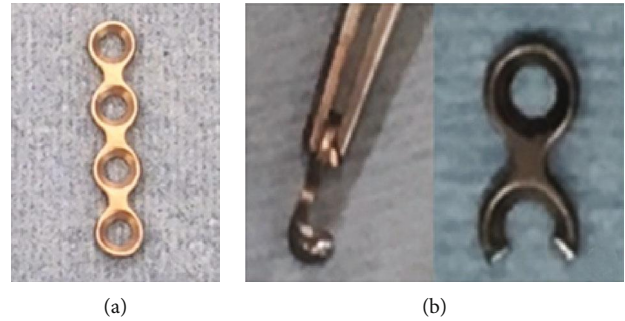
FIGURE 3: The 1.5 mm mini plate before (a) and after the plate was modified by cutting the hole and bending the ends of crescent arc (b).

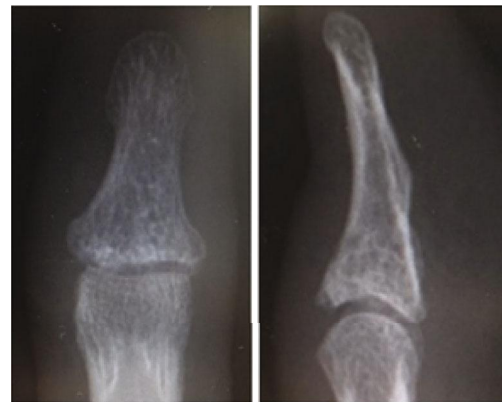
FIGURE 4: Follow-up radiographs showing the healed fracture.

was removed 3 months after the procedure (Figure 4). At the last follow-up of 6 months after surgery, the active range of motion at the IP joint was 80 degrees of flexion and 8 degrees of extension. The range of motion on the contralateral side was 85 degrees of flexion and 10 degrees of extension (Figures 5(a) and 5(b)). The patient had a transverse line nail deformity (Figure 6) that gradually improved. According to Crawford's evaluation criteria [5], the result was excellent. The patient experienced no injury-related difficulties both at work and while playing softball.

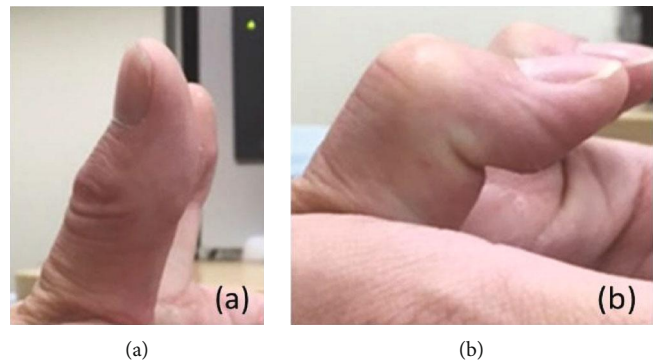
FIGURE 5: Active range of motion of the IP joint of 8° of extension (a) and 90° of flexion (b).

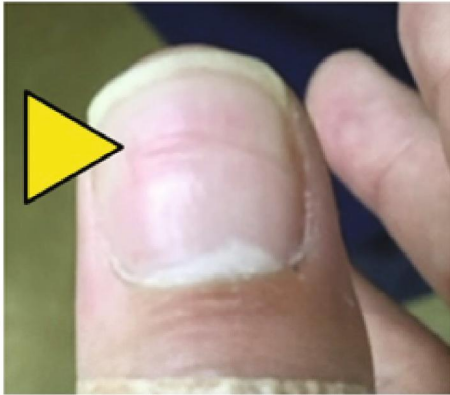
FIGURE 6: Transverse line deformity of the nail that gradually disappeared.

The hook plate technique has advantages that include control and anatomical reduction of even large dorsal fragments and can be used to manage thin or avulsion fractures. It can also apply compression and stability to the fragment. The hook produces the force in the distal direction (Figure 7 (1)), the screw and the plate produce the force in the horizontal direction (Figure 7 (2)), and they are combined to be a compression force applied to the fragment (Figure 7 (3)). The hook plate technique permits early resumption of joint motion and does not require meticulous percutaneous pin care [8]. The reported postoperative complications of the hook plate technique include articular cartilage damage, nail deformities, extensor tendon lesions, and skin irritation [8]. Damage of the articular cartilage of the middle phalanx head may result from inadequate length or shape of the hook. In this patient, the hook was placed into the distal fragment through the EPL and articular cartilage damage did not occur. Nail deformities can occur following damage of the nail matrix by the screw or the plate, but the deformity that occurred in this patient did not occur when the plate was located. The deformity may have happened at

the time of injury. The nail matrix is located close to the bony insertion of the terminal extensor tendon. The distance from the terminal extensor tendon insertion to the proximal edge of the germinal nail matrix is approximately 1.2 mm [11]. If the hook plate rests on the nail bed, damage of the germinal nail matrix will produce nail deformity. As the hook plate was placed under the nail matrix, the chance of nail deformity was minimized.

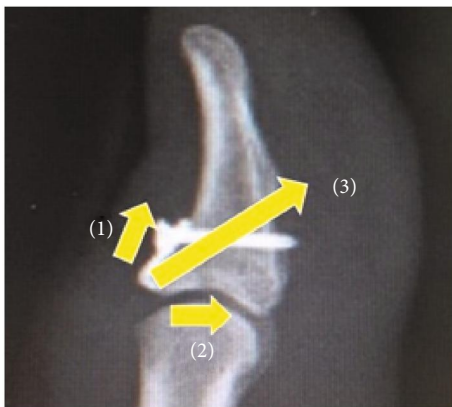
FIGURE 7: The mechanism of compression force generation involved. (1) Force in the distal direction produced by the hook. (2) Force in the horizontal direction produced by the screw and plate. (3) Compression force is applied to the fragment.
