Forensics in motion - Historic vehicles, genuine or fake?

Historic vehicles
Forensic examination
Counterfeit detection
Collector cars
Original materials

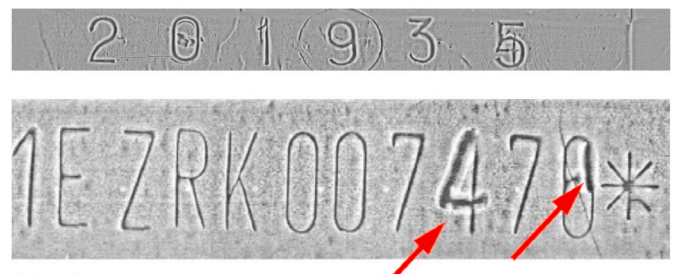
Fig. 6. Using magneto-optical imaging to examine stamped markings in metal substrates. (a) Magneto-optical image of manipulated digits on one of our test-panels: “3” (second left) was sanded out and restamped with “0”. “6” (4. left) was cut out, the cut segment turned by 180° and re-inserted to make it a “9”. “4” (far right) was stamped over to make it a “5”. (b) Magneto-optical image of manipulated digits in an original vehicle identification number (see red darts): “6” (far right) was changed to “8”. “1” (4. right) was restamped to make it look like “4”. (For interpretation of the references to color in this figure legend, the reader is referred to the Web version of this article.)

Extensive testing together with Zetos GmbH have shown that related devices can also be applied to historical vehicles. They enable fast and non-destructive verification of the chassis or engine numbers even on painted components. The use of this technique is limited only by the

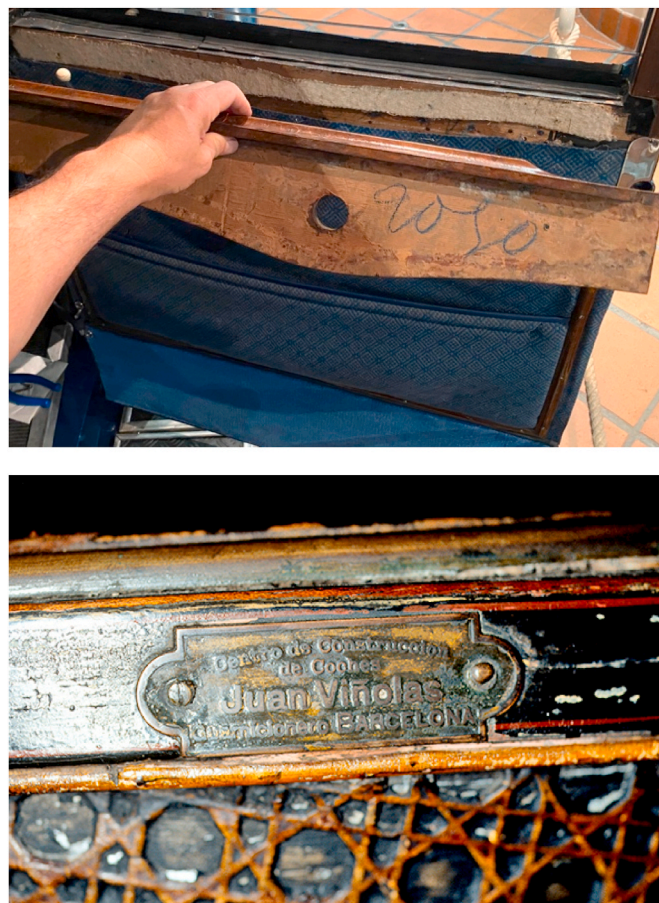
Fig. 8. Historical markings can help to clarify the local and chronological context of elements and materials preserved on a vehicle. (a) Body number 2090 of a 1931 Delage D8L, applied by the upholsterer during the production process with blue wax crayon on the back of a wooden interior trim panel. Such markings, both how they were applied, and their location can give clues to the manufacturer of the body, its upholstery and interior trim, as well as to their initial affiliation with the vehicle in question. (b) A coach builder’s plaque on a 1900 Renault type C, relating to body modifications commissioned by the first owner located in Spain. (For interpretation of the references to color in this figure legend, the reader is referred to the Web version of this article.)
