# Mid and long-term ecological impacts of ski run construction on alpine ecosystems

Csilla Hudek<sup>1,4</sup>✉, Elena Barni<sup>2</sup>, Silvia Stanchi<sup>1,3</sup>, Michele D'Amico<sup>1</sup>, Emanuele Pintaldi<sup>1</sup> & Michele Freppaz<sup>1,3</sup>

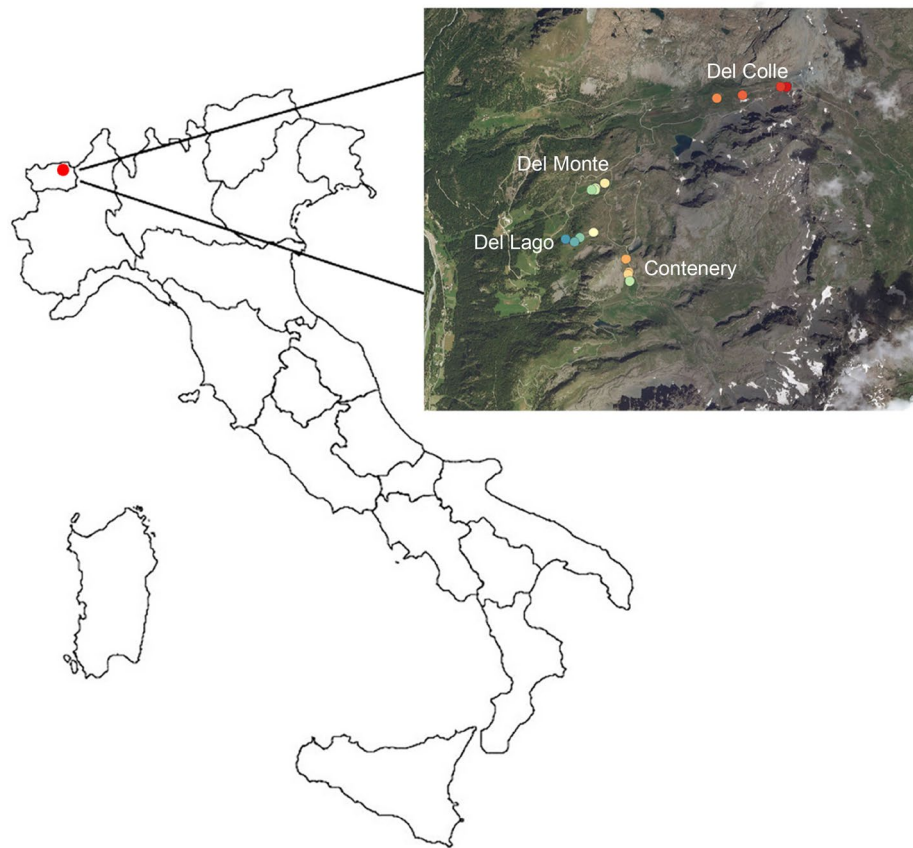
**Figure 1.** Map of the study area in the Monterosa ski resort with the plots in the ski runs; Del Colle (A, B, C, D), Contenery (E, F, G, L), Del Monte (H, J, K, M) and Del Lago (I, N, O, P) (Aosta Valley, NW-Italian Alps). (The map was created using Q GIS software (version 3.3.0) then modified and assembled using Photoshop version (CS6)).

**Study sites.** The research was performed on ski runs located in the Monterosa ski resort (45°51'35" N; 7°45'35" E), in the NW Italian Alps (Champoluc, Val d'Ayas, Aosta) (Fig. 1). Each ski run was paired with a control site off the ski runs, representing undisturbed conditions. The sites (ski runs and the corresponding control locations) are located between 2,100 and 2,700 m a.s.l. with an inner-alpine subcontinental climate. The average precipitation in Champoluc weather station is 722 mm year<sup>-1</sup> (1,560 m a.s.l.) while the mean annual air temperature in the elevating gradient ranges between 2 and – 2 °C<sup>24</sup>. Maximum precipitation during May and June is 80 mm each, while the winter months are generally dry, with a mean of 130 mm (snow water equivalent) during the winter trimester<sup>24</sup>.

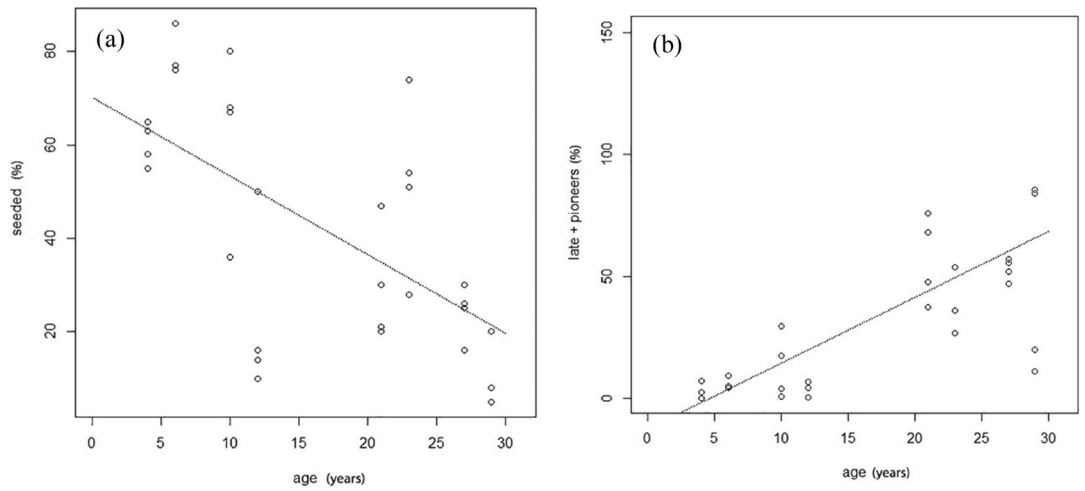
**Figure 2.** (a) Seeded species cover (%) and (b) Native species cover (pioneers + late successional, %) change on ski runs correlated to years after seeding.

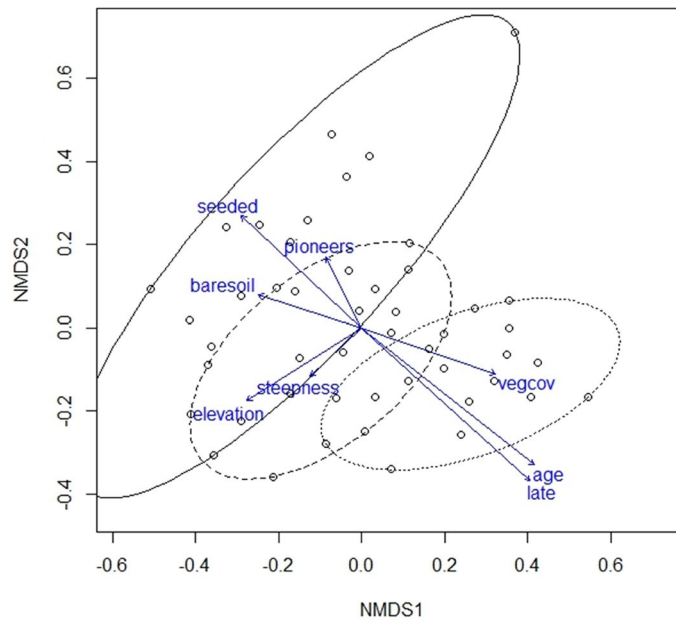
**Figure 3.** Non-metric multidimensional scaling (NMDS) of native plant (pioneer + late-successional species) cover at each study site. Ellipses enclose samples corresponding to 2000 surveys (solid line), 2017 surveys (dashed line), control surveys (dotted line). Arrows indicate the direction of the vegetation and environmental variables explaining differences in species composition among samples.

The NMDS ordination (Fig. 3), carried out on the cover values of native plant species (i.e. pioneer + late-successional, without seeded species), showed that study sites were arranged along the first ordination axis which strongly reflected a time gradient (Table 1). On the left side of the diagram were the ski run plots surveyed in 2000, several years after machine-grading and seeding, dominated by seeded species with an uneven occurrence of pioneer species. On the right side were the undisturbed control plots, with the dominant vegetation being late-successional species. The ski run plots re-surveyed in 2017, between 20 and 30 years after ski construction and hydroseeding, appeared in the middle of the first axis, highlighting the shift in plant species composition over time.

The second ordination axis reflected an elevation gradient (Table 1). The earliest surveyed plots (2000) are spread broadly along this axis, showing a more uneven cover and composition of native species relating to elevation, while the latest (2017) were more gathered, similarly to control plots, indicating a vegetation cover more homogeneous with respect to elevation.

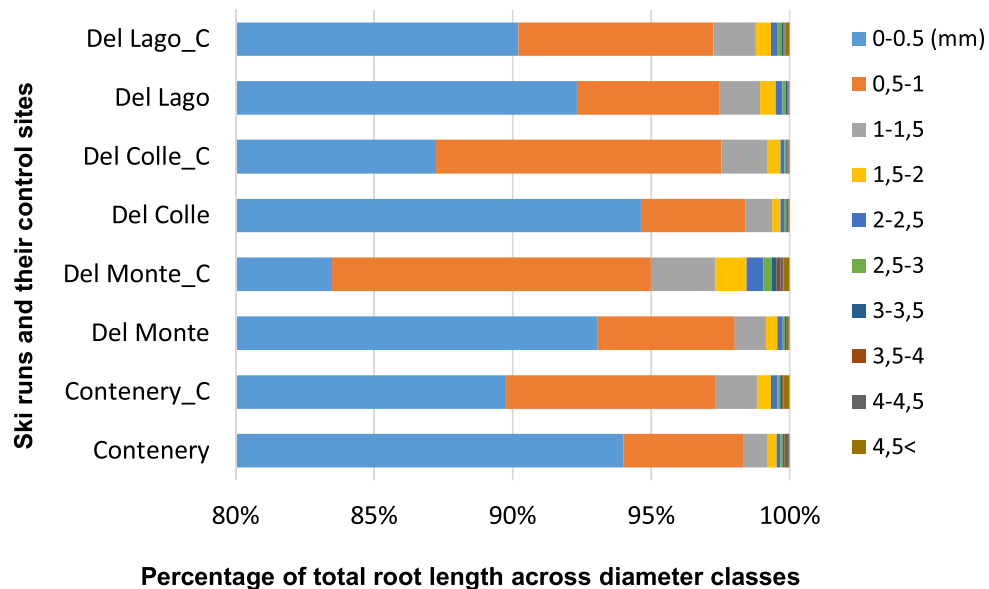
**Figure 4.** Root length distribution in different root diameter classes of the four machine-graded ski runs (Del Colle (A, B, C, D), Contenery (E, F, G, L), Del Monte (H, J, K, M) and Del Lago (I, N, O, P)) and their corresponding undisturbed control sites (Del Colle\_C (AC, BC, CC, DC), Contenery\_C (EC, FC, GC, LC), Del Monte\_C (HC, JC, KC, MC), Del Lago\_C (IC, NC, OC, PC)) measured in 2017.

The highest mean RL (83–94%) was in the diameter class  $0 < L < 0.5$  (mm) for all sites followed by the class  $0.51 < L < 1$  (mm) with 3.7–11.4% and class  $1.1 < L < 1.5$  (mm) with a 2.3–0.9% (Figure 4) (year 2017). Roots in larger diameter classes  $1.51 < L < 2$  (mm) make up less than 1% of the TRL for all ski run samples and 2% for the control plots. Results from control plots showed a higher RL distribution in higher diameter classes compared to ski run results. Apart from the highest elevation control plot, all control plots had root diameters higher than  $4.51 < L < 5$  (mm) while results from ski runs showed that root diameter over 3.5 mm was only found on one mid-elevation ski run. The mid-term results are in line with the results from 2017. The TRL results showed significant differences between ski runs in 2000 ( $p < 0.01$ ) but not in 2017 and the difference between the ski runs and their corresponding control sites were significant only at mid-altitude (2,300 m a.s.l.) ( $p < 0.05$ ).
