Journal section: Oral Medicine and Pathology  
 Publication Types: Research

## A zinc-doped endodontic cement facilitates functional mineralization and stress dissipation at the dentin surface

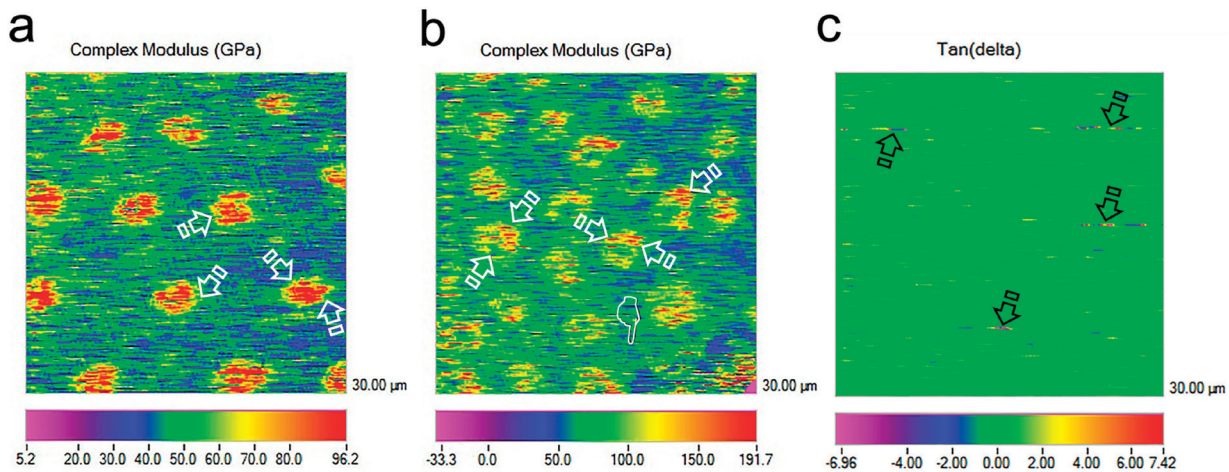
**Fig. 1.** (a), Scanning mode nano-DMA analysis of the map of the complex modulus ( $E^*$ ) at the EDTA+oxapatite group, obtained at 21 d storing in SBFS. In the color scheme shown, the redder color corresponds to higher values of the locally measured moduli, potentially associated to  $E^*$  of intratubular mineral precipitation. The intertubular dentin was represented by the blue color. Peritubular dentin was associated with the green to yellow color (arrows). (b), Scanning mode nano-DMA analysis of the map of the complex modulus ( $E^*$ ) at the EDTA+calciapatite group, obtained at 21 d storing in SBFS. In the color scheme shown, the redder color corresponds to higher values of the locally measured moduli, likely corresponding to the highest resistance to deformation of the peritubular dentin at both time points (arrows).  $E^*$  referred to intertubular dentin appears bluish green (pointers). The pixel data array at the mapping are organized according to a  $E^*$  distribution that concur with a clear delimitation between intertubular and peritubular dentin (faced arrows). (c), Scanning mode nano-DMA analysis of the map of the  $\tan \delta$  at the PA+oxapatite group, obtained at 21 d storing in SBFS. In the color scheme shown, the redder color corresponds to higher values of the locally  $\tan \delta$  value moduli, potentially associated to  $\tan \delta$  of intratubular mineral precipitation. The capacity for getting rid of the energy at peritubular dentin is represented by the blue-red-yellow diffused marks (arrows) at the mapping.

The scanning mode nano-DMA analysis of EDTA+oxipatite, EDTA+calciapatite and PA+oxipatite are contained in Fig. 1. Fig. 2 shows topographic mapping obtained with AFM from dentin surfaces treated with EDTA+calciapatite, PA+calciapatite and PA+oxipatite, at 24 h (I) and 21 d (II) of storage time.

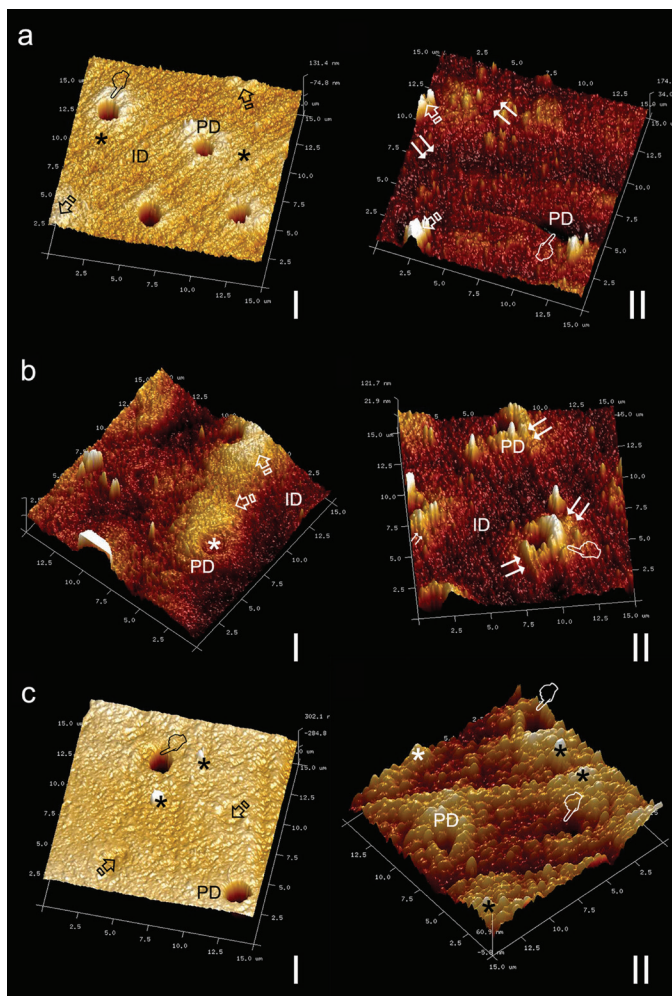
**Fig. 2.** a), Topography mapping of dentin surface treated with EDTA+calciapatite obtained by AFM after 24 h (I) and 21 d (II) storing in SBFS. Peritubular (PD) and intertubular (ID) dentin are clearly observed. Some tubules appear totally occluded (arrows) or empty (pointers) at both storage times. Morphologically, homogeneous transition between peritubular and intertubular dentin (asterisks) characterizes the dentin surface at 24 h, but a neat stick-slip image crossed over the dentin surface stored 21 d time point (double arrows). b), Topography mapping of dentin surface treated with PA+calciapatite obtained by AFM after 24 h (I) and 21 d (II) storing in SBFS. Peritubular (PD) and intertubular (ID) dentin mineralization is evident. Some tubules appear partially occluded (asterisk). Morphologically, homogeneous transition between peritubular and intertubular dentin (arrows) characterizes the dentin surface at 24 h time point. Stick-slip images and little rod-like minerals (double arrows), as bridge-like structures as sight of energy dissipation were observed anchoring both peritubular and intertubular dentin, though some peritubular cuffs appeared debonded (pointer) c), Topography mapping of dentin surface treated with PA+oxapatite obtained by AFM after 24 h (I) and 21 d (II) storing in SBFS. Remarkable peritubular dentin (PD) collars are clearly defined in the intertubular dentin (ID). Tubules are totally occluded (arrows) or mineral-free (pointers). Knob-like mineral precipitates (asterisks) deposited on the dentin surface. No sign of stress concentration was discovered through the dentin surface due to the homogeneity of viscoelastic properties between peritubular and intertubular dentin, especially at the  $\tan \delta$  values.

Strong processes of precipitated minerals covered, occasionally, the dentin surface. They concentrated, mostly, at the peritubular-intertubular dentin border (Figs. 2a•II, 2b•II, 3a). These mineral processes were absent in dentin treated with PA+oxipatite (Figs. 2c•II, 3b).

The topography mapping obtained by AFM confirmed the existence of a neat stick-slip image crossing over the dentin surface treated with EDTA+calcypatite (Fig. 2a•II) and PA+calcypatite (Fig. 2b•II) at 21 d time point. It is speculated that these precipitated minerals, located at the peritubular-intertubular dentin limit, may be assumed as frictional pullout with cracks originated as a consequence of discrepant viscoelastic properties between both structures. Fatigue cracks in restored teeth are typically oriented perpendicular to the dentin tubules (19). Moreover, crack bridging by the collagen fibrils could enhance the toughness along direction parallel to the tubule axes (20). Cracks extending parallel to the tubules (Fig. 2b•II) experienced the highest degree of bridging and gives rise to the larger fracture toughness for this orientation (19). Calcypatite contains calcium hydroxide  $[Ca(OH)_2]$  (Table 1). Below the first zone of necrosis that results after its application on dentin, Holland, 1971 (21) described the existence of mineralized tissue resembling a bridge, composed of calcium salts and calcium-protein complexes from around 7th to the 10th day following application. The bridge also appeared in the walls of dentinal tubules or even beyond these structures (21). These mineral bridges or asperities enhance the interface strength in biological materials (22). Comparable morphological results were

obtained in the present study, where it is speculated that an extended layer of new mineral with frictional pullout crossed over a part of the dentin surface (Fig. 2b•II). Nevertheless, this calcified barrier is porous and weakens roots when placed for extended periods. These observations could also suggest that there is relatively weak bonding between the peritubular and intertubular components (23) in samples treated with calceypatite, as evident from debonded peritubular cuffs in Fig. 2b•II. Dentin surfaces treated with EDTA+oxipatite showed a ~13.5 fold lower  $\tan \delta$  values at peritubular dentin than at intertubular dentin, after 21 d of storage time (Table 3).  $\tan \delta$  reflects how well a material can get rid of the energy. The lower  $\tan \delta$ , the greater the proportion of energy available in the system for recoil and/or failure (24). At the 2-D contour map of the  $\tan \delta$  distribution in a specimen of dentin surface treated with EDTA+oxipatite, at 21 d of storage time (Fig. 1a), it was observed that  $\tan \delta$  values of peritubular dentin decreased an approximately 93% in comparison with the intertubular dentin. This gave rise to a zone of energy concentration at this junction. Topography mapping of dentin surface treated with EDTA+oxipatite obtained by AFM permitted to observe crack formations (Fig. 3a) and multiple zones of little rod-like minerals, as bridge-like structures anchoring both type of dentin. These bridges might be influential in effectively resisting crack propagation (18), after compensating the bridging stress intensity (5). Nevertheless, when the dentin surfaces were treated with PA+oxipatite,  $\tan \delta$  values, obtained at 21 d of storage time proved to be practically similar, 0.17 and 0.16 at intertubular and peritubular dentin, respectively (Table 3) (Fig. 1c). Thereby, zones and signs of energy concentration did not appear at the dentin interface (Fig. 2c•II), due to the homogeneity of viscoelastic properties, and the pullout was not evident in this PA+oxipatite treated dentin, suggesting that this interface is tightly bonded (Fig. 3b). Perhaps, the higher mineralization of dentin with PA+oxipatite results in an increase of cohesion between the two constituents, thereby decreasing the relative interfacial sliding with crack growth (23). This remains to be addressed through additional study. The presence of  $Zn^{2+}$  in oxipatite applied on PA-treated dentin performs as Ca/P growth inhibitors (25), favoring intrafibrillar mineralization of collagen (26) linked to the raise of  $H_i$  (Table 2). After PA demineralization, and further oxipatite application, some Ca positions in apatite could be filled by the divalent cation  $Zn^{2+}$  (6). As binding constant of Zn is 8.7 and it is 6.8 for Ca, therefore, Zn can compete with Ca for binding even at a very low concentration. An isomorphous substitution can be obtained when  $Ca^{2+}$  is replaced by  $Zn^{2+}$  into dentin HAp (27). Son *et al.*, 2011 (28) hold that based on crystal structure theory, one can expect that if, in HAp,

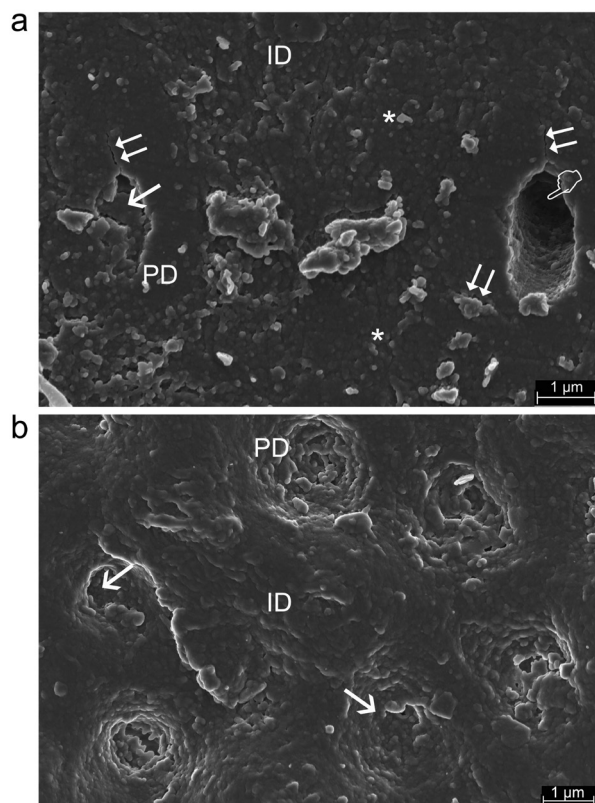
**Fig. 3.** a) Representative FESEM topographic images of treated dentin with EDTA+oxipatite after 21 d storing in SBFS. Mineral deposition is completely covering the dentin surface (asterisks). Partially filled (arrow) or totally empty (pointer) tubules were shown. Crack extending through the peritubular dentin (PD) and at the peritubular/intertubular (ID) dentin limits can be observed (double arrows). b) Representative FESEM topographic images of treated dentin with phosphoric acid (PA)+oxipatite after 21 d storing in SBFS. Dentin resulted totally mineralized at both peritubular (PD) and intertubular (ID) dentin and the mineral formations did allow the display of the entrance of tubules, most of them occluded (arrows). Any peritubular cuff appeared debonded.
