“Valve”-Type Retainment of Flexible Ureteroscope in the Distal Ureter

Abstract

Case Presentation: The patient was a 53-year-old male with a 7 mm left upper pole renal stone managed by fURS and laser lithotripsy. A ureteral access sheath (UAS) was not deployed during the procedure. During fragmentation of the stone, we were unexpectedly unable to retract the ureteroscope from the ureter. Herein, we describe the procedural details leading up to the complication and the careful maneuvering required to remove the ureteroscope without damaging the ureter or the instrument.

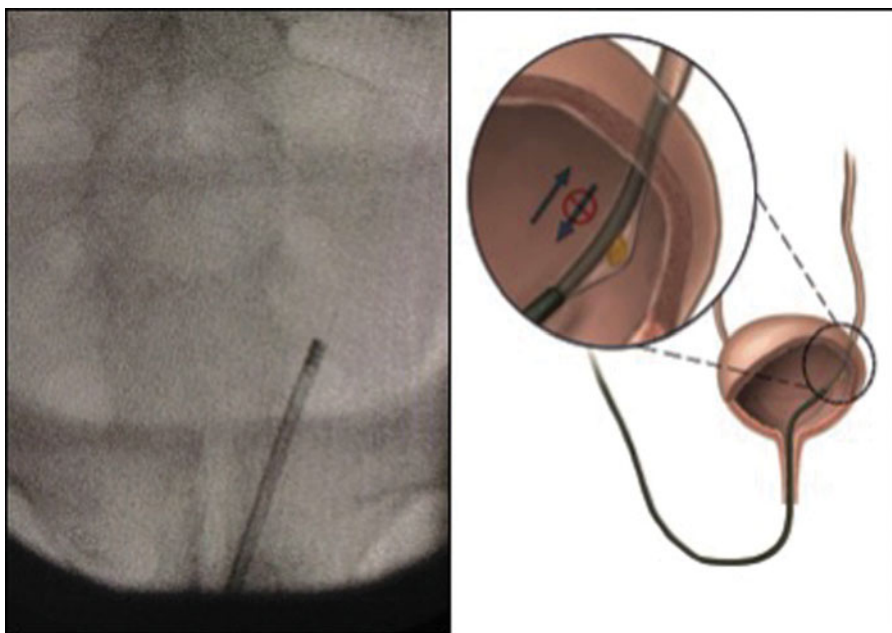
FIG. 2. X-ray film of impacted flexible ureteroscope in the distal ureter and possible mechanism of impaction.

ureteroscope and the distal ureter. We were able to advance the ureteroscope toward the proximal ureter; however, the endoscope could not be withdrawn past the distal ureter. The laser fiber was subsequently removed and multiple unsuccessful attempts were made to retrieve the ureteroscope. Therefore, we proposed the following mechanism: stone fragments were abutting the coating at the distal end of the ureteroscope and the ureteral wall as shown in Figure 2. At that point, we placed a guidewire through the working channel of the ureteroscope and a Foley catheter was placed for proper drainage of the bladder. Although there was no evidence of significant bleeding, endoscopic visualization was signifi-

our type of complication has never been presented before. The mechanism used was as follows: the stone fragment was abutting the outer coating of the distal end of the ureteroscope, which is fluted (Fig. 4) from one side of the ureteral wall to the other. Slow rotational movements under visual control resulted in instrument withdrawal. Also, we believe that the muscle relaxants injected during the procedure facilitated ureteral muscle relaxation and significantly helped to remove the scope.

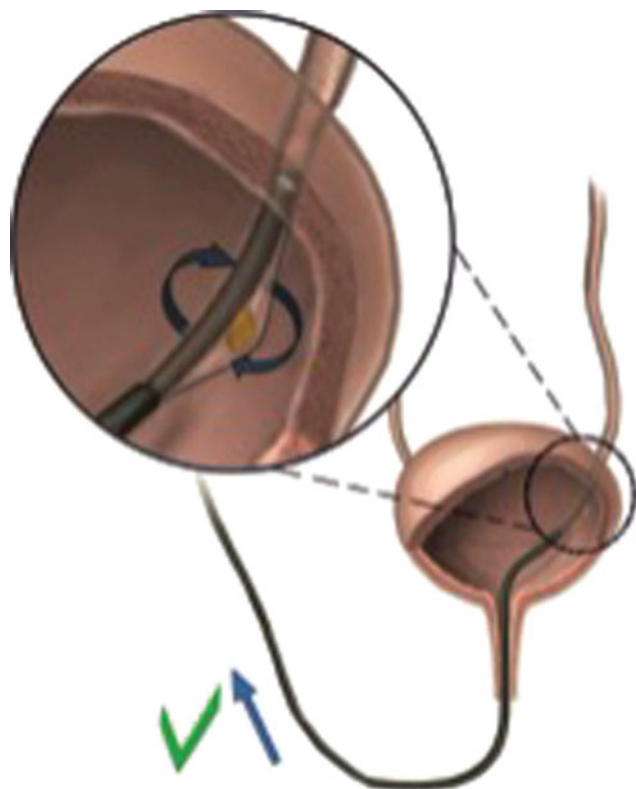
FIG. 3. Mechanism of instrument retrieval.

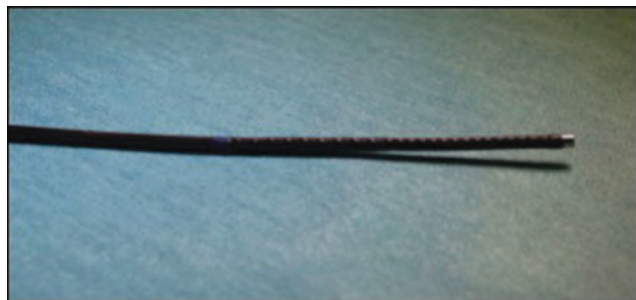
FIG. 4. Outer coating of a distal end of the flexible ureteroscope.
