Imaging of cartilage repair procedures

Abstract

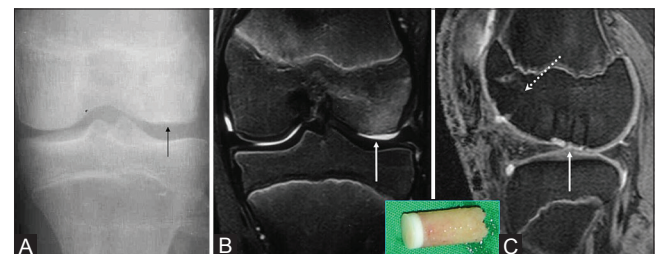
Figure 3 (A-C): Mosaicplasty after bike accident in a 13-year-old boy. (A) Radiograph shows flattening of the lateral femoral condyle (arrow). (B) Coronal Short Tau Inversion Recovery (STIR) MRI shows osteochondral lesion (arrow). (C) Osteochondral plugs (inset) were harvested from non-weight-bearing surface (dotted arrow) and transplanted at site of defect (solid arrow) at weight-bearing articulating surface. Postoperative sagittal Proton Density (PD) image shows excellent congruity of repair tissue (solid arrow) with parent cartilage. The repair tissue shows normal thickness, signal and smooth surface

This entails harvesting osteochondral plugs from a non-weight-bearing area and transplanting at the site of the cartilage defect in the weight-bearing segment [Figures 3

and 4]. The aim of surgery is to have osteochondral plugs perpendicular to the articular surface and congruent with the adjacent normal cartilage. As compared to the microfracture technique, where the repair tissue is fibrocartilage, OATS involves transplantation of the patient's own hyaline cartilage. As compared to cadaveric allografts, osteochondral autografts are less likely to induce immune-mediated graft rejection and rate of graft incorporation is higher.^[7] Limitations of this technique are possible donor site morbidities.

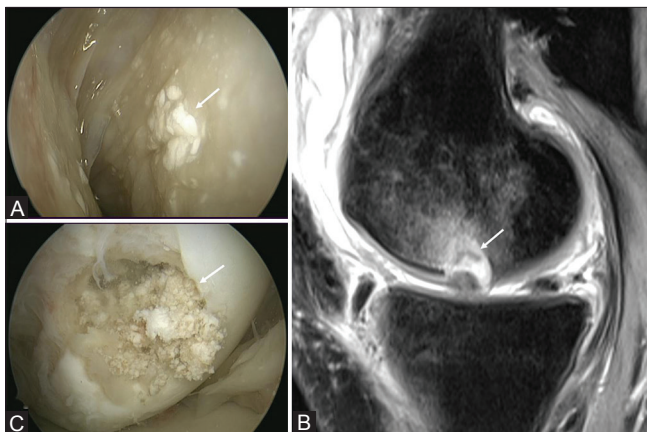
Figure 6 (A-C): Failure of synthetic osteochondral scaffold implant with a MOCART score of 10. (A) Follow-up arthroscopic image show foreign body reaction with synovitis and (B) failure of graft incorporation (arrow). (C) Follow-up sagittal proton density MRI shows failure of graft incorporation with incomplete integration, damaged surface, and inhomogeneous signal of graft

These involve using artificial osteochondral scaffolds to replace the focal defects of bone and cartilage [Figures 5 and 6]. The technique is similar to mosaicplasty, except that there is no need for graft harvest. The advantage of this technique is the absence of donor site morbidity associated with OATS. The disadvantage of the present generation of artificial scaffolds is the risk of immune reactions, early graft resorption with collapse, and incomplete graft resorption.^[8]
