# A Forgotten Entity following Breast Implant Contracture: Does Baker Need a Change?

Arch Plast Surg 2022;49:360–364.

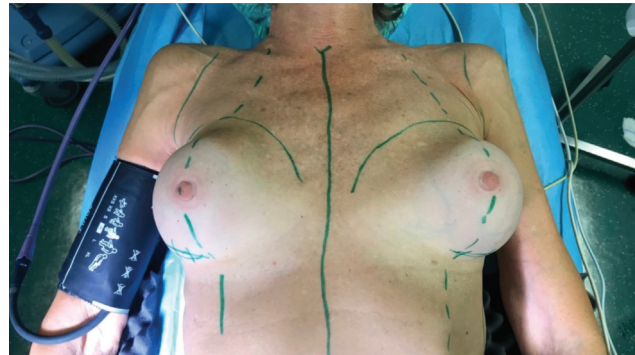
**Fig. 1** The patients' preoperative clinical presentation. The patient reported firm, painful, and mineralized breast implants with deformation, consistent with the clinical diagnosis of capsular contracture.

The first clinical examination showed significant deformation of the projection of the breast and a concomitant displacement of the implant, suggesting dislocation and rupture of the breast implant ( $\rightarrow$ Fig. 1).
