## All-inkjet-printed thin-film transistors: manufacturing process reliability by root cause analysis

We report on the detailed electrical investigation of all-inkjet-printed thin-film transistor (TFT) arrays focusing on TFT failures and their origins. The TFT arrays were manufactured on flexible polymer substrates in ambient condition without the need for cleanroom environment or inert atmosphere and at a maximum temperature of 150 °C. Alternative manufacturing processes for electronic devices such as inkjet printing suffer from lower accuracy compared to traditional microelectronic manufacturing methods. Furthermore, usually printing methods do not allow the manufacturing of electronic devices with high yield (high number of functional devices). In general, the manufacturing yield is much lower compared to the established conventional manufacturing methods based on lithography. Thus, the focus of this contribution is set on a comprehensive analysis of defective TFTs printed by inkjet technology. Based on root cause analysis, we present the defects by developing failure categories and discuss the reasons for the defects. This procedure identifies failure origins and allows the op

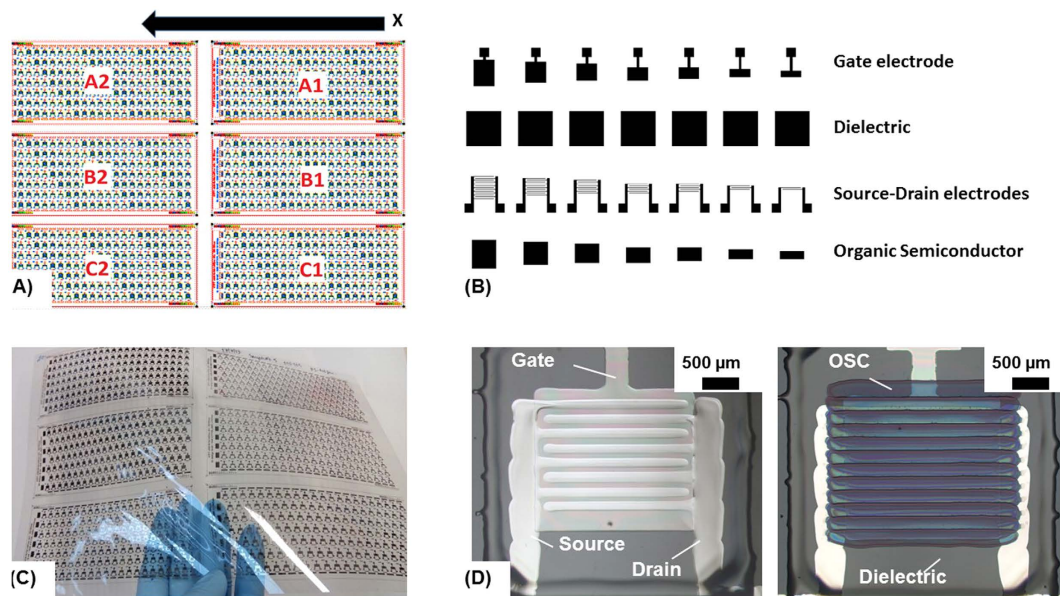
**Figure 1.** (A) Layout of the design for 924 TFTs arranged in six arrays each with 154 TFTs based on the BGBC architecture, (B) print pattern layout of the individual layers of the TFTs having different active areas by variation of the gate, S-D and OSC layer layout which results in the different W/L ratios; (C) all-inkjet-printed TFT array as designed in (A) on flexible PEN substrate and (D) microscopic images of TFTs with W/L of 140 showing the TFT layer stack with (right) and without (left) OSC.

**Printing process development.** All-inkjet-printed TFTs arrays were manufactured as described in materials and methods on DIN A4-sized PEN films. The scheme in Fig. 1A shows the printing origin marked with x and the printing direction for each layer. Thus, the printing starts with the array A1 line by line and finishes with array C2. Printing was performed unidirectional, so that the deposition takes place only in the indicated direction. This specific printing direction was mainly chosen to allow the deposition of the S-D electrodes along the printing transfer path resulting in well-defined line morphologies. Thus, any misalignment effects are avoided.

A scheme of the layout is shown in Fig. 1A. The unidirectional printing direction is indicated in Fig. 1A with a black arrow and the printing origin is marked with  $x$ . Further information about the printing direction is available in Supporting Information (Fig. S1). The influence of the printing direction on morphological properties of deposited lines was studied elsewhere<sup>20</sup>. As depicted in the Fig. 1B, the print pattern layout consists of four separated layers: (i) gate, (ii) dielectric, (iii) S-D electrodes, and (iv) OSC. The area of the dielectric layer was kept constant in order to have identical layer forming conditions and thus identical morphological layer characteristics for all the TFTs.

The final device is shown in Fig. 1D. The left image depicts the TFT without the OSC in order to observe clearly the gate, dielectric and S-D electrodes. The image on the right in Fig. 1D shows the TFT including the OSC layer. Fig. 1C shows the all-inkjet-printed A4-sized PEN substrate with 924 TFTs.

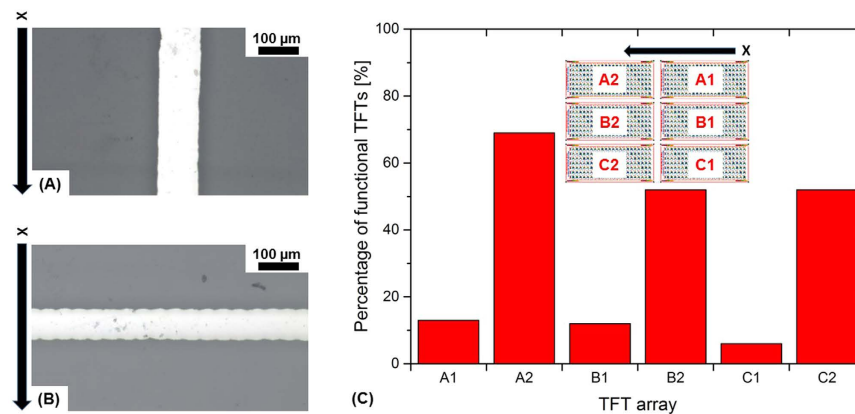
**Figure 2.** Inkjet-printed line with silver ink on PEN substrate deposited (A) along printing direction and (B) perpendicular to printing direction; (C) percentage of functional TFTs per TFT array (each array has 154 TFTs).

The influence of the printing direction on the morphology of the deposited electrode is depicted in Fig. 2A,B. Printing perpendicular to the finger electrode directions usually results in lower line width, lower edge sharpness and higher line thickness and roughness<sup>20</sup>. Therefore, the homogeneity is lower compared to the line morphology obtained by printing along the printing direction increasing the risk of device failures. The occurrence of the different line morphology as a function of printing direction is mainly due to the droplet jetting frequency. It is much higher perpendicular to the printing direction than along the printing as explained in our previous works<sup>20</sup>. Detailed studies about line formation were done by Soltman *et al.*<sup>21</sup> demonstrating the importance of print resolution and the droplet ejection frequency on the morphology of the inkjet-printed lines.

**TFT manufacturing yield as a function of array position.** Figure 2C shows the percentage of functional TFTs per printed array. The yield ranges between 69% in array A2 and only 6% in array C1. In average, the manufacturing yield is about 34%. There is obviously a very high yield difference on the printed DIN A4 substrate between the different arrays. The arrays A1, B1 and C1 have a much lower yield than A2, B2 and C2. The final yield strongly depends on the position of the arrays on the substrate. In the arrays A1, B1 and C1, the printing process starts moving to A2, B2 and C2 and finally moves back and starts again. Thus, A1, B1 and C1 represent the parts that are printed first (before A2, B2 and C2) after a longer period of non-jetting when the printhead is moving back from the end of the substrate to the starting point. This period of non-jetting causes instabilities in the droplet formation process. Some of the droplets are not formed or not formed properly. Thus, the deposition process is disturbed. Droplets might deviate from the targeted position on the substrate due to a quality loss in jet straightness. Several DIN A4 substrates using the same TFT design were manufactured using similar printing parameters to confirm this behavior. We found that the trend is highly reproducible and all the time similar to Fig. 2C. The average yield varied about  $\pm 10\%$ .

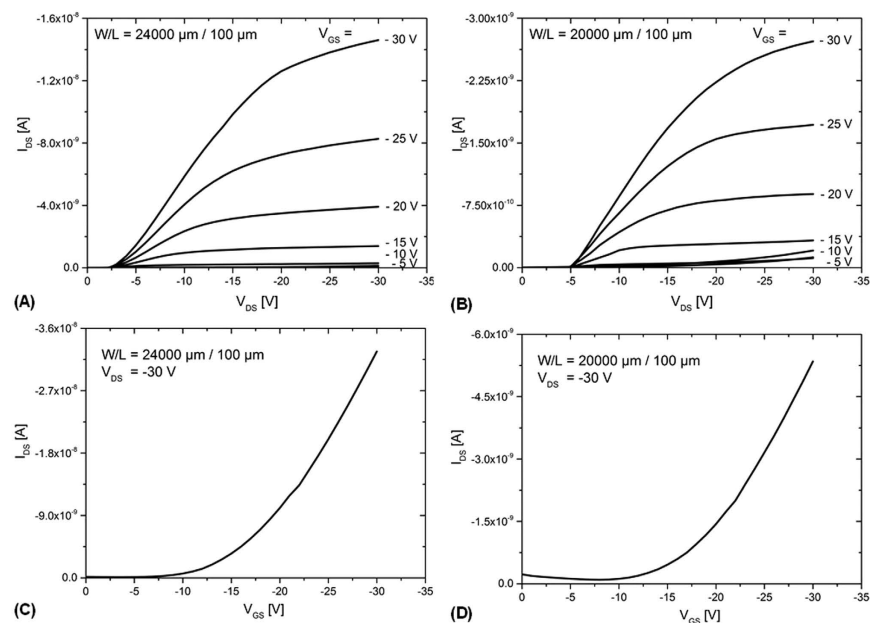
**Figure 3.** Electrical characteristics of the all-inkjet-printed TFTs showing exemplarily the TFT performance of the best functional devices with (A) output curves and (C) transfer curve as well as the worst functional device with (B) output curves and (D) transfer curve.

**Basic electrical characteristics and variability of the TFTs.** The performance of the all-inkjet-printed TFTs is shown exemplarily in Fig. 3 based on typical current-voltage ( $I$ - $V$ ) or output characteristics and transfer curves measured in saturation region.

Figure 3A,C show the output and the transfer characteristics for one of the best functional TFTs measured ( $W/L = 240$ ). Fig. 3B,D show the electrical characteristics for a bad performing device ( $W/L = 200$ ). Both  $I$ - $V$  characteristics are highly non-linear for low  $V_{DS}$  voltages. Source and drain contacts are not ohmic. This might be caused by the formation of a high resistive area in the vicinity of the drain and source electrodes or a barrier that impeded carrier injection. The major difference between the two TFTs is on the on/off ratio. The best TFT shows a significant higher current modulation.

Comparatively, good and bad performing devices do not show dramatic differences in threshold voltage or in field effect mobility. This suggests that the major source of variability is due to variations on the TFT off-current.

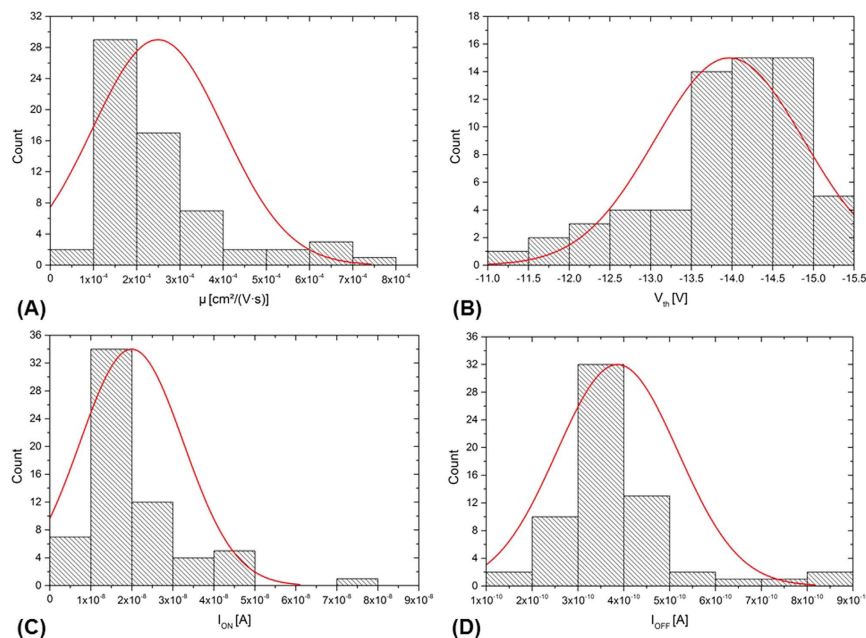
**Figure 4.** Histograms showing the parameter distribution of the all-inkjet-printed TFTs: **(A)** mobility, **(B)** threshold, **(C)**  $I_{ON}$  and **(D)**  $I_{OFF}$  distribution.

Figure 4 shows exemplarily the variability of 64 functional TFTs with a  $W/L$  of 140 based on histograms of various TFT performance values. Fig. 4A represents the mobility that does not clearly follow the normal distribution curve. It is more close to the Weibull distribution. The mobility in saturation regime is on average  $0.00026 \pm 0.00015 \text{ cm}^2/(\text{V}\cdot\text{s})$ . Thus, the deviations among the devices are quite high. This is mainly caused by inhomogeneities of the OSC layer as a consequence of the printing process (see explanations later on) and by changes of the dimensions of the devices, e.g. the channel length and channel width. The maximum mobility value for  $W/L$  of 140 is about  $0.00076 \text{ cm}^2/(\text{V}\cdot\text{s})$ . The maximum mobility taking in consideration all TFT sizes is

0.00082  $\text{cm}^2/(\text{V}\cdot\text{s})$ . Fig. 4B–D represent the distributions of the threshold voltage,  $I_{ON}$  current and  $I_{OFF}$  current, respectively. Compared to mobility, they are more close to a normal distribution. The threshold voltage is on average about  $-14.0 \pm 0.9$  V. The  $I_{ON}/I_{OFF}$  ratio is on average  $55 \pm 41$ . The large distribution of the  $I_{ON}/I_{OFF}$  ratio is mainly caused by the high variation of the off-current. Reasons for the high off-current are variations of the OSC layer dimensions (e.g. thickness) or layer structure and probably also leakage current variations in the dielectric layer.

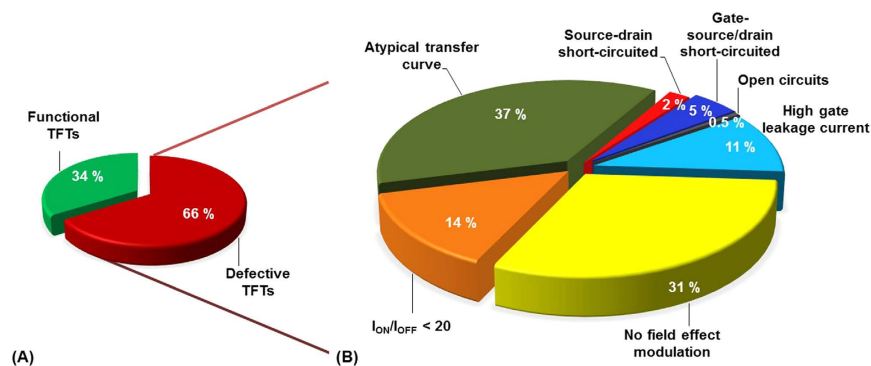
**Figure 5.** Statistical data of 924 all-inkjet-printed TFTs, (A) shows the proportion of functional TFTs to defective TFTs, (B) is a pie chart of the 66% defective TFTs presented in (A), the defective TFTs are assigned to cause of failure categories as defined in Table 1 (percentage is rounded).

**Overview of failures origins causing defective TFTs.** In the following section the focus is set on the defective TFTs to study the different kinds of failures. All the TFTs printed on a DIN A4-sized PEN substrate were characterized as described in the materials and methods and assigned to cause of failure categories. Fig. 5 presents the statistical results of 924 all-inkjet-printed TFTs and Fig. 6 provides an overview of the different failures based on microscopic images. As shown in Fig. 5A, about 34% of the TFTs are functional while 66% of the TFTs are classified as defective. Thus, the process yield is comparable low. Fig. 5B shows in detail the causes of the failures and their distribution.

As shown in Fig. 5B, most of the devices (37%) suffer from atypical transfer curves. Atypical transfer curves characterize a non-monotonic behavior and/or negative slopes in the transfer curve. About 31% of the defective devices are classified as devices with a lack in field effect modulation. About 14% of the defects are related to a low current ratio ( $I_{ON}/I_{OFF} < 20$ ). All these failures are operational instabilities that do not necessarily refer to printing problems but to material or contamination issues, e.g. due to the processing in ambient condition enabling the integration of impurities and water molecules in the TFT stack. The operational instabilities are most probably caused by a high density of trap sites and ionic impurities in the bulk of the dielectric and at the interface between dielectric and the OSC (interface states). Once these traps are filled an internal field is established that effectively shields the external applied gate bias and prevents the observation of field effect modulation. cPVP has been frequently used as gate dielectric in literature but it is also well known for its problematic nature based on hydroxyl groups<sup>33</sup>. The hydroxyl groups are responsible for the flexibility of the material and are reactive groups allowing a simple thermal cross-linking. However, a complete cross-linking of the polymer chain of the material is difficult to achieve<sup>34</sup> – even at a temperature of 150 °C. Usually, hydroxyl groups remain on the surface and in the bulk resulting in polar, hygroscopic properties that act as charge trapping sites. Consequently, electronic in-homogeneities will appear that dramatically influence the device performance. Additionally, water molecules might be absorbed in the dielectric layer during the manufacturing in ambient condition.

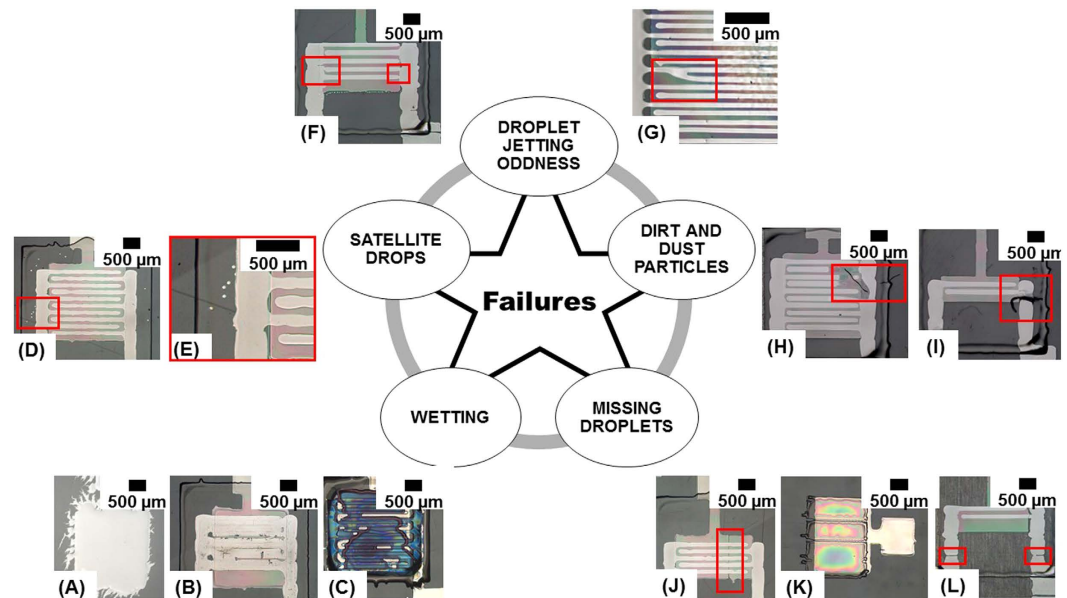
**Figure 6.** Overview of failures detected in the printed layers of the all-inkjet-printed TFTs, (A–C) are failures due to wetting properties of the deposited ink on the printed surface: (A) depicts a printed gate electrode with intense spreading, (B) shows intense ink spreading of the S-D electrodes resulting in a short-circuit and (C) depicts inhomogeneous layer formation of the OSC due to the surface energy contrast between cPVP layer and S-D silver electrodes; (D) shows satellite drops of silver ink and (E) is a magnification of the marked area in (D); (F,G) represent short-circuited S-D electrodes due to odd drop jetting; (H) is an example of a short circuit between S-D and (F) between drain and gate electrode due to dirt and dust particles appearing during printing or the post-processing; (J,L) present TFTs with an open circuit due to missing droplets in the gate and the S-D layer, and (K) shows the dielectric layer with missing lines due to inkjet nozzle clogging.

Also, dirt and dust particles are an important cause for short circuits between the S-D electrodes as shown in Fig. 6H where a fiber-like dirt particle connects S-D electrodes due to the intense coalescence of silver ink along the particle. Dirt and dust particles were recognized frequently on the PEN substrate, since all the printing processes were performed in a standard laboratory without high level of cleanliness in ambient condition. Another cause are the wetting problems of the silver ink on the dielectric layer causing an intense spreading of the S-D electrodes and a short circuit as shown in Fig. 6B. The failure origin is the interaction of surface energy of the cPVP layer and surface tension of the silver ink. Furthermore, wetting problems can appear as well for the gate electrode and the OSC layer. Some of the printed silver gate electrodes showed intense, irregular lateral spreading resulting in a low edge sharpness and thus fringing, as demonstrated in Fig. 6A. The image shows bleeding of the silver ink on the PEN substrate. The reason might be the locally high hydrophilicity of the substrate attracting the highly polar silver ink – e.g. due to electrostatic charging. Via optical characterization, we also found several TFTs that were classified as functional with satellite droplets of silver ink as shown in Fig. 6D,E. These occasionally generated extra droplets can have negative impact on the printed layers e.g. forming short circuits. However, in most of the cases we could not see any influence of the satellite drops on the functionality or performance of the TFTs since they were usually located outside the active area.

A defective dielectric layer can result in short circuits between gate and source or/and drain electrodes or to a high gate leakage current. The defective dielectric layer can be caused by several reasons related to the inkjet process, the nature of the dielectric material and its processing. Failures related to the inkjet process are missing droplets due to jetting problems (that finally result in very thin dielectric layers or dielectric layers with missing lines) or as a misalignment of the print layers to each other e.g. due to axis or print layout inaccuracy. Failures related to the nature of the dielectric material and its processing are e.g. problems with the thermal crosslinking process so that the dielectric will be penetrated by the solvent of the on top printed S-D electrodes. Further reasons for defective dielectric layers are dirt and dust particles. Since the printing was performed in ambient condition, dirt and dust particles in the micrometer range are ubiquitous in the ambient air as well as in the printing system. Fig. 6I depicts an example of a TFT with a dirt particle short-circuiting the gate with the drain electrode.

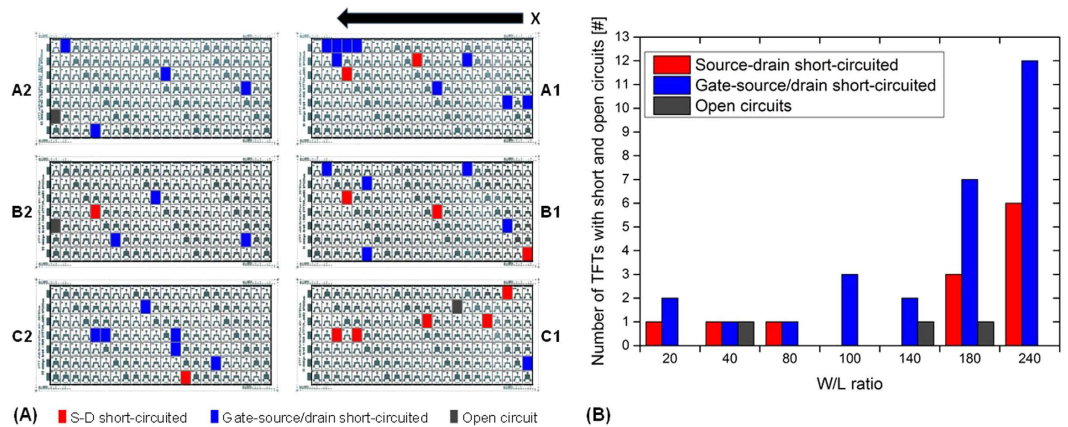
**Figure 7.** (A) Position map of printed TFTs: each color pixel represents the position of a defective TFT: the red pixels indicate TFTs with S-D short circuits, the blue pixels TFTs with gate-source/drain short circuits and grey pixels open circuits; (B) histogram based on the position map showing the number of TFTs with short and open circuits as a function of W/L ratio.

**Short circuits and open circuits.** Figure 7A shows the position map of the printed DIN A4 substrate with 924 TFTs. The basis of the map is an optical scan using a standard flat-bed office scanner of the DIN A4 substrate with all the printed TFTs. Thus, the printed silver layers appear dark green to black due to the high reflectance of their surface. Next to the TFTs, test areas, alignment marks and other patterns can be seen on the scanned image. These patterns were employed to align accurately the different print layers, to identify the arrays and the individual TFTs and to analyze some standard print layer geometries. The scan also allows to identify the spatial uniform size (W/L ratio) distribution of TFTs. The six arrays are marked with frames and grids has been laid on each of the arrays. Based on the grids, the defective TFTs can be marked by coloration of the respective pixel in the grid. Thus, a colored pixel represents the position of a defective TFT. Here, pixels that are marked red represent TFT having short-circuited S-D electrodes and pixels that are marked blue represent TFT with short-circuited gate-source/drain electrodes. Grey pixels are TFTs with open circuits. Obviously, the arrays A1, B1 and C1 are the most affected areas. Especially in case of the short circuits between the S-D electrode. Thus, the trend is similar to that of Fig. 2C. This distribution is mainly caused by the above mentioned first drop problem. The printhead has jetting failures due to the long idle period to move the printhead back to the print start position. In the first arrays, the jetting process is clearly unstable. However, it seems to recover over the time since the arrays A2, B2 and C2 have less short circuits of S-D electrodes. The distribution of the short circuits between gate-source/drain electrodes is less clear. Many defects appear in array A1. The dielectric ink formulation exhibited a superb droplet jetting process characterized by well-formed droplets and a high process stability (observation was made with the installed drop watcher system). The ink is a solution without any nanoparticles simplifying the inkjet printing process compared to the silver nanoparticle inks applied for the TFT electrodes. Thus, we suppose that most of the short circuits through the dielectric are not caused because of issues related to the jetting process, but due to dirt and dust particles and surface spikes of the silver layer underneath. However, no trend can be derived.

The histogram in Fig. 7B shows the defective TFTs as a function of the TFT size given by the W/L ratio. TFTs with larger W/L ratios are more frequently affected by short circuits than TFTs with smaller W/L ratios. The probability of defects increases with the size of the TFT because larger TFTs have (i) a higher number of finger electrodes increasing the risk of a short circuit between them and have (ii) larger overlapping electrode areas that should be separated by the dielectric increasing the risk of short circuits through the dielectric.

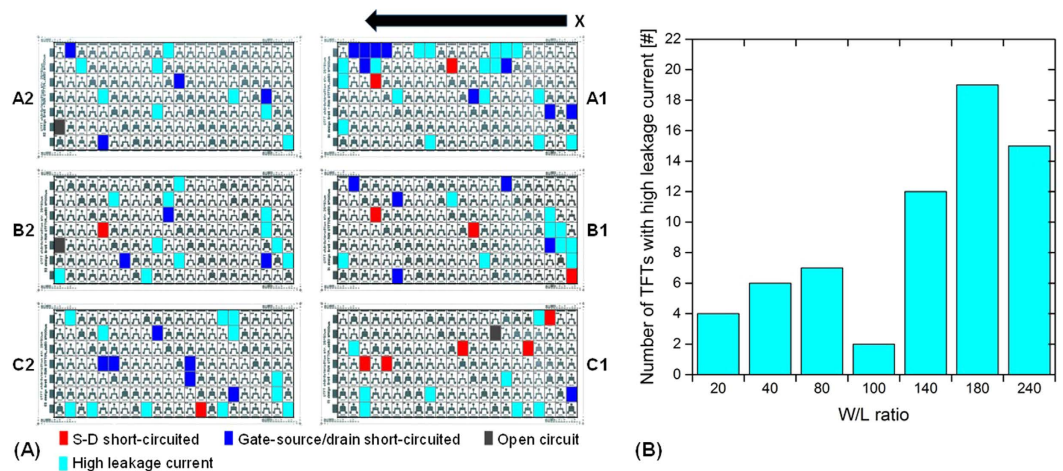
**Figure 8.** (A) Position map of printed TFTs indicating high leakage current devices (cyan pixels); red, blue and grey pixels are defective TFTs determined before; (B) histogram based on the position map showing the number of TFTs with high leakage current as a function of W/L ratio.

**TFTs with high leakage current.** Figure 8A shows a position map of TFTs with high leakage current (cyan pixels). Red pixels indicate the before determined defective devices having short-circuited S-D electrodes, blue pixels the devices with short-circuited gate-source/drain electrodes and grey pixels open circuits. The failures in Fig. 8A are not in all cases clearly correlated to the printing area. However, in total TFTs with smaller area (W/L ratio) are less affected by high leakage currents. Since the jetting process of the dielectric ink formulation was characterized by well-formed droplets and a high process stability, we suppose that most of the TFTs with high leakage current through the dielectric are caused by dirt and dust particles, wetting problems and surface irregularities of the silver layer underneath.

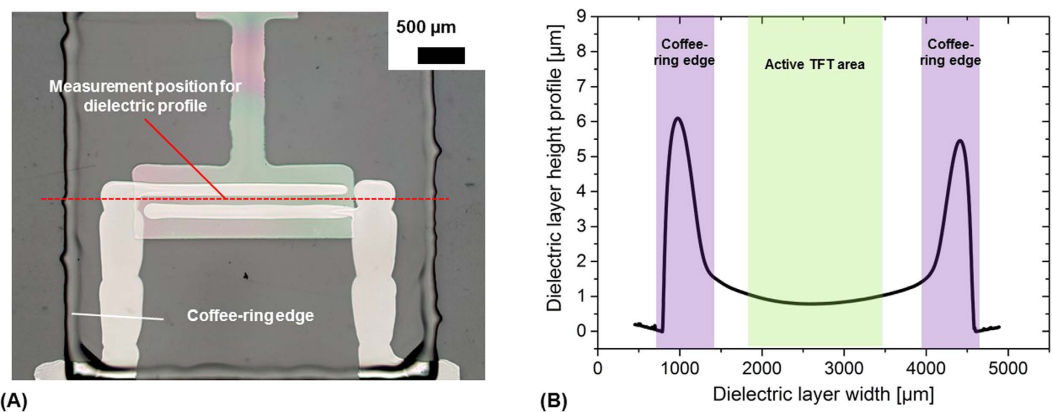
**Figure 9.** (A) Printed layer stack of gate electrode, dielectric layer and S-D electrodes; the dielectric layer has a remarkable coffee-ring edge designed far outside the active area of the TFT; (B) height profile of the dielectric layer determined along the center of the TFT as indicated in (A).

The number of devices with high leakage current is reasonable low. The dielectric layer was optimized during the manufacturing several times. The aim was to facilitate the formation of a smooth and homogeneous dielectric surface. However, inkjet printing of a thin, pinhole-free dielectric layer with smooth surface characteristics and high uniformity is a challenge. We found that thin dielectric layers of about  $1\ \mu\text{m}$  thickness with homogeneous surface morphology were obtained in the center of the TFT by exploiting the well-known coffee-ring effect<sup>36</sup>. Since the edge of the dielectric layer with peak heights of more than  $5\ \mu\text{m}$  is clearly shaped by the coffee-ring effect as shown in Fig. 9, the dielectric layer area was designed comparable large so that the layer edge is far away from the active area of the TFT. Taking advantage of the coffee-ring effect that transports most of the dielectric solute to the edge of the layer, a thin and homogeneous dielectric film was formed reliably in the center of the TFT as indicated in Fig. 9B. In addition to profilometry, FIB cutting was employed to obtain a cross-sectional view of the dielectric layer. Based on spot checks at the different TFT arrays on the substrate, the dielectric thickness is about  $1080 \pm 190\ \text{nm}$ . We could see a slight drift of thickness by comparing the arrays A1, B1 and C1 with A2, B2 and C2. A2, B2 and C2 have in average slightly higher dielectric thickness (about 10%). Representative SEM images showing the cross-sectional areas of the printed TFTs are provided in the Supporting Information (Fig. S5)

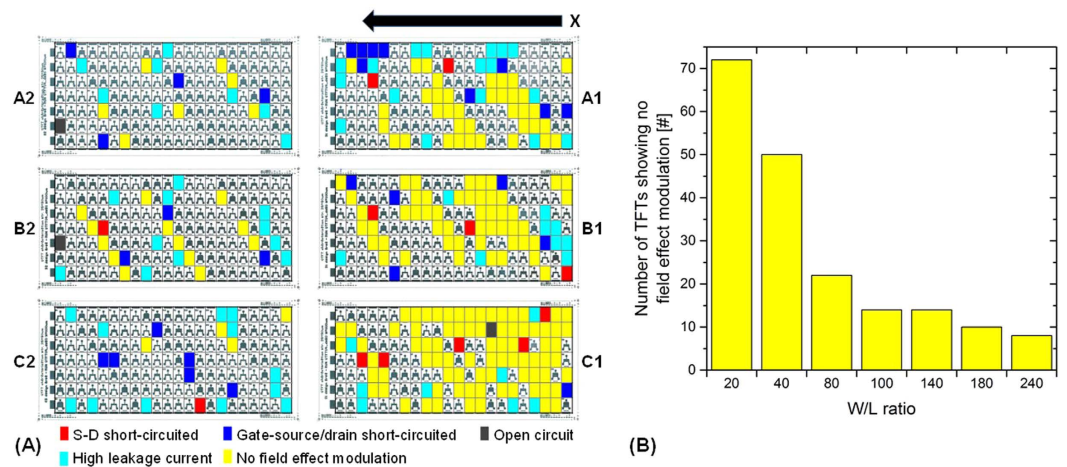
**Figure 10.** (A) Position map indicating TFTs having no field effect modulation colored as yellow pixels; the other colors represent defective TFT determined in test procedures before; (B) histogram based on the position map depicting the number of TFTs showing no field effect modulation as a function of W/L ratio.

Again, most of the defective devices appeared in arrays A1, B1 and C1. Additionally, this type of failure occurs frequently in small area TFTs having low W/L ratio. In the arrays A2, B2 and C2, most of the smaller TFTs (W/L ratio of 20) do not have field-effect modulation as indicated in the position map of Fig. 10A. Therefore, the TFT size

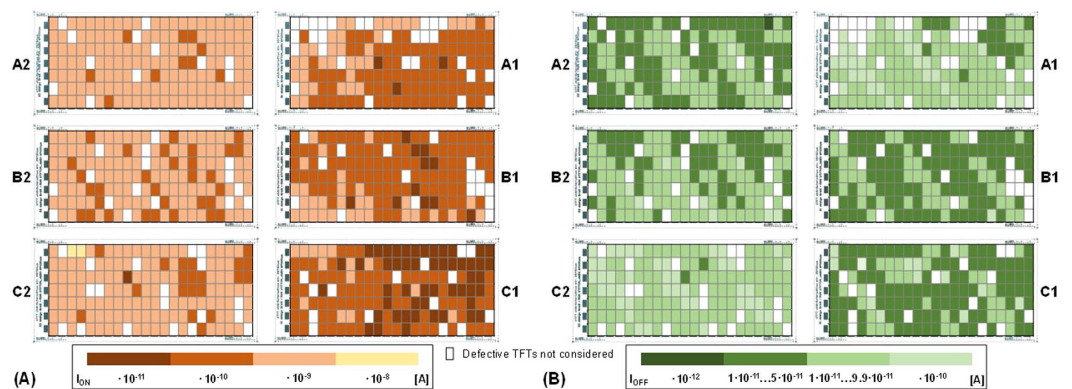
**Figure 11.** Position maps of normalized (A)  $I_{ON}$  and normalized (B)  $I_{OFF}$  values over the substrate; white pixels are all the defective TFTs with short circuits, open circuits or high leakage current.

has a direct relation with the phenomena that degrades the field effect modulation. Fig. 11 shows a position map indicating the normalized  $I_{ON}$  ( $V_{DS} = -30$  V and  $V_{GS} = -30$  V) and  $I_{OFF}$  ( $V_{DS} = -30$  V and  $V_{GS} = 0$  V) values of the TFTs. Obviously, there is a strong gradient in the  $I_{ON}$  and  $I_{OFF}$  values over the substrate. The  $I_{ON}$  shows a clear trend: The TFTs in the arrays A1, B1 and C1 have much smaller currents than the TFTs in A2, B2 and C2. The position map of the  $I_{ON}$  data shows similarities to the map of Fig. 10A. There is a clear relationship between  $I_{ON}$  and TFTs having no field effect modulation (e.g. compare array B2 in Figs 10A and 11A). Again, many TFTs with low W/L ratio have comparable low  $I_{ON}$  values. In average,  $I_{OFF}$  is about  $0.59$  pA  $\pm$  3.3 pA. Most of the values are in the range of 0.1 pA to 0.99 pA as shown in Fig. 11B. Thus, the spread is less for the values of  $I_{OFF}$  than for the values of  $I_{ON}$ .

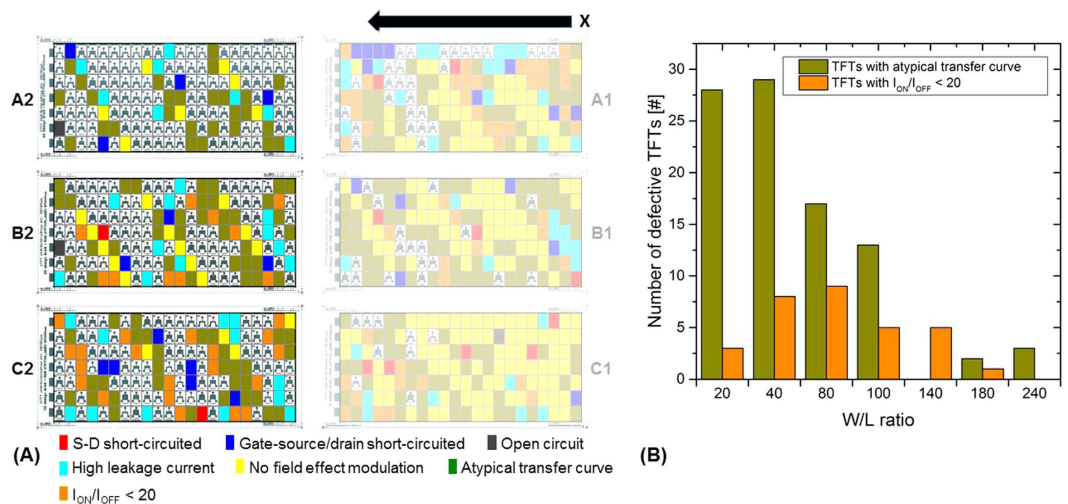
**Figure 12.** (A) Position map indicating TFTs with atypical transfer curve and  $I_{ON}/I_{OFF} < 20$  colored as green and orange pixels; (B) histogram based on the position map showing the number of defective TFTs classified in low  $I_{ON}/I_{OFF}$  ratio and devices having an atypical transfer curve.

**TFTs with atypical transfer curve or/and  $I_{ON}/I_{OFF} < 20$ .** Due to the high quantity of failures that already appeared in the arrays A1, B1 and C1, only the arrays A2, B2 and C2 were considered for the analysis of the stability test to increase the statistical relevance. Fig. 12A shows the failure map and Fig. 12B the histogram. A1, B1 and C1 are marked blurry since they were not considered for the histogram data as explained before. Green pixels represent TFTs with an atypical transfer curve such as curves with non-monotonic behavior and/or negative slope. Orange pixels represent TFTs with  $I_{ON}/I_{OFF} < 20$ . Pixels marked with other colors indicate the TFTs sorted out in the test procedures before. Although A1, B1 and C1 are marked blurry, it can be seen that most of the defects appeared again in these arrays. This seems to be reasonable due to the mentioned first drop problem and in general fault propagation. TFTs of smaller size thus having lower W/L ratio show a more unstable behavior in the transfer curve similar to the trend in Fig. 10A due to gate-bias stress issues and the explained high electrical resistance of the OSC layer due to the low thickness. The size distribution of TFTs with low  $I_{ON}/I_{OFF}$  ratio is not very clear. No trend can be derived. However, taking also into account the arrays A1, B1 and C1, the trend would be quite similar as the one for the TFTs with atypical transfer curves confirming as assumed above that both types of failures have the same physical origin.

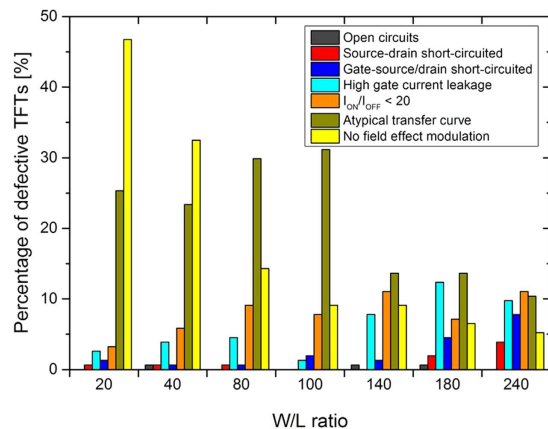
**Figure 13.** Summary of device failure distribution as a function of W/L ratio, 610 defective TFTs out of the 924 all-inkjet-printed TFTs were considered in this graph.

**Summarized distribution of failure origins of defective TFTs.** Figure 13 shows the device failure distribution of the defective TFTs as a function of TFT size represented by the W/L ratio. The trends for the different origin of device failures are clearly visible. Open circuits are related to unconnected silver tracks which appeared only three times in case of 924 printed TFTs. Therefore, the influence of this failure is very low and no statistical relevant data about the failure distribution can be derived. The number of short-circuited TFTs increase with the W/L ratio for both S-D short circuits as well as short circuits between gate and S-D. This is reasonable since the TFT area increases with increasing W/L ratio and thus more droplets and finger electrodes are printed increasing the risk of short circuits, e.g. due to ink coalescence or defects in the dielectric as presented in Fig. 6H,I,K. TFTs with high gate leakage current and  $I_{ON}/I_{OFF} < 20$  follow similar trend. The higher the W/L ratio, the higher the number of TFTs affected.

Figure 13 shows that the smaller the TFT the higher is the number of failures caused by lack of field effect modulation or atypical transfer curves. This trend is not so systematic for the failure caused by atypical transfer curves. However, it is clear that smaller TFTs are more affected than TFTs having larger areas.

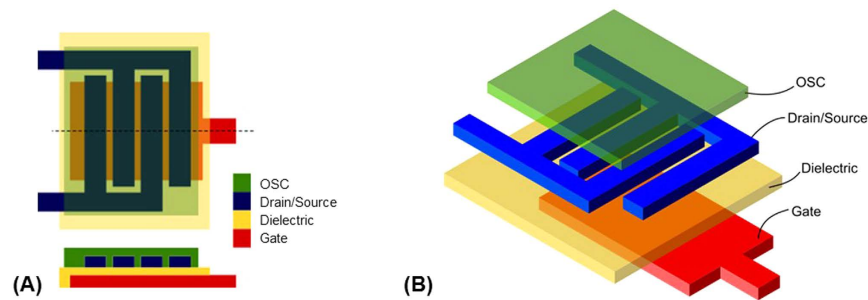
**Figure 14.** (A) Layout of the design of the TFTs as side and top view, (B) 3D representation of the BGBC TFT structure.

The chosen TFT architecture was the BGBC (Bottom Gate Bottom Contact) design to avoid the OSC material suffering from thermal curing processes of silver and dielectric layers needed in a TGBC (Top Gate Bottom Contact) architecture. The TFT comprises of (from bottom to top): a bottom gate layer (silver nanoparticle ink), an insulating dielectric layer (cPVP), S-D electrodes (silver nanoparticle ink) and a p-type OSC (FS0096) as shown Fig. 14.
