Safety and Health at Work

Original article

Occupational Exposure to Refractory Ceramic Fibers in the Semiconductor Scrubber Manufacturing Industry

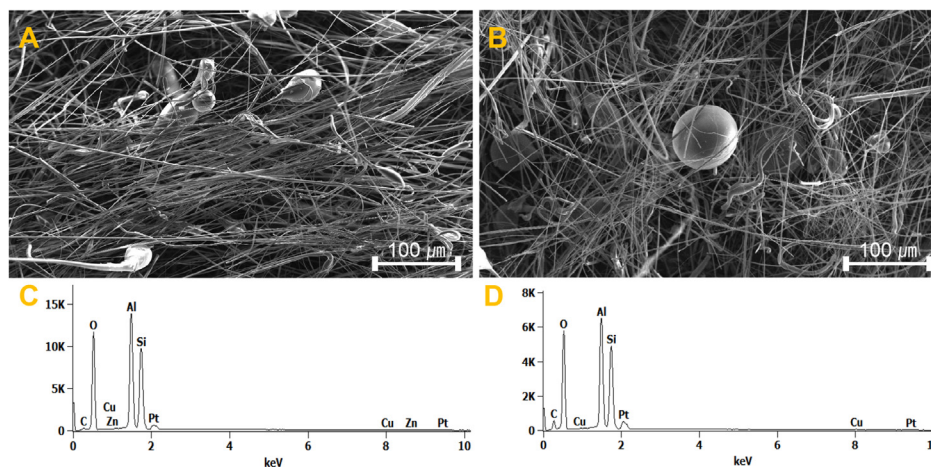
Fig. 1. FE-SEM images of bulk RCFs. (A) Bulk RCFs before high-temperature exposure under 100X magnification; (B) Bulk RCFs after high-temperature exposure under 100X magnification; (C) FE-SEM-EDS spectra of bulk RCFs before high-temperature exposure; (D) FE-SEM-EDS spectra of bulk RCFs after high-temperature exposure.

The bulk RCFs that were used had blanket-type insulation. Workers handled two types of RCFs during insulation replacement: RCFs before and after exposure to 700°C temperatures; the former represents new RCFs prior to wrapping inside the scrubber, and the RCFs analyzed by the FE-SEM were in the form of an RCF bundle (Fig. 1(A)). The manufacturer's "normal" RCF diameter was $3 \mu\text{m}$, and the average bulk RCFs ($n = 300$) diameter measured in this study was $2.6 \pm 1.2 \mu\text{m}$. Bulk RCFs had a length of $200 \mu\text{m}$ or greater, but all fibers exceeded the area of the FE-SEM lens; thus, the exact length could not be measured. SiO_2 and Al_2O_3 comprised more than 89% of the total RCF composition, based on weight percentage (Fig. 1(C) and (D)). RCFs before exposure to high temperatures were amorphous (Fig. 2(A)). Broad Si–O peaks in the Raman spectra were observed at 1080 cm^{-1} , 808 cm^{-1} , and 440 cm^{-1} .

Workers disassembled the scrubber frame and removed the insulation that had been exposed to 700°C . The average diameter of high-temperature exposed RCFs ($n = 300$) was confirmed by FE-SEM as $2.9 \pm 1.4 \mu\text{m}$ (Fig. 1(B)). The main chemical components were SiO_2 and Al_2O_3 , comprising 84% of the total (Fig. 1(D)). Similar to RCFs before high-temperature exposure, broad Si–O peaks were observed at 1060 cm^{-1} , 806 cm^{-1} , and 442 cm^{-1} in Raman spectra (Fig. 2(B)).

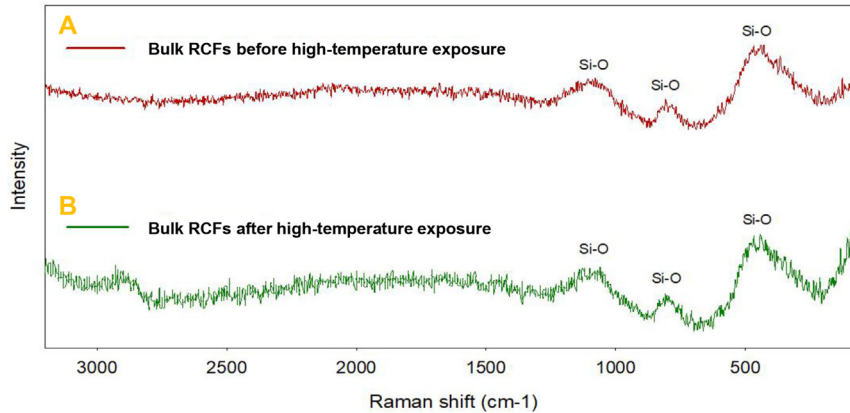
Fig. 2. Raman spectra of bulk RCFs. (A) Bulk RCFs before high-temperature exposure; (B) Bulk RCFs after high-temperature exposure.

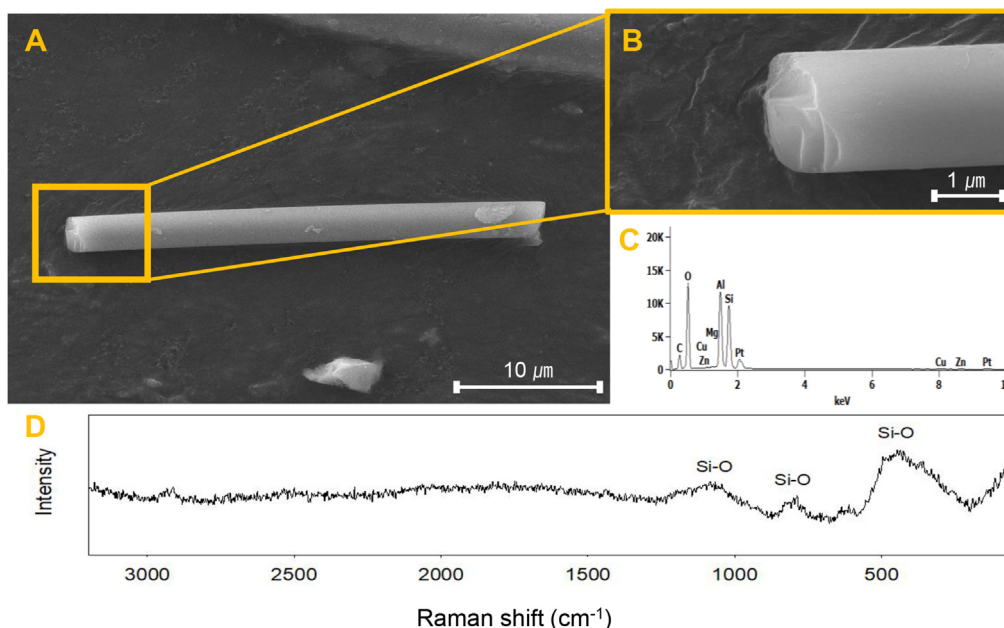
Fig. 3. FE-SEM and Raman microscope images of airborne RCFs. (A) FE-SEM images of airborne RCFs under 3,000X magnification; (B) FE-SEM images of airborne RCFs cross section under 20,000X magnification; (C) FE-SEM-EDS spectra of airborne RCFs; (D) Raman spectra of airborne RCFs.

($p < 0.05$). Transverse breakage was demonstrated in the cross-section of airborne RCFs (Fig. 3(B)). Airborne RCFs comprised SiO_2 and Al_2O_3 (77%) and had an amorphous structure, with broad Si-O peaks at 1067 cm^{-1} , 789 cm^{-1} , and 436 cm^{-1} (Fig. 3(D)).

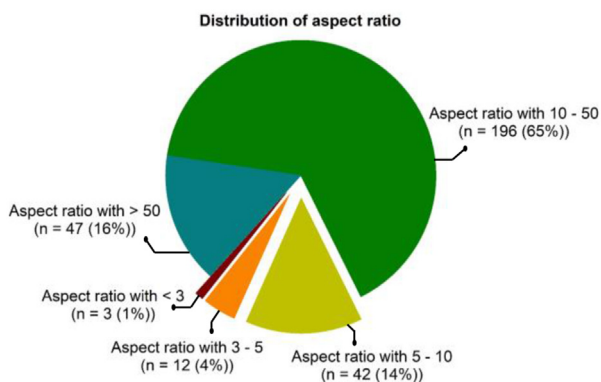
Fig. 4. Aspect ratio distribution of airborne RCFs in insulation replacement workplace.

As shown in Fig. 4, RCFs with an aspect ratio of 3–5 constituted 4% ($n = 12$), and those with an aspect ratio of 5–10 constituted 14% ($n = 42$) of the total ($n = 300$). RCFs with an aspect ratio of 10–50 accounted for the largest proportion, i.e., 65% ($n = 196$). Additionally, RCFs with an aspect ratio of 50 or greater constituted 16% ($n = 47$).
