Review

Imaging in Hip Arthroplasty Management Part 2: Postoperative Diagnostic Imaging Strategy

Keywords: hip; arthroplasty; CT; MRI; loosening

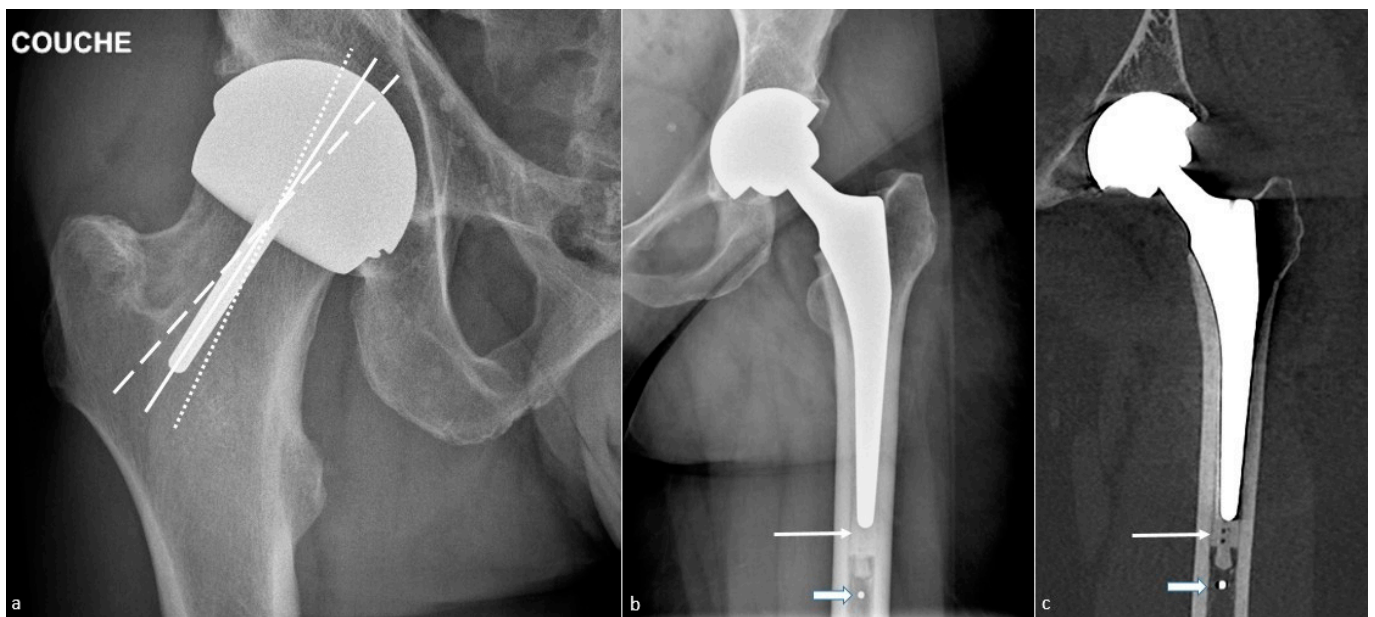
Figure 1. Total hip arthroplasties. A resurfacing arthroplasty is shown on (a) an antero-posterior hip radiograph and a conventional arthroplasty on (b) an antero-posterior hip radiograph and (c) a frontal CT-scan reformat. On (a), note the neutral position of the stem of the femoral component (white line). One should consider that slight valgus can be tolerated (little-dotted white line) and that varus positioning should not occur (large-dotted white line). On (b,c), also note the cement (thin arrow) and a metallic marker at the distal part of a cement restrictor (thick arrow).

THA can be conventional or resurfacing types and replaces both the femoral and acetabular sides of the hip. The component's analysis must include the acetabular cup, the femoral head, and the femoral stem. Acetabular and femoral components may themselves be modular (neck-head and/or neck-stem junctions) or nonmodular (one piece), the latter being currently uncommon [13]. Therefore, the femoral component might be composed of one, two, or three parts (stem, collar, head) and the acetabular component of one or two (metal-back and insert) pieces. Dual mobility works by containing a three-component system: a socket, a free polyethylene (PE) liner, and a head, allowing mobility between the femoral head and the liner and between the liner and the acetabular cup [41]. "Sandwich" liner refers to a PE insert outlined in its inner face by a ceramic or metallic layer to combine PE elasticity and metal or ceramic resistance, and in its outer surface by an acetabular metal back so that the PE finds itself in a "sandwich" position between two "hard" layers [42]. A resurfacing prosthesis only replaces the proximal femoral head, leaving the native femoral neck and a part of the femoral head intact. This kind of prosthesis is mostly used in younger patients as it preserves bone stock and allows for easier revision than conventional THA [14,32] (Figure 1).

Resurfacing arthroplasty responds to specific issues. Even though the acetabular component position does not differ from other types of prosthesis (lateral inclination of $30\text{--}50^\circ$ and anteversion of $5\text{--}25^\circ$), the femoral component must be placed in a relative valgus position of $5\text{--}10^\circ$ to avoid notching the neck (in case of excessive valgus) and to adequately cover the femoral neck [32] (Figure 1).

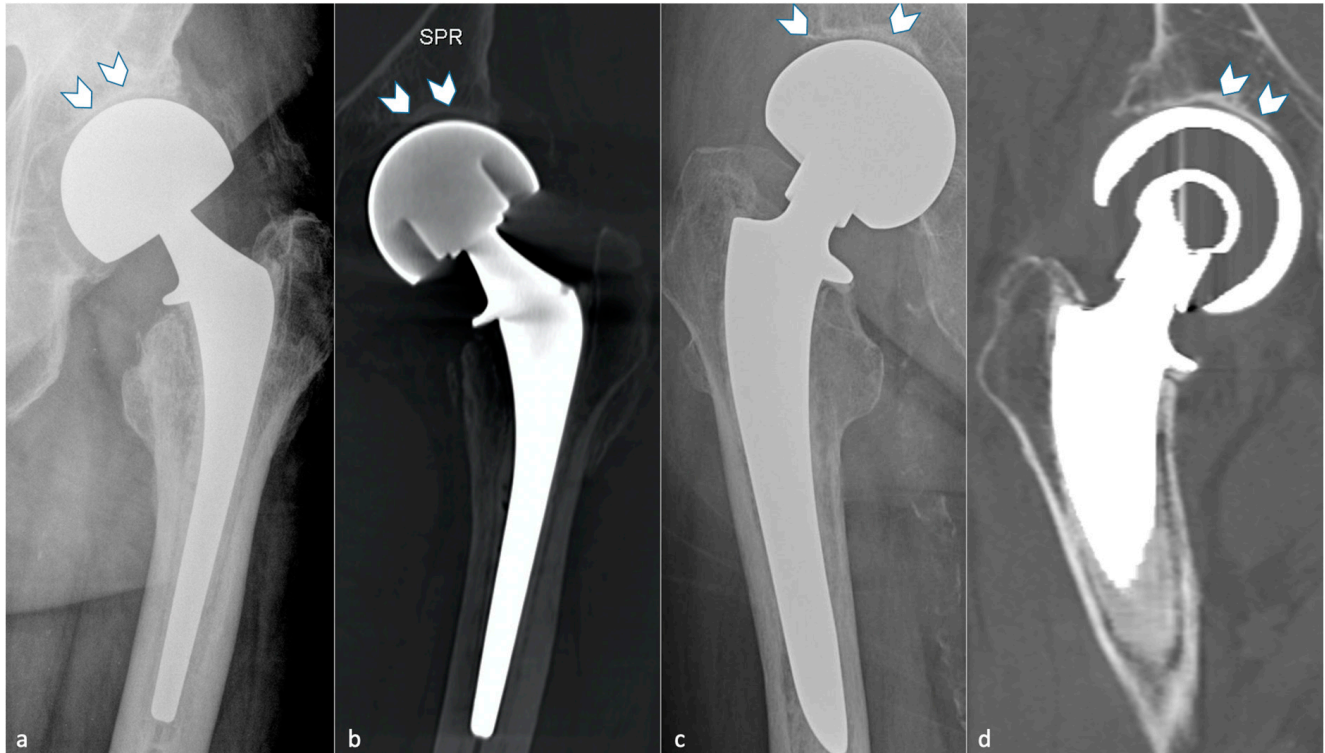
Figure 2. Hip hemi-arthroplasties. A unipolar arthroplasty is shown on (a) an antero-posterior hip radiograph and (b) a coronal slice of CT-MAR. A bipolar arthroplasty is shown on (c) an antero-posterior hip radiograph and on (d) a coronal slice of CT-MAR. Note that the native acetabulum can be seen on all imaging modalities in both cases (white arrowhead).

A hemi-prosthesis only replaces the femoral head and can be unipolar (femoral component articulating with the native acetabulum) or bipolar (femoral component articulating with a non-fixated acetabular cup) (Figure 2). Distinguishing a hemi-prosthesis from THA is crucial and can be completed by analyzing acetabular native cartilage and subchondral plate, both preserved in hemiarthroplasty. One must keep in mind that the acetabular cartilage might wear down, leading to a protrusion of the acetabular modular piece, which might be confused with an acetabular THA component. Additionally, a bipolar femoral head has a slightly greater than hemispheric shape, lacks screw holes, and has a smooth outer surface rather than a textured one in case of THA [37].

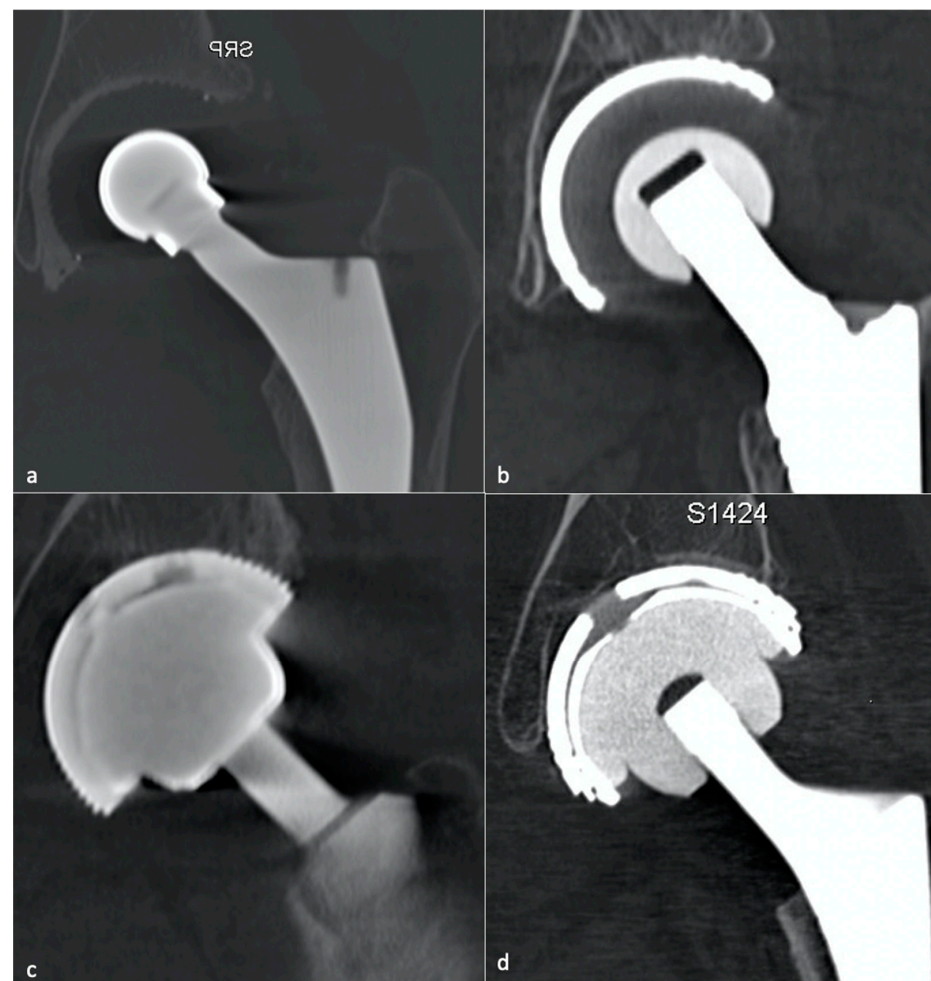
Figure 4. Bearing surfaces. Coronal slices of CT-scan showing on (a) a metal–polyethylene couple, (b) a ceramic–polyethylene couple, on (c) a metal–metal couple, and on (d) a ceramic–ceramic couple. The material can be recognized by its density with a «visual» scale as polyethylene is less dense than ceramic which is itself less dense than metal.

The four couples used are metal–PE (MoP), ceramic–PE (CoP), metal–metal (MoM), and ceramic–ceramic (CoC) (Figure 4). However, the optimal bearing surfaces are still under debate. PE liners are often used on the acetabular side, regardless of the artificial head [52]. MoM THA with large femoral head diameters have led to a high rate of adverse reactions to metal debris and pseudo-tumors, leading to an almost worldwide cessation of their use and reinforced surveillance [53]. MoP bearing was known to lead to particles disease secondary to contact pressure-induced wear, but recent data showed that the use of an acetabular ultra-high molecular weight PE cup in association with a titanium alloy femoral head could reduce the wear rate compared to cobalt chromium molybdenum and stainless steel so that it can extend the life of THA, in developing countries, especially for Indonesian and, more widely, Asian people [6]. Additionally, to decrease the amount of PE wear debris, alumina ceramics can be used with newer PE, with good long-term functional and radiologic outcomes, so that CoP is thought to be an excellent bearing couple and accounts for more than half of THA in the USA [52]. CoC bearings have been widely used in Korea for economic purposes but can lead to ceramic fractures and squeaking. Those specific complications rate might be dramatically decreased by the use of CoP bearing surfaces [52].

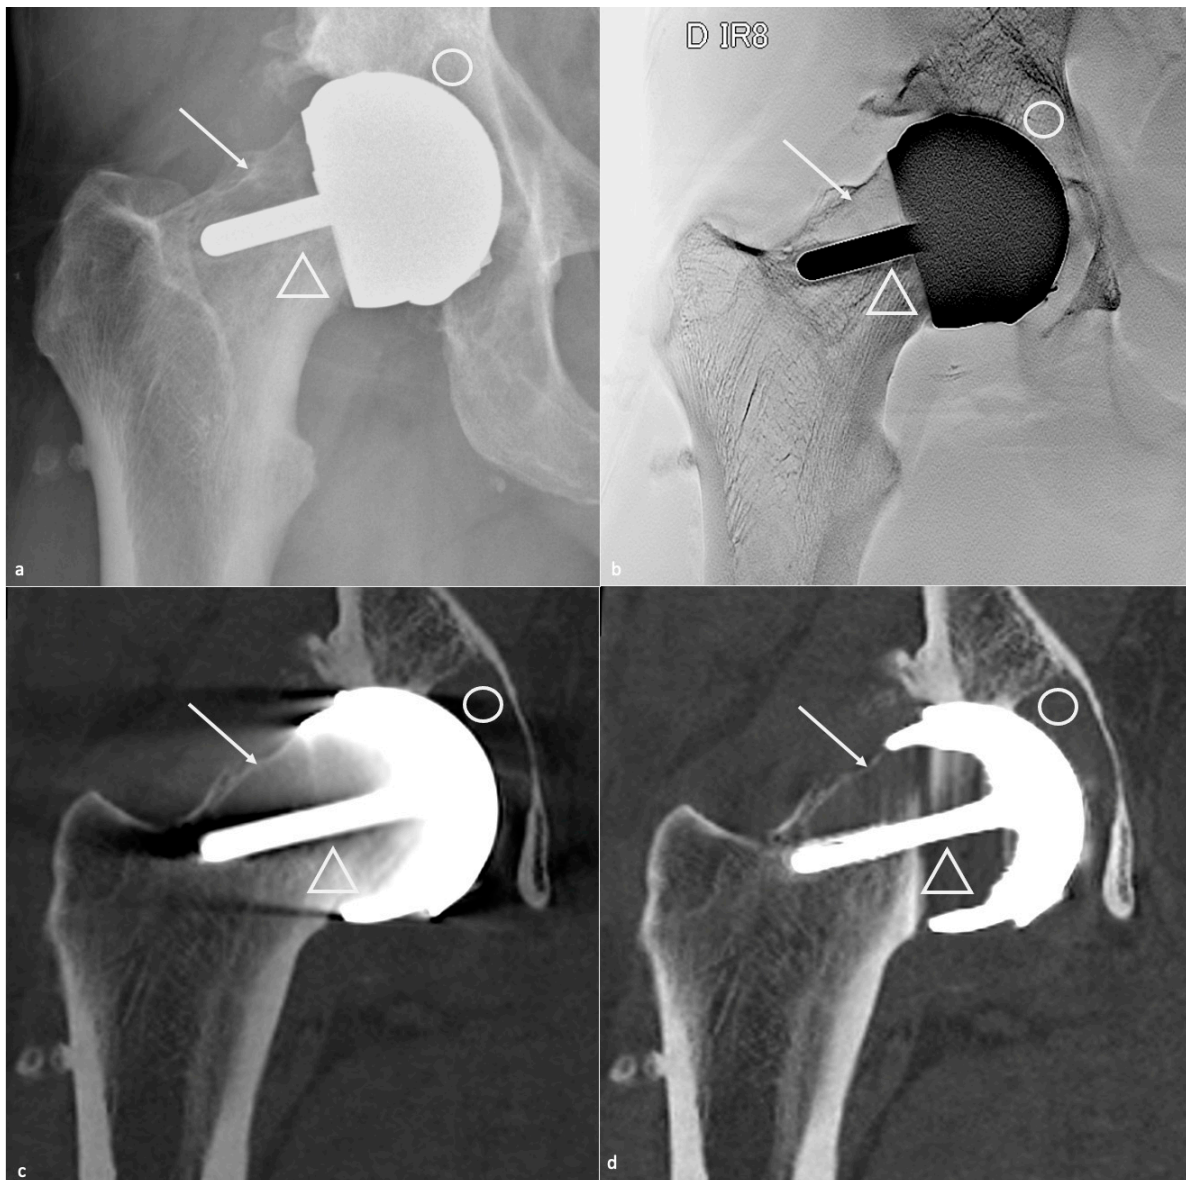
Figure 5. Peri-prosthetic osteolysis. Radiolucent zones are shown on (a) an anteroposterior hip radiograph, (b) an anteroposterior tomosynthesis view, (c) a coronal CT image, and (d) a coronal metal-artifact reduction CT image. All imaging modalities depict true osteolysis in the superomedial acetabulum (grey circle). Superior femoral neck osteolysis (grey arrow) is doubtful on (a,d) but is depicted on tomosynthesis (b) and CT with metal-artifact reduction (d). On the other hand, artefactual osteolysis is seen in (d) (grey triangle), underscoring the need for a combined interpretation of all imaging modalities.

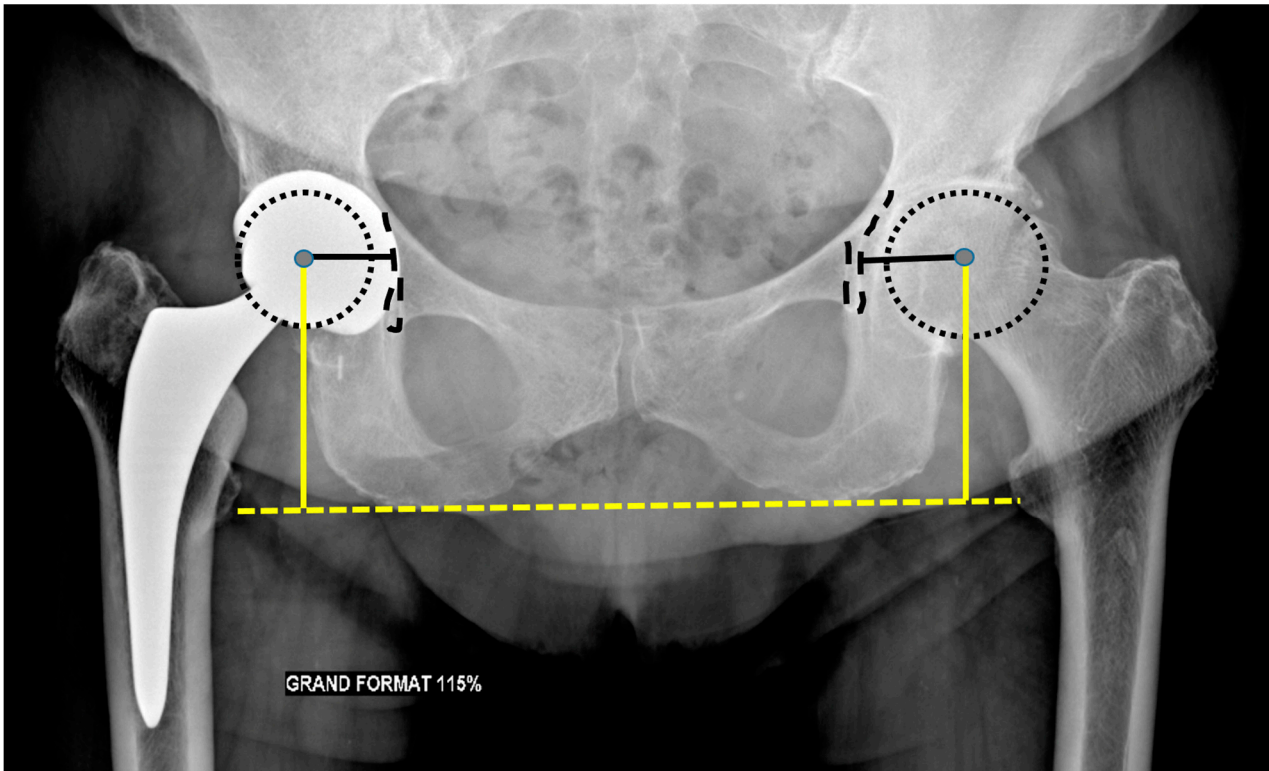
Figure 6. Acetabular centers of rotation. Pelvic anteroposterior radiograph. The horizontal center (black line) corresponds to the distance between the femoral head (dotted circle) center (grey point) and the teardrop (large black dotted curve) shadow, the vertical one (yellow line) to the distance between the center of the femoral head and the transischial line (dotted yellow line).

The acetabular vertical center of rotation corresponds to the vertical distance between the center of the femoral head and the trans-ischial tuberosity line, and the horizontal center of rotation to the distance between the center of the femoral head and the teardrop shadow (Figure 6). Those values should be similar to the contralateral hip [32], as a lateralized horizontal center might favor dislocation.

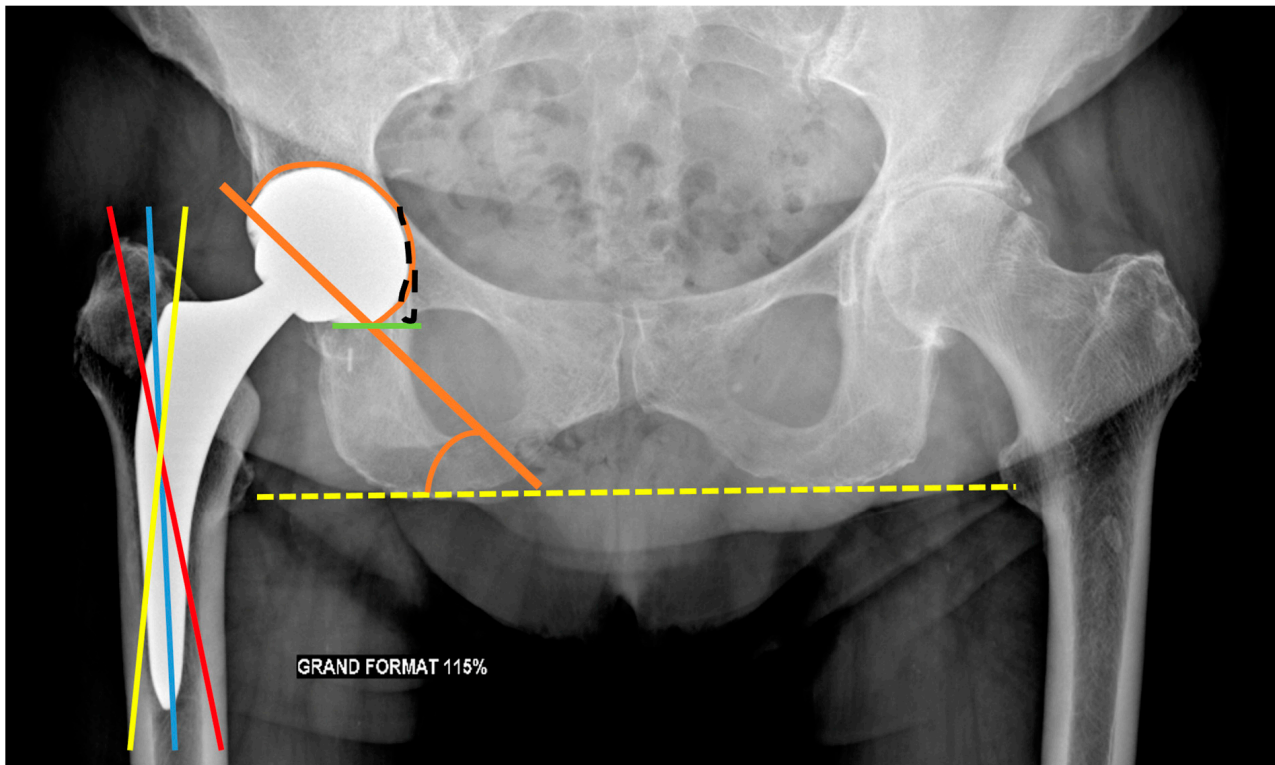
Figure 7. Acetabular frontal inclination and femoral stem position. Pelvic anteroposterior radiograph. The acetabular inclination corresponds to the orange angle between the acetabular piece contour (orange circle) and the transischial line (dotted yellow line). Additionally, note that the acetabular piece is aligned (green line) with the bottom of teardrop shadow (dotted black curve). The femoral stem should be placed in a neutral position (blue line). A slight valgus (red line) can be tolerated, but varus (yellow line) should not occur.

The frontal acetabular inclination is the angle between the lateral edge of the cup and a transischial tuberosity line in the frontal plane and should be of $40 \pm 15^\circ$, as a lesser angulation would limit hip abduction, whereas a greater one would increase the risk of dislocation [32] and premature wear. The inferomedial border of the acetabular component should be aligned with the bottom of the teardrop on an AP pelvic view (Figure 7).

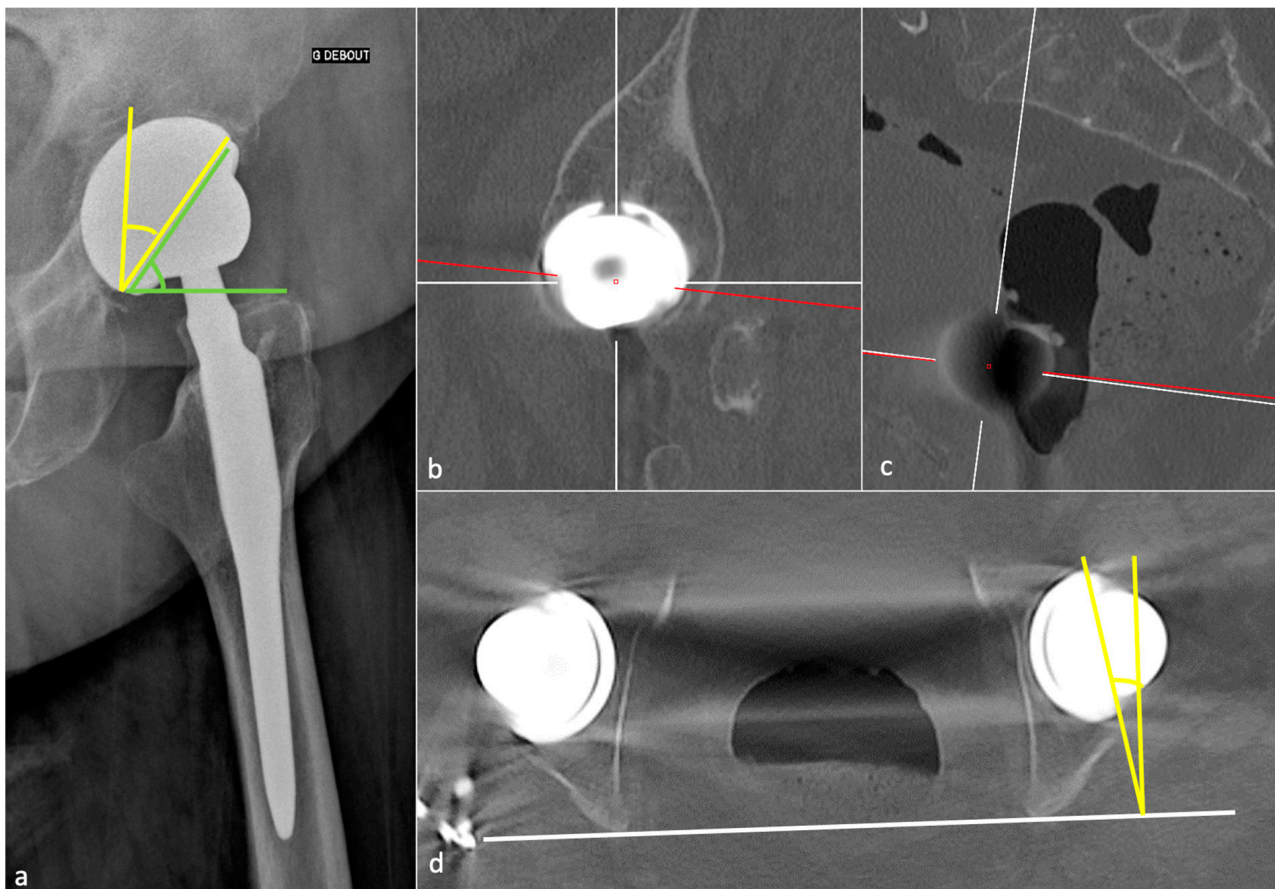
Figure 8. Acetabular cup anteversion and sagittal inclination. The radiographic angle of anteversion is shown on (a) a hip profile radiograph and corresponds to the angle between the vertical axis and the acetabular piece edges (yellow angle). The sagittal acetabular inclination is shown in (a) and corresponds to the angle between the horizontal axis and the acetabular piece edges (green angle). A CT method is then proposed to calculate anteversion: on (b) a sagittal CT slice, one should restore the femoral head center, then align it within the middle of S1 superior plate as shown on (c) in the sagittal plane. The anteversion can be measured in the so-created plane (red lines) on (d), as the yellow angle between the cup edges and the perpendicular line to the transischial line (white line).

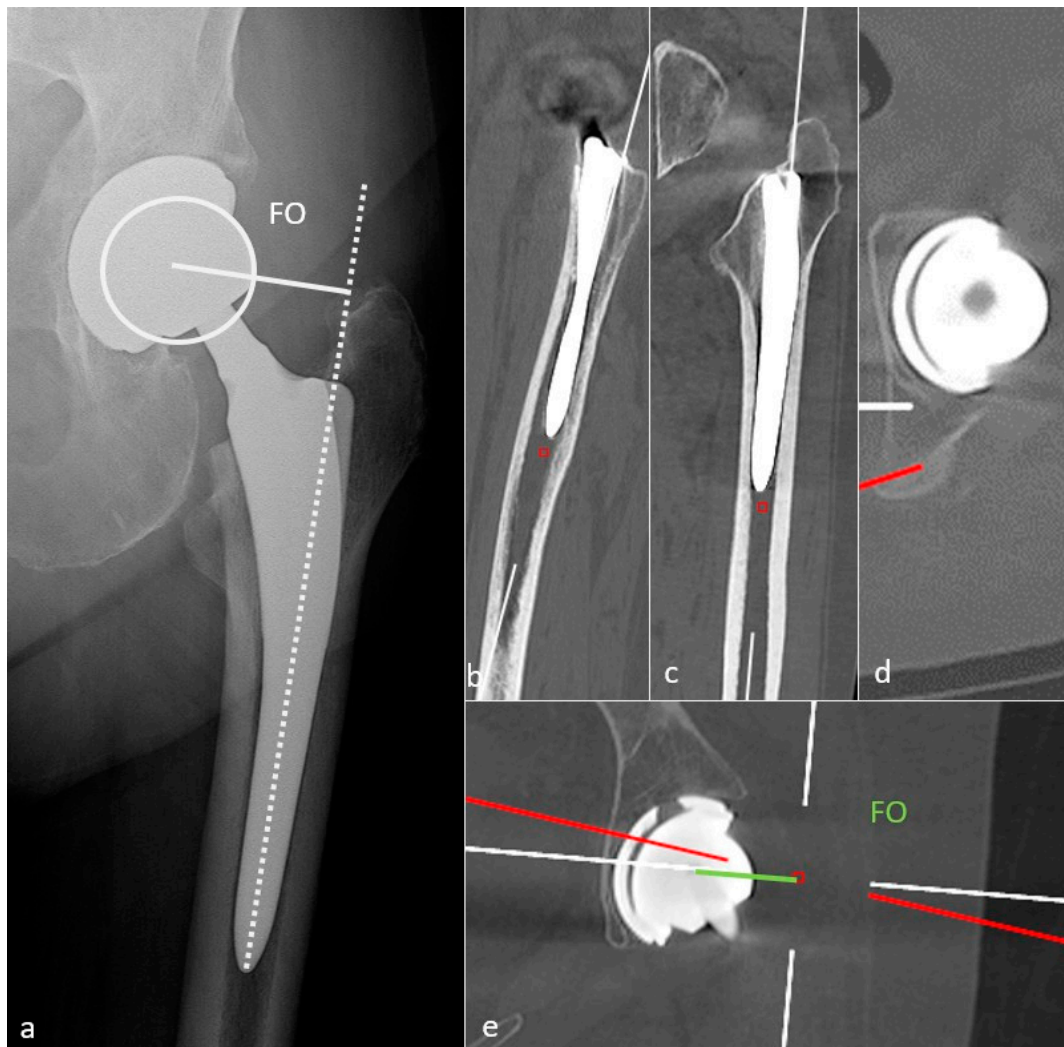
Figure 9. Femoral offset (FO). The radiographic method is shown on (a) an anteroposterior hip view and corresponds to the perpendicular distance (white line) between the femoral head (white circle) and the femoral axis (dotted white line). A CT method is also proposed. First, on (b), in the sagittal plane, the femoral inclination is considered, then on (c) in the frontal plane, and the level of the center of the femoral head is repaired in (d). Finally, in (e), the FO can be measured (green line) as the perpendicular distance between the resulting femoral axis (white vertical line) and the center of the femoral head.

The FO should be like the contralateral hip and measure 41–44 mm. This value must be measured on an anteroposterior hip view in neutral rotation, as rotation might induce significant measure variation. It can also be obtained with the EOS system or CT-scan (a method proposed in Figure 9) [54]. A low FO can lead to limping, mobility limitation, and dislocation by gluteal muscles weakness. A loss of FO negatively influences patients' satisfaction after THA [74]. A too high FO might induce gluteal muscle pain because of exacerbated tension and PE wear.

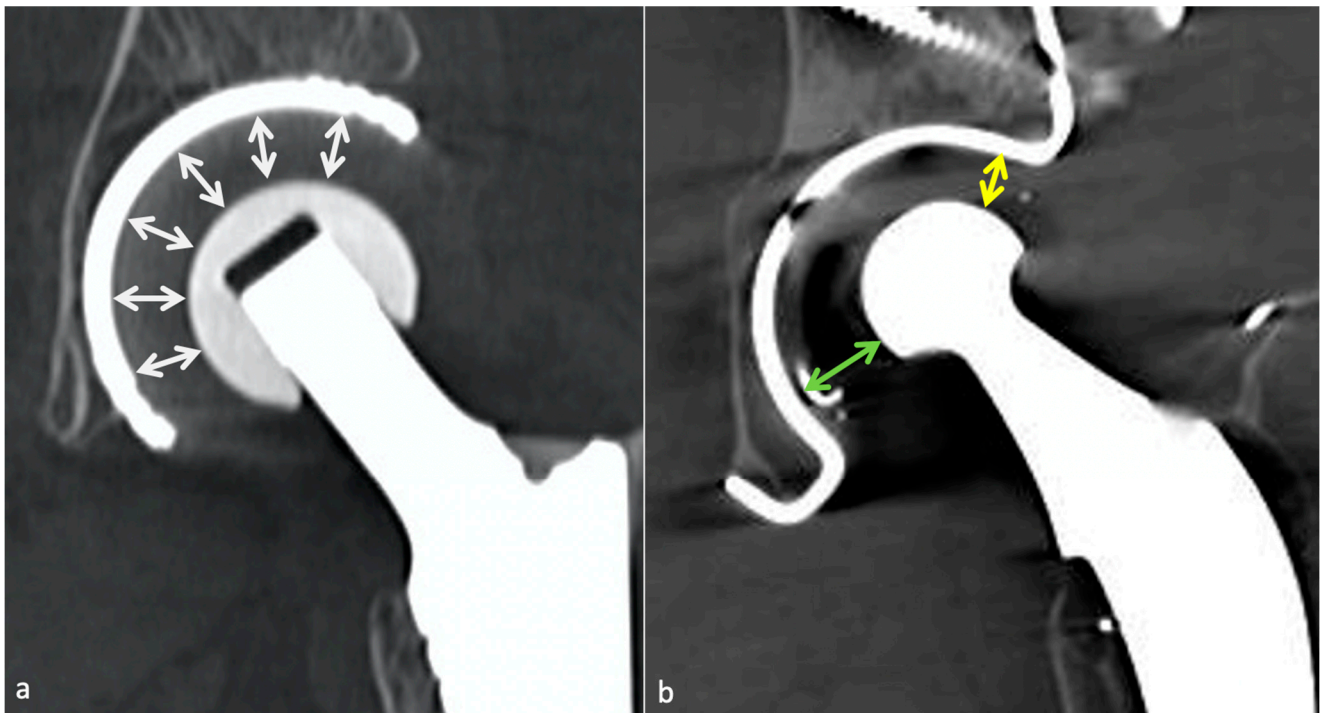
Figure 10. Polyethylene wear. Normal polyethylene appearance is shown in (a) a frontal CT-scan slice, with a regular thickness as all double arrows are equal, whereas wear is shown in (b) a similar frontal CT-scan slice, with asymmetric thickness as the superior yellow double arrow is smaller than the inferior green one.

The prosthetic femoral head should be centered within the acetabular cup or slightly inferiorly located as the PE liner has a thicker superior rim. In case of PE liner, wear of 0.1 mm/year is considered normal [54]. Therefore, if it is located upwards, it indicates PE wear and should raise suspicion for granulomatous osseous resorption (Figure 10).

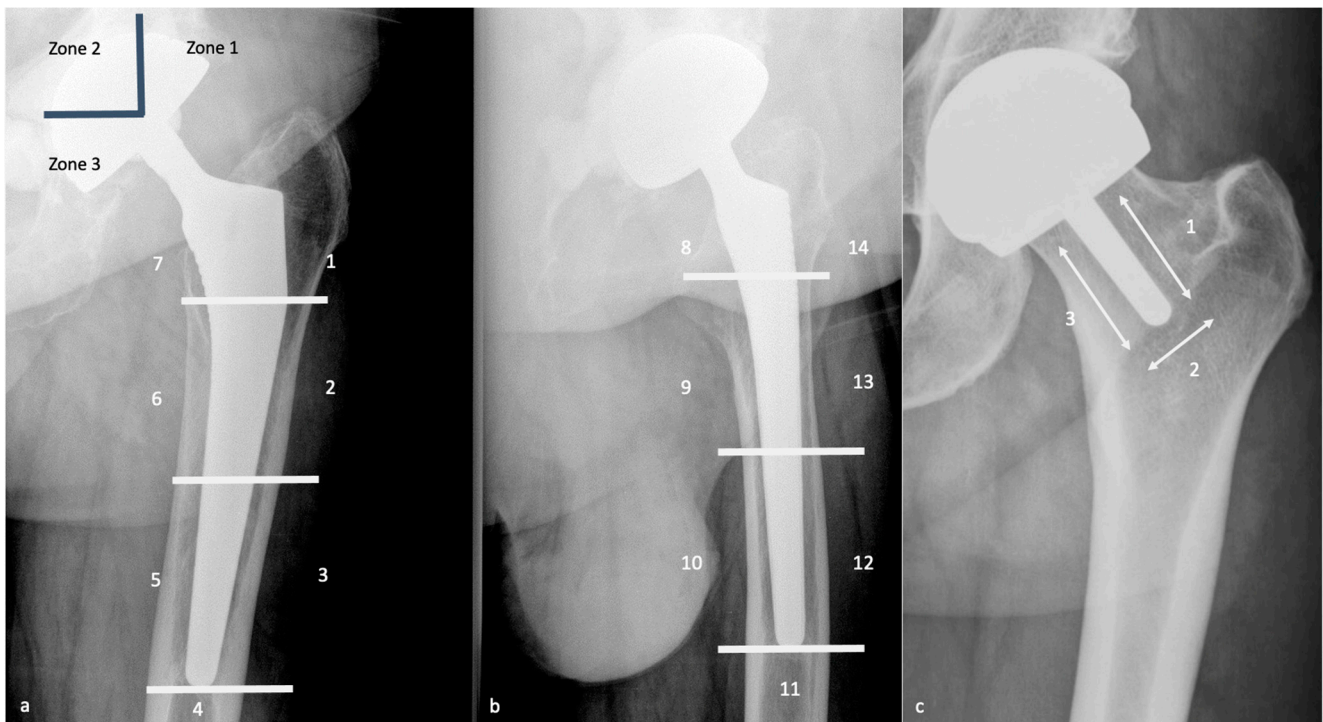
Figure 11. Acetabular and Femoral Zones to be described for osteolysis. The De Lee and Charnley acetabular zones and Gruen 1–7 femoral zones are shown on (a) an anteroposterior hip view, the Gruen 8–14 femoral zones on (b) a profile hip radiograph. The three zones to consider for femoral stem in resurfacing arthroplasties are shown on (c) an anteroposterior hip radiograph.

With radiographs or CT, the presence of periprosthetic radiolucent zones (RLZ) might be a normal finding if it meets strict criteria. Pathologic or regular, they should be described according to the classification of De Lee and Charnley for the acetabular component and with the Gruen zones for the femoral component (Figure 11). Concerning resurfacing arthroplasty, three zones are described around the peg [78] (Figure 11). RLZ around the metaphyseal stem of a resurfacing prosthesis are often asymptomatic, and a neck narrowing can be found without clinical significance [79].

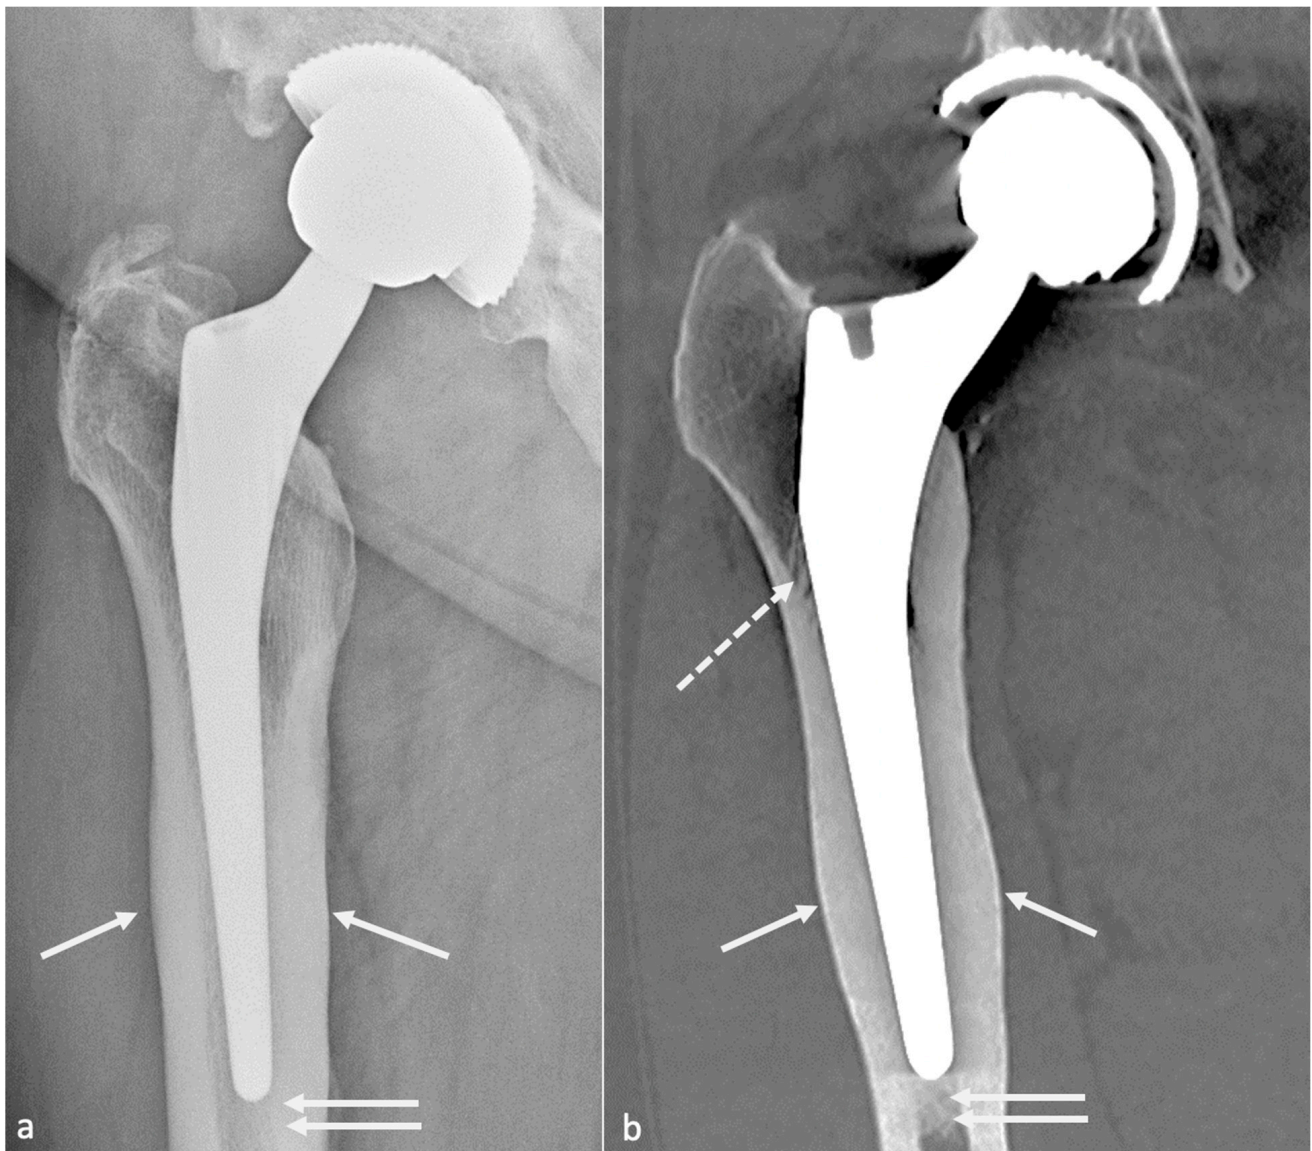
Figure 12. Successful fixation of an uncemented total hip arthroplasty. Regular and circumferential cortical thickening (white arrow) and bony pedestal (double white arrow) are seen on (a) an anteroposterior hip view and (b) a coronal CT-scan slice. Additionally, note spot welds (white dotted arrow) better depicted on CT-scan, and the slight valgus position of the femoral stem, better depicted on the radiograph.

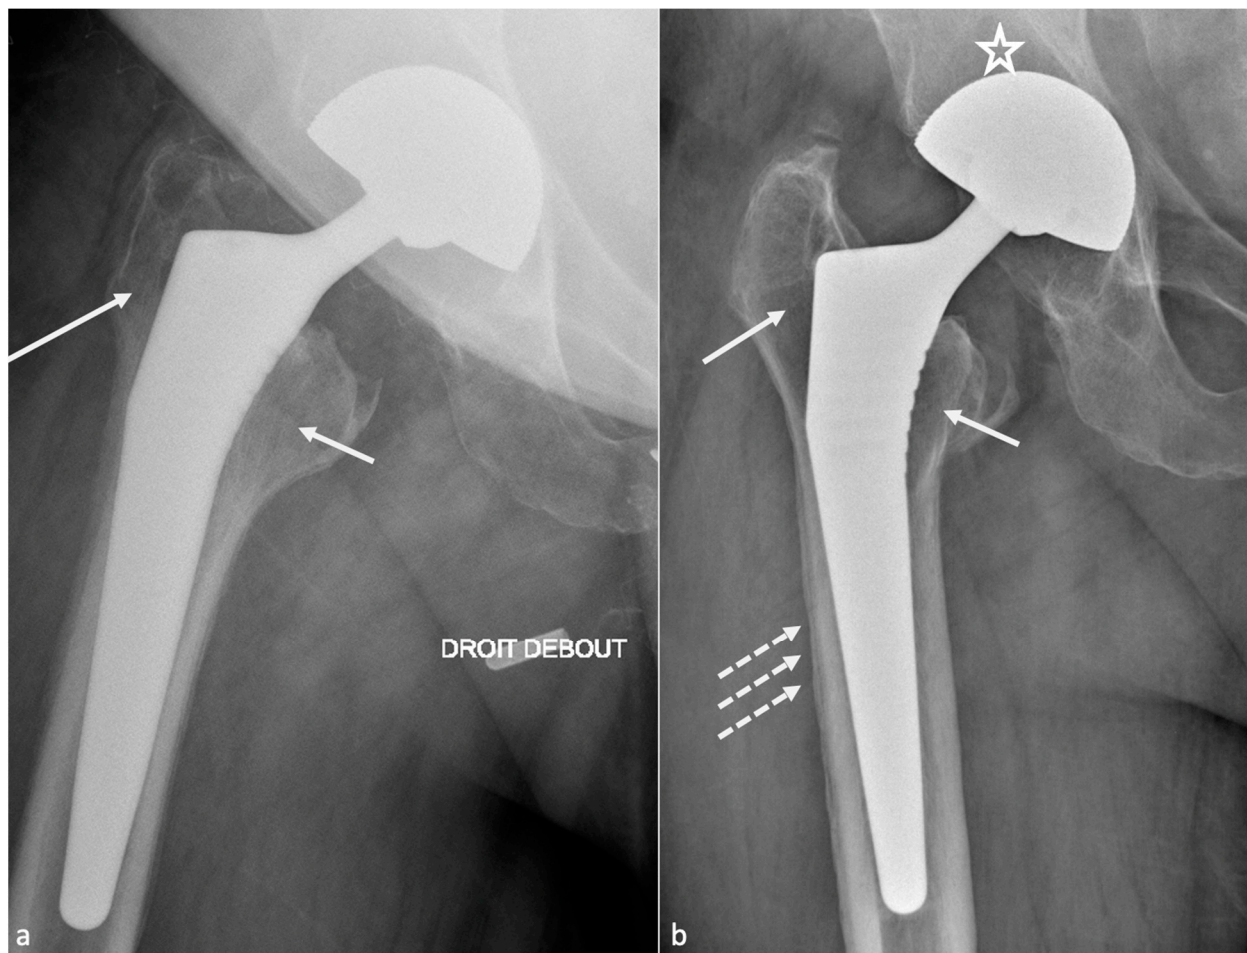
Figure 13. Stress shielding. Post-operative (a) and one-year follow-up (b) radiographs show proximal femoral (white arrows) and superomedial (white star) acetabular demineralization. Additionally, note the subtle lateral unilamellar periosteal reaction (dotted white arrows) on (b), which might be favored by the slight varus position of the stem.

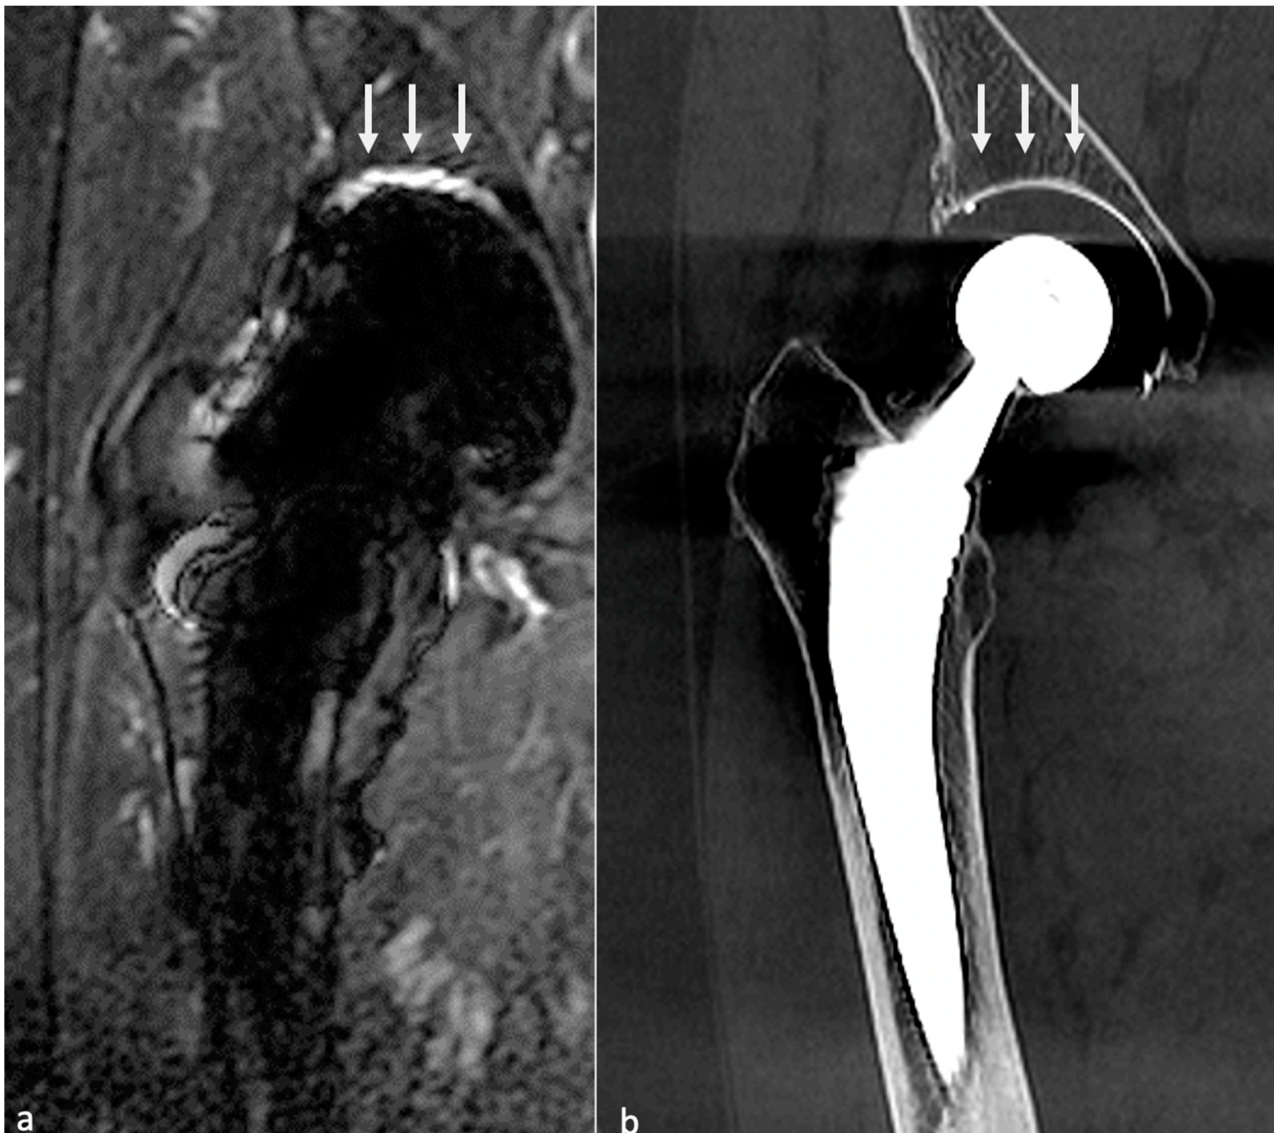
Figure 14. Acetabular fibrous membrane. A thin STIR hyperintense layer (white arrows) is shown close to the acetabular piece on (a) a frontal STIR image, without osteolysis in the corresponding zone on (b) a coronal CT-scan slice.

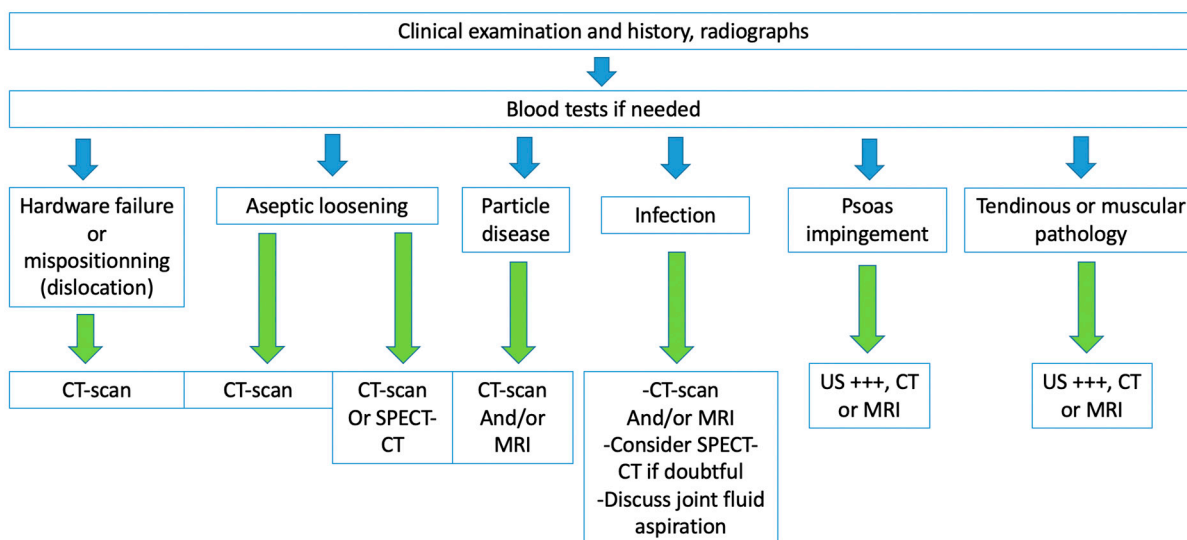
Figure 15. Imaging diagnostic algorithm proposition, adapted from Blum et al. [80,81].

Complications can be classified as common to all kinds of arthroplasties (loosening, dislocation, peri-prosthetic fractures, psoas impingement, heterotopic ossification, implant failure, neurovascular and muscle pathology), and specific to bearing surfaces (MoP: wear and osteolysis; MoM: metallosis, pseudo-tumor, and trunnionosis; CoC: squeaking and prosthetic fracture; CoP: ceramic fracture and wear). Resurfacing arthroplasty complications are developed in a separate section. An imaging-based algorithm is proposed in Figure 15 [80,81].

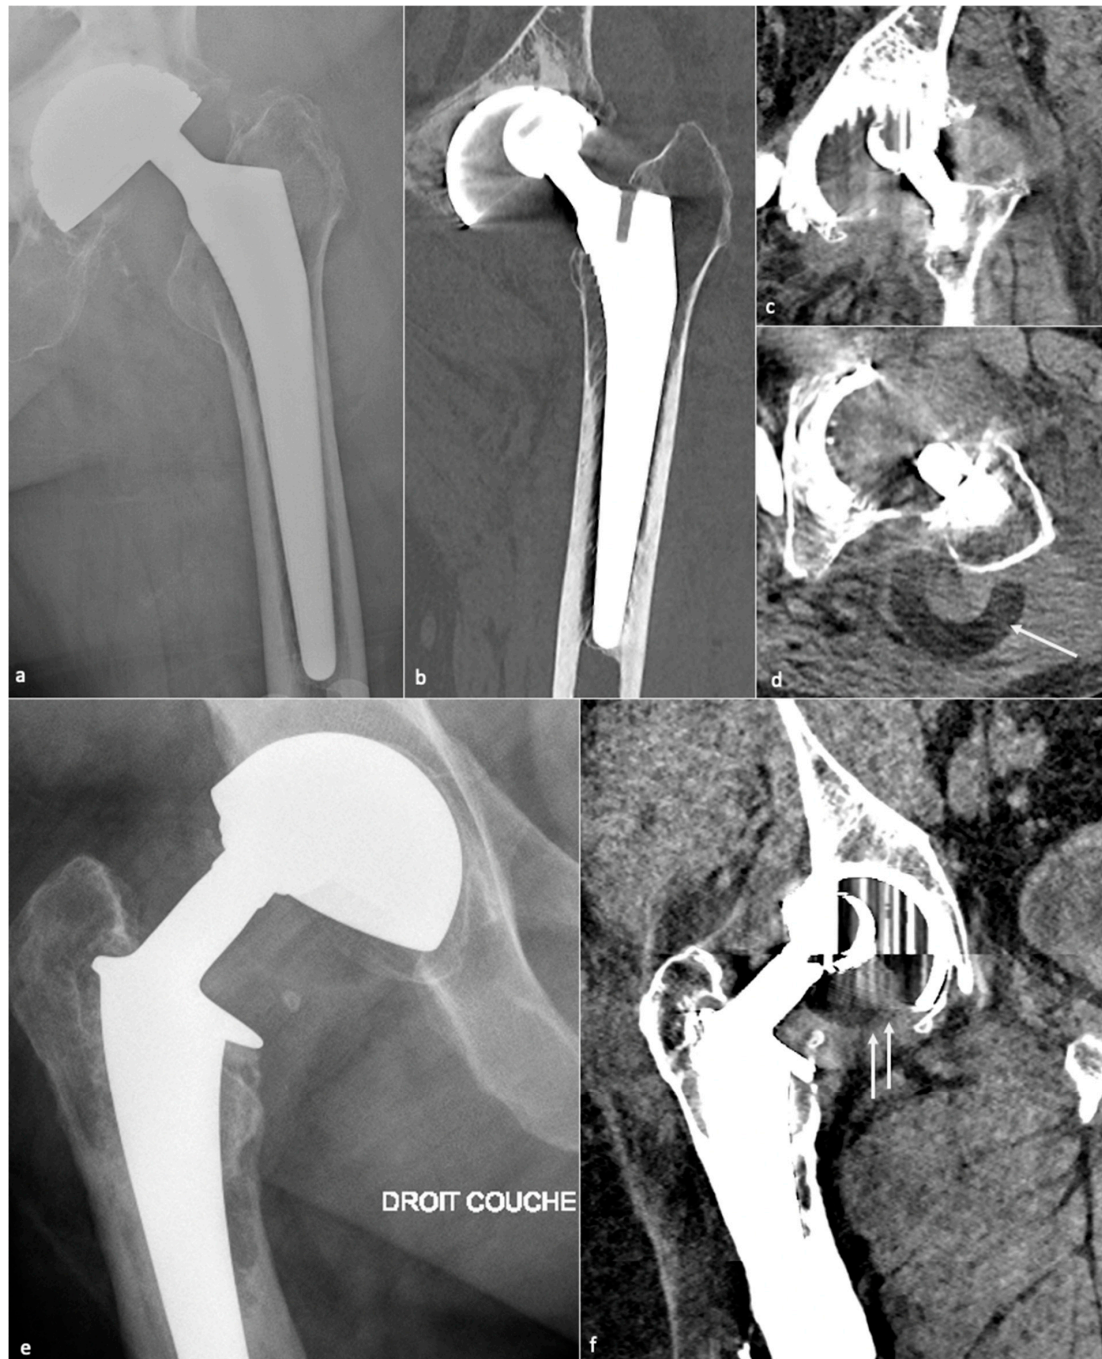
Figure 16. Polyethylene dislocations. An intra-prosthetic dislocation is shown on (a) an anteroposterior radiograph and (b) a coronal CT-scan with bone kernel where out-of-round of the femoral head is seen. Using soft tissue kernel in (c) frontal and (d) axial CT-scan slices, no polyethylene is seen in its usual position in (c) but is depicted behind the great trochanter in (d) (white arrow). In another patient, an intra-prosthetic dislocation is shown on (e) an anteroposterior hip radiograph where exenteration of the femoral head is seen, and on (f) a frontal CT-scan slice where the polyethylene (double white arrow) is located downwards.

prosthetic PE dislocation [84], defined as a loss of contact between the head and the PE. The latter can occur during the reduction of a classical dislocation in the early setting and lately secondary to wear [85] (Figure 16).

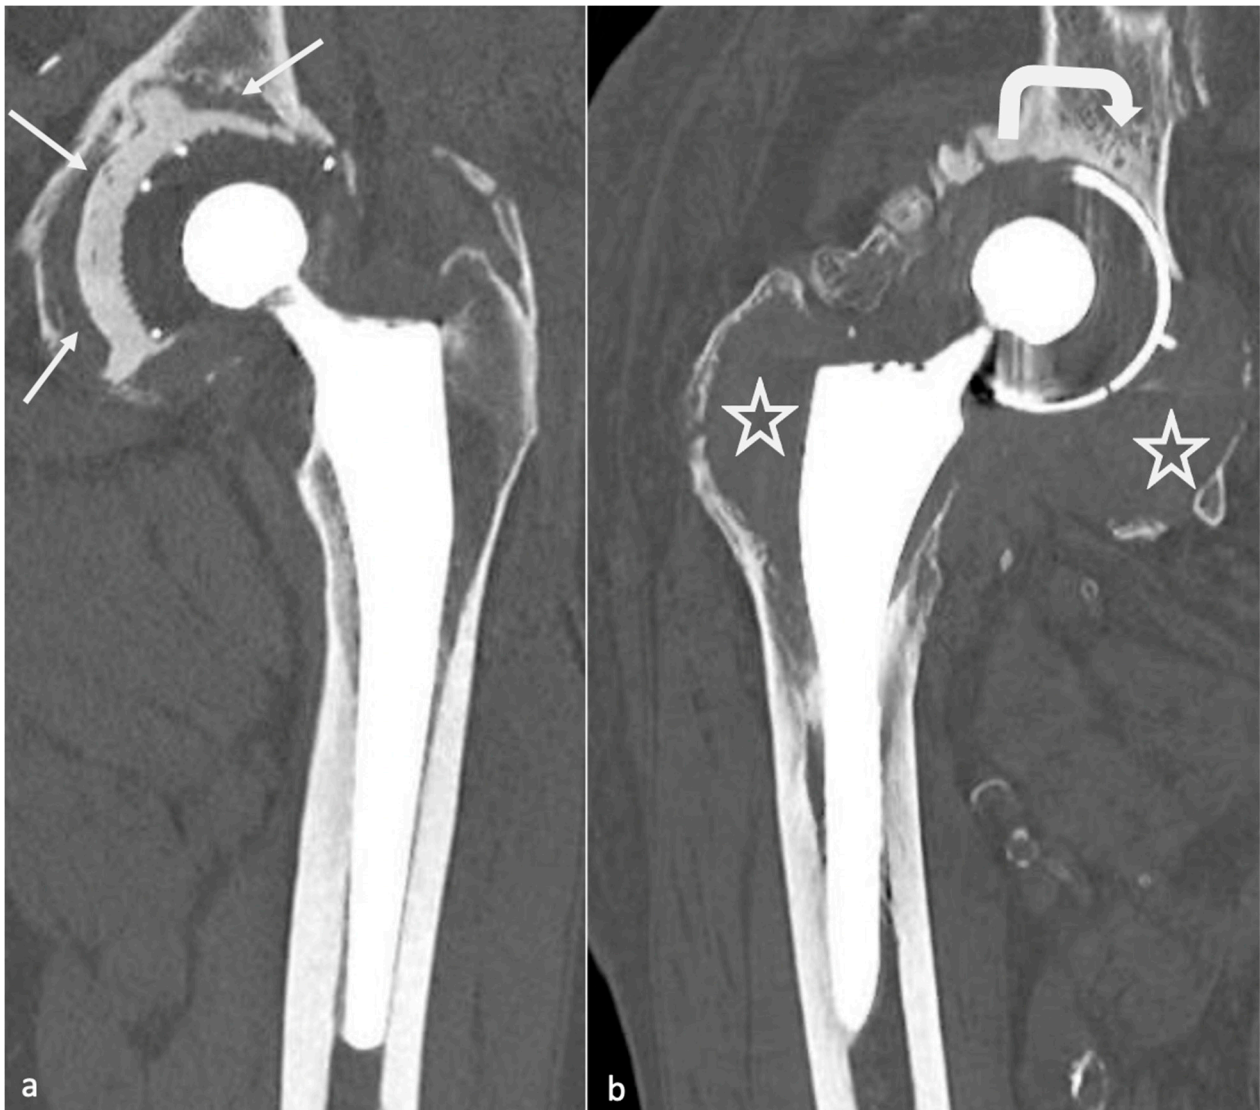
Figure 17. Mechanical and granulomatous loosening. An acetabular mechanical loosening is shown on (a) a frontal CT-scan slice with regular acetabular osteolysis (white arrows). A granulomatous loosening is shown on (b) a frontal CT-scan slice and consists of bulky osteolysis (white stars) both on the femoral and acetabular sides, with a displacement of the acetabular metal-back (white curved arrow).

Most of the failures occurring at five years or later result from osteolysis, leading to aseptic loosening and peri-prosthetic fractures. Loosening corresponds to the loss of fixation of a cemented prosthesis or the absence or loss of osteointegration of an uncemented one. In imaging studies, loosening, therefore, corresponds to implant mobilization over time, raising the need to visualize previous radiographs, even the post-operative in the best-case scenario. Infection must be ruled out by puncture in case of doubt. Loosening can be “mechanical” (implant mispositioning or miss-dimensioning, poor primary fixation) or “biological”, secondary to almost all kinds of particles released (bone, cement, PE, metal, ceramic) by mechanical wear leading to granulation tissue formation in the osteolytic zones (Figure 17).
