Review

Imaging in Hip Arthroplasty Management Part 2: Postoperative Diagnostic Imaging Strategy

Keywords: hip; arthroplasty; CT; MRI; loosening

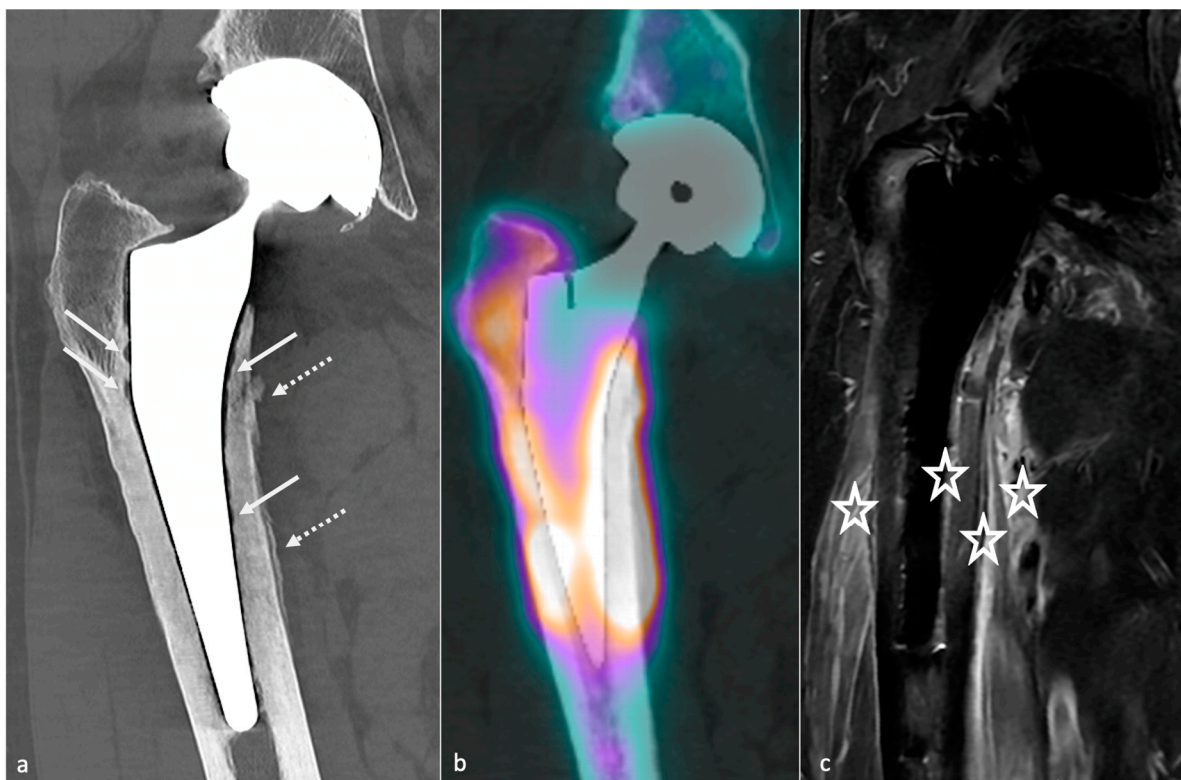
Figure 18. Infectious loosening (staphylococcus lugdunensis). An infectious loosening is shown on (a) a frontal CT-scan slice with irregular femoral endosteal osteolysis (white arrows) and periosteal reaction (dotted arrows), (b) a frontal SPECT-CT slice with diffuse hyperfixation, (c) a frontal T2 STIR image with a peri-prosthetic, cortical, and soft tissue hypersignal (white stars).

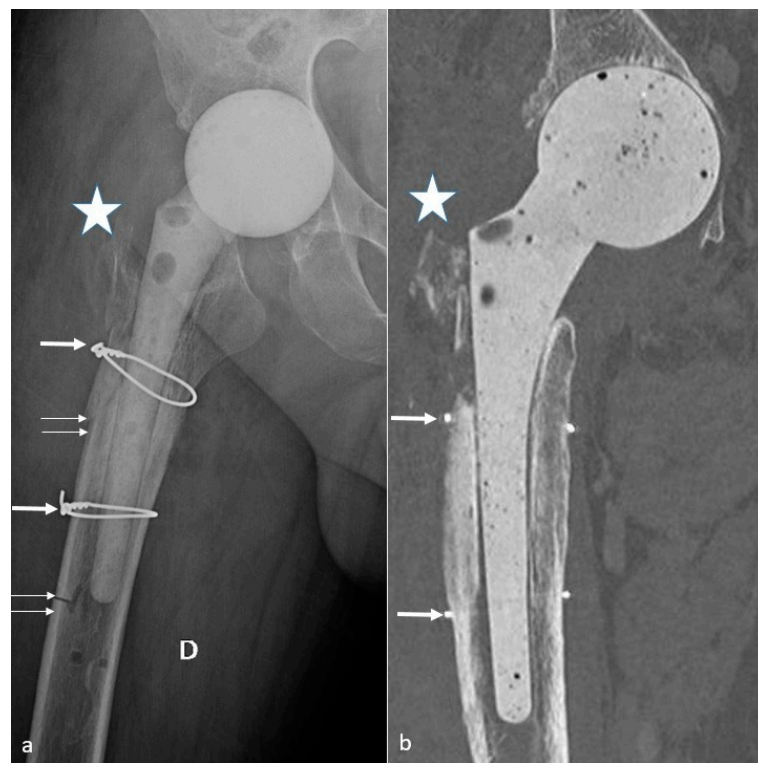
Figure 19. Spacer appearance. A spacer is shown on an AP radiograph (a) and a coronal CT-scan slice (b). Note the cerclage wires (thick arrows), the trochanteric lysis (white star), and the femorotomy sequelae (thin double arrows). NB: “D” in (a) means “droite” and is referred to the right side.

One should be aware of the aspect of temporary cement spacer, impregnated with antibiotics, temporarily used when revision surgery is performed to allow functional hip movement while locally treating an infection (Figure 19). Dislocation, periprosthetic fractures, and secondary infection can occur [100].

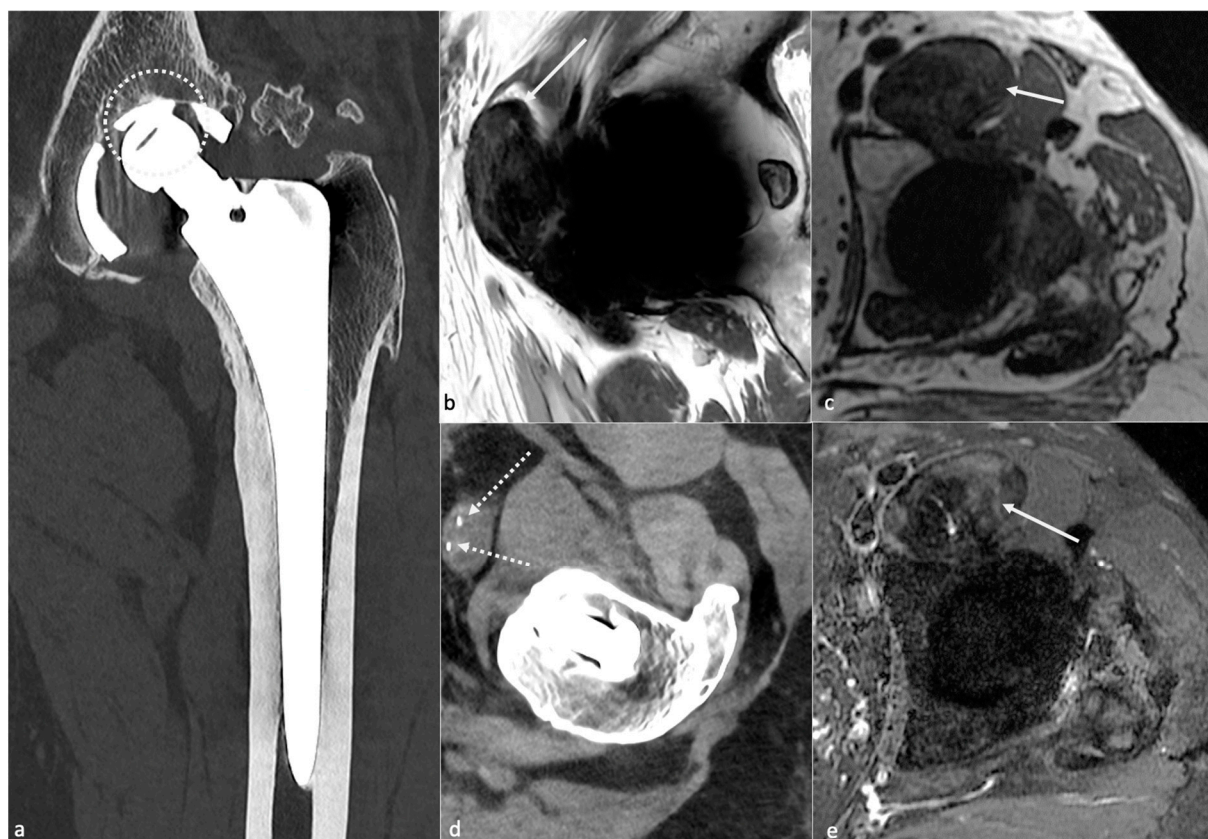
Figure 20. Metallosis. Contact between the acetabular metal-back and the femoral head (dotted white circle) is shown on (a) a frontal CT-scan slice, secondary to polyethylene wear. A pseudo-tumor extending into the iliopsoas bursae is shown on (b) a sagittal T2-weighted image, (c) an axial T1 MAVRIC and STIR (e) images as hypointense. Additionally, note on (d) an axial CT-scan slice the presence of metallic debris (dotted white arrows) into the pseudo-tumor.

- *Metallosis* results from the shedding of metallic debris (secondary to a MoM prosthesis with corrosion, a conflict between a metallic acetabular cup and the prosthetic neck, or a contact between a metallic head and an acetabular metal back in case of PE wear or dislocation) that induces synovitis and an indolent pattern of osteolysis, potentially leading to loosening (i.e., potentially looking similar to osteolysis and PE wear). Synovitis may contain low-signal intensity or metallic density debris, causing MRI artifacts and bone erosion, best depicted on CT-MAR (Figure 20). Such debris might also be located in periprosthetic soft tissue and lymph nodes [54,57]. Metallic debris presence might also accentuate PE wear (i.e., third fragment wear) [54]. Of note, high serum metal-ion levels can be found in symptomatic and asymptomatic patients and would be associated with pseudo-tumors, so that such a biological finding should lead to the prescription of an MRI to rule out a pseudo-tumor even in asymptomatic patients [6,103].

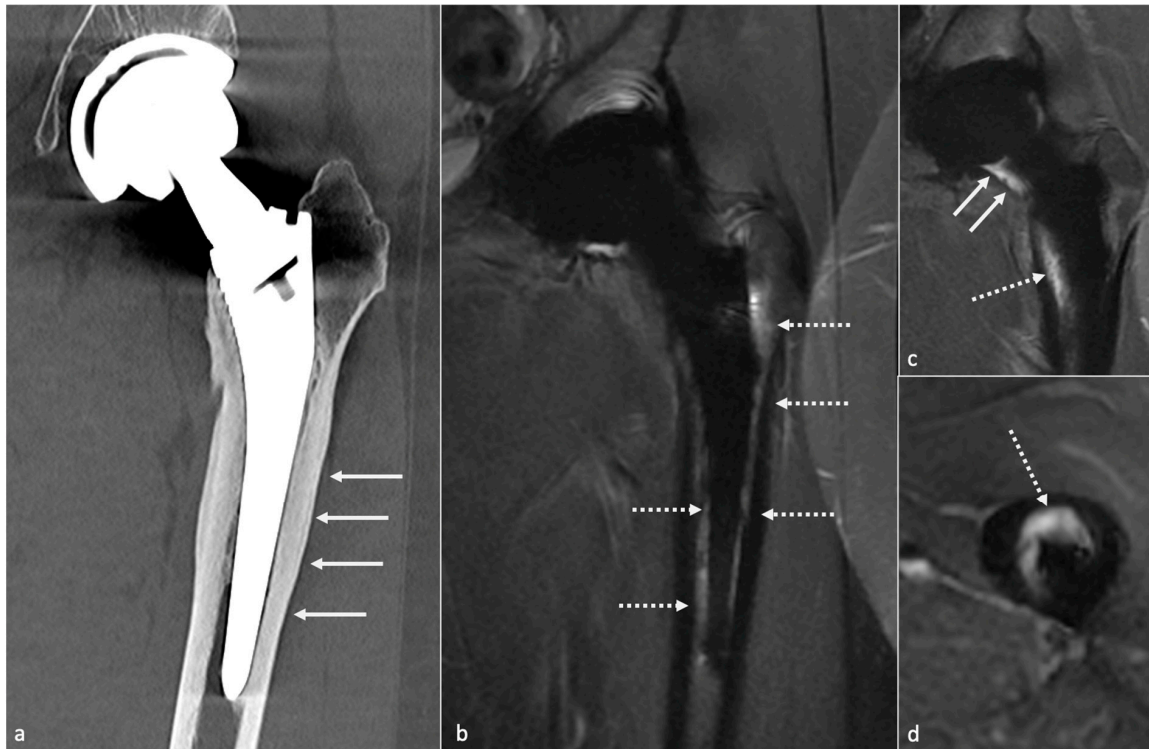
Figure 21. Stress reaction. A stress reaction is shown on (a) a coronal CT-scan slice with a varus stem position and asymmetric periosteal reaction (arrows). Periprosthetic bone marrow edema (dotted arrows) is doubtful on (b) a coronal STIR image but is depicted on another (c) coronal and (d) axial STIR image. Additionally, note the small amount of joint fluid (double arrow) on (c), considered nonspecific.

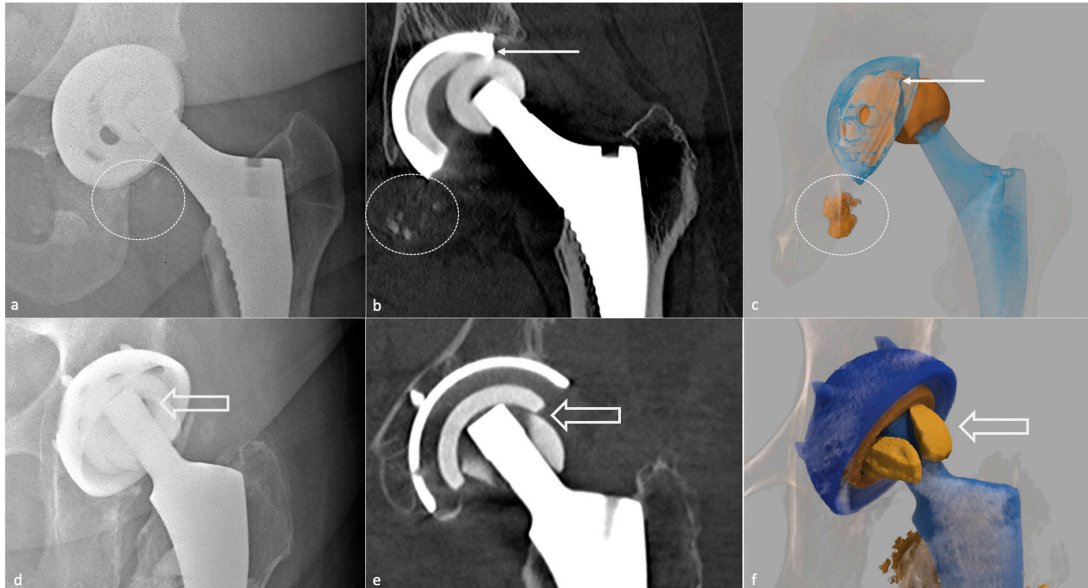
Figure 22. Ceramic fractures. An acetabular liner fracture is shown on (a) an anteroposterior hip radiograph, (b) a coronal CT-scan slice, and (c) a global illumination reformat with femoral head exenteration. The fracture is better depicted in (b,c) (white arrow), and ceramic debris can be seen on (a–c) (dotted circle). A femoral head fracture in a case of sandwich ceramic liner is shown on (d) an anteroposterior hip radiograph, (e) a coronal CT-scan slice (thick white arrow), and (f) a global illumination reformat. Note the interposition of a radiolucent space between the metal back and the ceramic liner due to the presence of PE, best seen on the CT-scan image.

Prosthetic fractures are rare, secondary to misleading conception or trauma, essentially concern CoC HA (head or acetabular insert), and require careful analysis of the components and of their environment as they can lead to particles reactive synovitis [54].
