Influence of pre- and post-usage flushing frequencies on bacterial water quality of non-touch water fittings

Methods: Eight non-touch fittings with brass valve blocks were mounted on a mobile test sink and connected to the same central water pipe source, differing only in presence or absence of water connection pipes, length of connection pipe, frequency of usage, and time intervals for pre- and post-usage water flush. The total bacteria colony-forming unit (cfu) counts were obtained by the spread plate technique.

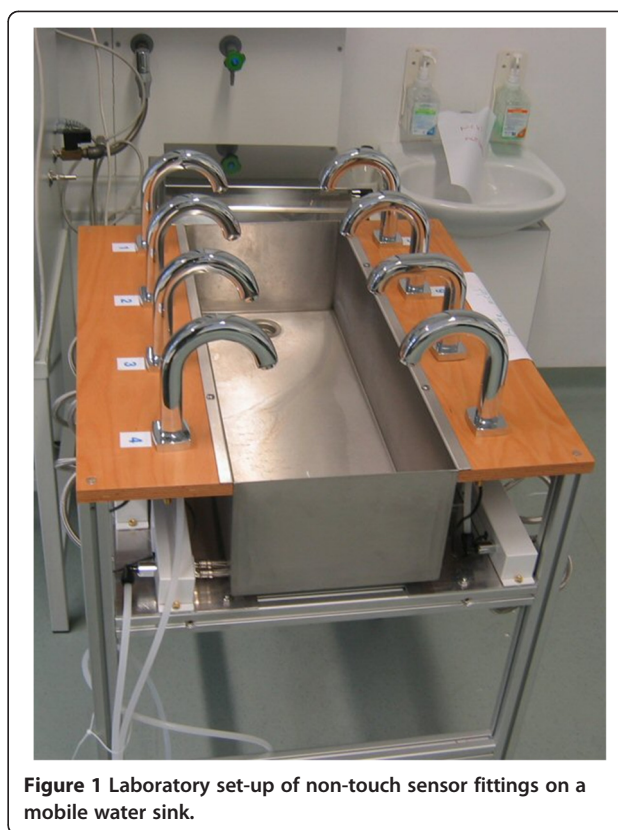
Eight non-touch fittings were mounted on a mobile test sink and connected to the same central water pipe source (Figure 1). The central water pipe was connected to the municipal drinking water supply of the City of Vienna, Austria. The set-up of the 8 fittings differed only in presence or absence of water connection pipes, length of connection pipe, frequency of usage, and time intervals for pre- and post-usage water flush (Table 1). The set-up of fittings no. 1 and 2 were used to test the potential influence of a frequency of usage for 30 seconds, once weekly or once monthly, respectively. Fittings no. 3 and 4 served to examine the potential influence of daily usage (10 times use for 30 seconds, each) and the influence of the length of stagnating water in the connection pipe. Fittings no. 5 and 6 allowed investigation of a potential effect of rinsing the fitting by programming an automatic post-flushing with cold water at 18°C for 2 or 10 seconds, respectively. And finally, fitting no. 7 allowed assessment of a possible influence of the used

Figure 1 Laboratory set-up of non-touch sensor fittings on a mobile water sink.

valve block material, and fitting no. 8 served to evaluate the possible effect of rinsing the fitting by programming an automatic pre-flushing with cold water for 30 seconds before use. This fitting also served as a “control”, representing bacterial accumulation (total cfu count/mL) occurring at a water fitting site with low frequency usage. The primary question at study was to investigate possible differences in bacterial counts obtained from regularly used fittings (fittings no. 3–7) with particular respect to no post-flushing and 2 seconds or 10 seconds of automated post-flushing with cold water.
