Article

A Textile Waste Fiber-Reinforced Cement Composite: Comparison between Short Random Fiber and Textile Reinforcement

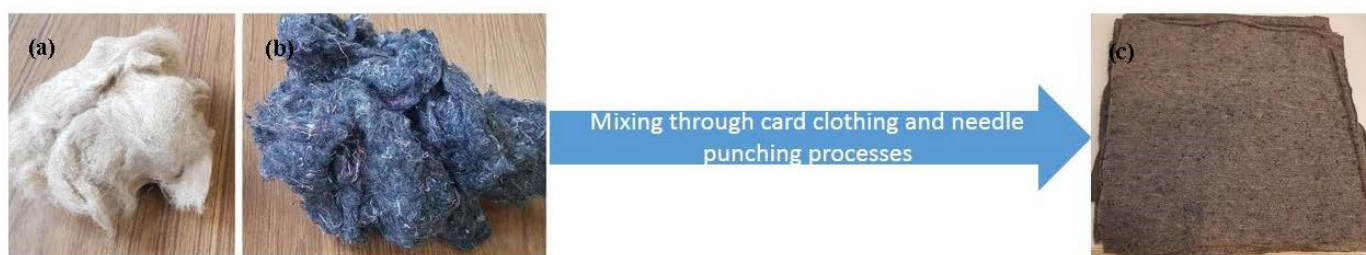
Figure 1. (a) Flax fiber; (b) textile waste fiber; (c) final nonwoven fabric.

As the production of nonwoven fabric from 100% TW fiber failed due to fibers being too short, longer flax fibers (F, hereinafter) with an average length of 60 mm, provided by Instytut Włokien Naturalnych (Poznań, Poland), were mixed with TW fibers. Each TW nonwoven fabric (see Figure 1), with dimensions of 0.75 mm \times 300 mm \times 300 mm and an areal weight of 155 g/m², was composed of 65% TW and 35% F fibers. Thus, the TW nonwoven fabric consisted of almost 80% vegetable fibers (35% Flax and 45% cotton) and 20% synthetic fiber. The production of nonwoven fabric, including card clothing and needle-punching, has been described in depth in [62]. The maximum tensile rupture load (per weight) of the TW nonwoven mats was reported as 2.0 N/g.

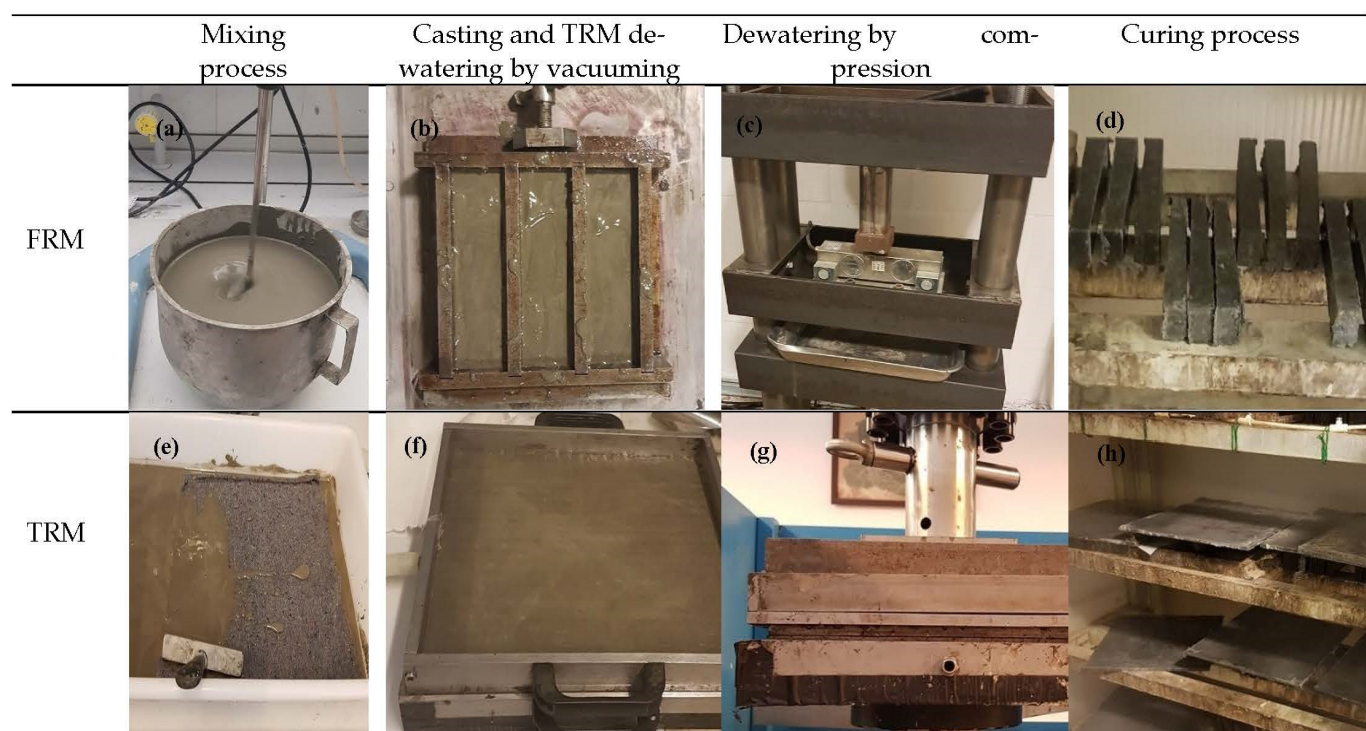
Figure 2. Preparation of the samples: (a) mixing process; (b) FRM casting; (c) dewatering of the FRM; (d) curing condition of the FRM; (e) impregnation of the nonwoven fabric with the paste; (f) TRM casting and vacuuming; (g) dewatering of the TRM; and (h) curing condition of the TRM plates. (FRM and TRM: Fiber- and Textile-Reinforced Mortar)

The FRM, a mortar reinforced with short TW fiber, was prepared in a laboratory mixer pan (Velp scientifica, model LS, Usmate, Italy) and cast into a 20 mm × 40 mm × 160 mm mold in which 5 MPa pressure was applied for 24 h to eliminate excess water. The TRM, a mortar reinforced with nonwoven textile, was prepared as plates of nonwoven layers impregnated with the cement paste placed cross-oriented in a mold with internal dimensions of 10 mm × 300 mm × 300 mm that underwent a homogeneous pressure of 3.3 MPa. The dewatering process for TRM plates included vacuuming (Vacuum pump, Matest, Treviolo, Italy) as well as compressing the mold for 24 h. All samples of FRM and TRM were cured for 28 days at ambient temperature (20 °C) in a humidity chamber (approximately 95% of relative humidity). Figure 2 depicts the process of preparation and casting of both composites.

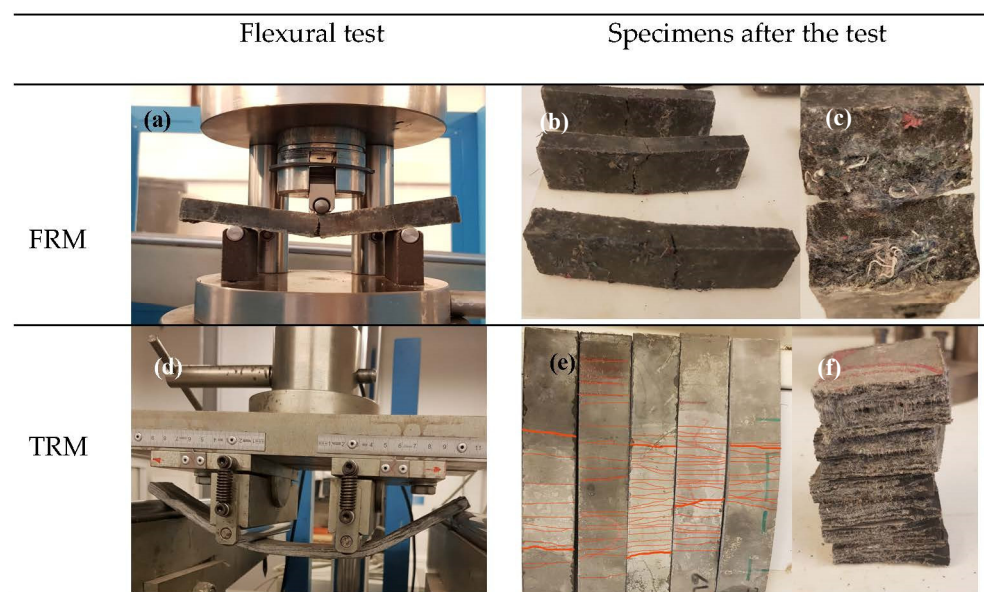
Figure 3. Flexural tests setup: (a) FRM three-point bending test; (b) cracks of FRM specimens; (c) cross-section of FRM specimens; (d) TRM four-point bending test; (e) cracks of TRM specimens; and (f) cross-section of TRM specimens.

Three-point (3P) flexural tests based on EN 12467:2012 [63] (Figure 3a–c) using an INCOTECNIC press machine (INCOTENIC UTM, Castelldefels, Spain) equipped with a load cell of 3 kN capacity and a loading rate of 4 mm/min on 100 mm span-length FRM specimens were carried out to identify the extent of the fiber's contribution to bridging cracks. The mechanical properties of the TRM composites were determined under a four-point (4P) bending test configuration (Figure 3d–f) following RILEM TFR1 and TFR 4 [64]. An INCOTECNIC press equipped with a maximum load cell of 3 kN with a crosshead speed of 20 mm/min with a major span (L) of 270 mm was used.

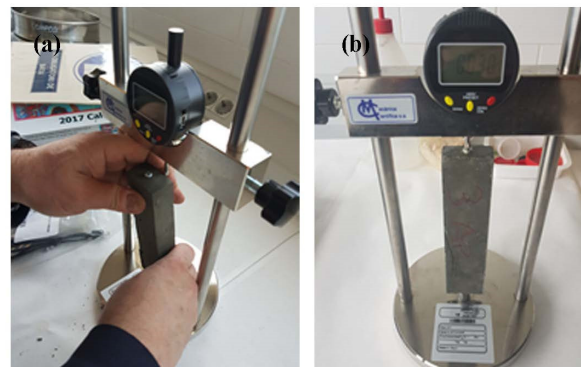
Figure 4. Shrinkage test: (a) shrinkage test setup; (b) monitoring the change in length.

In this study, the free drying shrinkages of the reference sample—cement paste only, without any fiber—and the FRM and TRM samples were measured using a digital micrometer (Matest, model E078KIT, Treviolo, Italy) to monitor the change in length at room temperature (see Figure 4). Shrinkage measurement started after 28 days of curing until reaching the maximum value. Microstrain shrinkage was computed using Equation (5), where ΔL_{sh} is the contraction of the length and L_0 is the initial length of the specimen.

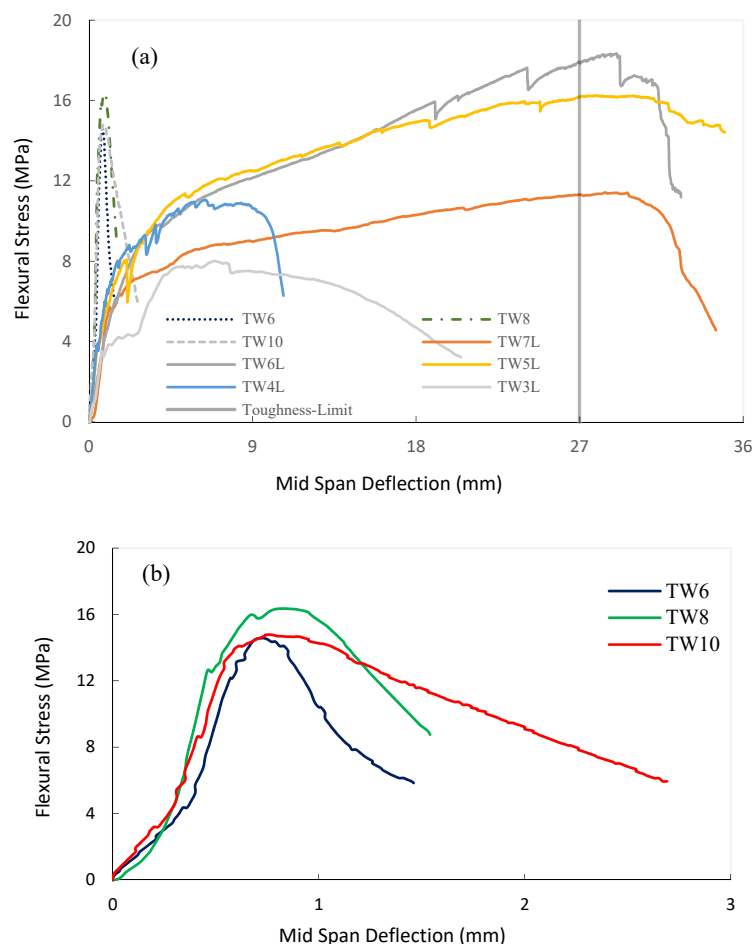
Figure 5. Representative flexural stress: deflection relationships obtained at 28 days for (a) all samples and (b) FRM samples.

On the one hand, the results depicted in Figure 5a suggest that TRM specimens show significantly greater post-failure energy absorption capacities under flexure than FRM specimens due to the multiple cracking patterns generated in the former. The bending response of TRM specimens could be divided into four distinct branches: (1) A linearly ascending branch, in which the external load was mainly borne by the cement matrix until a visible crack in the cement matrix was formed when the LOP (limit of proportionality) for strength was reached. (2) Crack propagation occurred along with multiple cracking formations. In this transition zone, the matrix contributed to the composite's strength at non-cracked zones (tension stiffening) whilst the reinforcement's contribution dominated the cracked zones. In the zones between cracks, the stress transfer mechanism was guaranteed by the reinforcement-matrix adhesion. (3) In another ascending branch (post-cracking), with the lowest slope due to degradation of the composites' stiffness, the fabric reinforcement bridged the cracks and bore the loads. No further new cracks occurred in this zone, and cracks grew only in width. (4) Finally, failure occurred due to rupture or debonding of the fibers followed by further widening of the cracks and, eventually, due to the concentration of damage in a single crack.

On the other hand, FRM specimens (Figure 5a,b) showed rather brittle responses once cracking began. In this regard, the bending response of FRM specimens could be divided into three distinct branches: (1) an elastic range for the pre-cracking zone, as observed in TRM; (2) a post-cracking regime with a reduced number of cracks (1–2) leading to a significantly smaller deformation capacity with respect to TRM; and (3) pre- and post-failure branches comprising less than 2 mm of deflection (from the cracking onset) and, hence, limiting both the ductility and energy absorption capacity and being insufficient for the majority of structural applications for building.

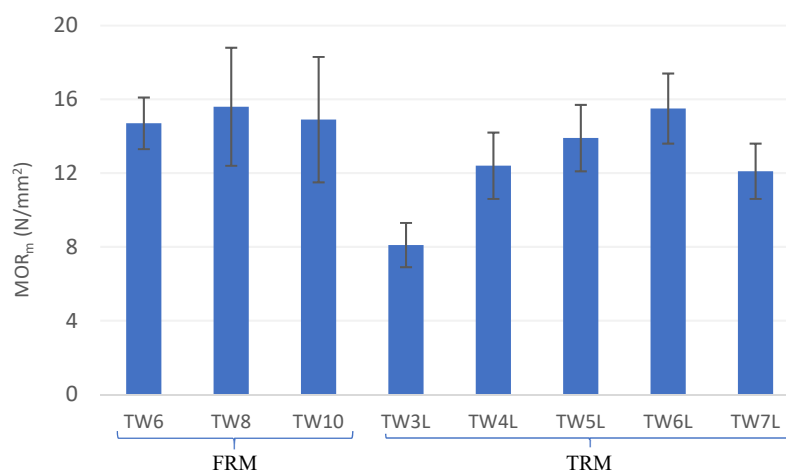
Figure 6. Results of Modulus of Rupture (MOR_m) for the tested composites.

Likewise, the addition of short TW fibers provided a post-cracking flexural strength capacity ($MOR_m/LOP_m > 1.0$) to the FRM composite. In this sense, fibers can bridge the cracks by controlling the opening and by ensuring a stress transfer mechanism across the crack height. The results highlight that the TW6 and TW10 composites presented similar MORs while the TW8 composites presented a 6% higher MOR at 28 days of curing (see Figure 6). Hence, MOR increased with an increase in the fiber content by up to 8% but decreased for greater fiber amounts due to technical difficulties associated with mixing, the balling effect, and compaction [5]. Similar results have been reported by Khorami et al. [68], in which the MOR of FRM reinforced by different amounts of waste kraft pulp fiber (1–14%) was investigated, for which it was shown that 8% fiber had the highest bending resistance. Nevertheless, although this material shows signs of post-cracking strength, its ductility and energy absorption capacity are limited and hence only nonstructural applications can be considered for this material.

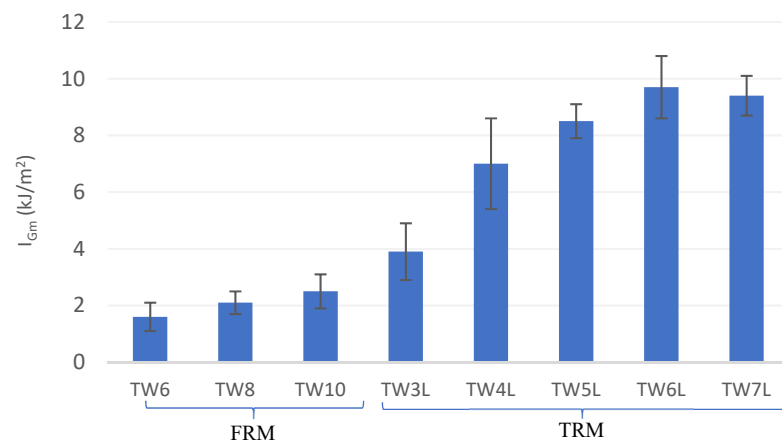
Figure 7. Results of toughness index (I_{Gm}) for the tested composites.

Regarding toughness (I_{Gm}), this parameter followed a similar tendency in TRM with respect to that obtained for MOR_m , i.e., it was found that I_{Gm} reached maximum for an optimal number of 6 layers, with 148% higher values than TW3L. However, in FRM, the results presented an increase in I_{Gm} with fiber dosage, with TW10 having higher energy absorption (56% higher values than TW6). As shown in Figure 7, the toughness index of all TRM composites had a greater value than that of FRM due to the formation of multiple cracking; for instance, TW6L had more than four times greater energy absorption than TW8. Hence, the previous statement regarding the potential structural and nonstructural applicability of both materials is further reinforced by these results.

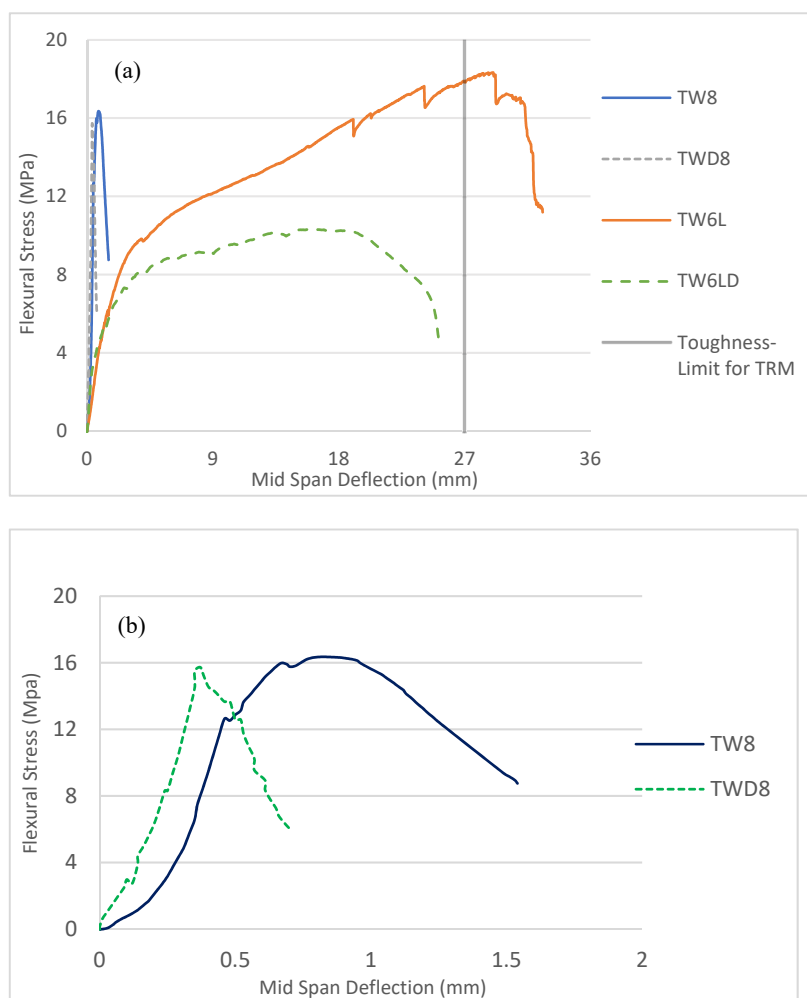
Figure 8. Representative flexural stress: deflection relationships obtained for aged samples for (a) all samples and (b) the FRM samples.

The results presented in Figure 8 and Table 3 allow us to confirm that the accelerated aging procedure negatively affected the post-cracking mechanical properties of the composites compared to those that were unaged. As expected, there was a loss of bending resistance in the composites after aging. In the textile laminate, the reduction of MOR* was about 35% (from 15.5 to 10 MPa), while this reduction was only 3% (from 15.6 to 15.2 MPa) for short reinforcement. Likewise, the reduction in the reinforcement contribution was 21 and 42% for FRM and TRM respectively, though the TW6LD still had a higher reinforcement contribution. It should be also mentioned that the TW short fibers were only made of cotton and polyester while TW fabric also contained flax. Thus, the amount of synthetic fiber—which is more durable than vegetable-based fibers—in the short reinforcement exceeded that of fabric fibers. When the fiber-reinforced composite was subjected to various wet-dry cycles the fibers, mainly vegetable fibers, lost adherence to the matrix due to reprecipitation of the hydrated compounds within the void space at the fiber-cement interface. Finally, full mineralization occurred, resulting in embrittlement of the vegetable fibers [65].

The reduction in toughness and energy absorption is considered one of the key matters of durability. This issue is related to an increase in fiber rupture and a decrease in fiber pull-out strength due to a combination of the weakening of the fibers by alkali attack, fiber mineralization, and volume variation due to the high water absorption of fibers. In this regard, the FRM and TRM samples experienced 42 and 30% I_{Gm} * reductions, respectively. Nonetheless, due to the longer fiber length and more contact with the cement paste, the TRM sample could still develop a flexural hardening response with multiple cracking, though the slope of this zone was less than the corresponding unaged ones, demonstrating the loss in fiber stiffness due to degradation.

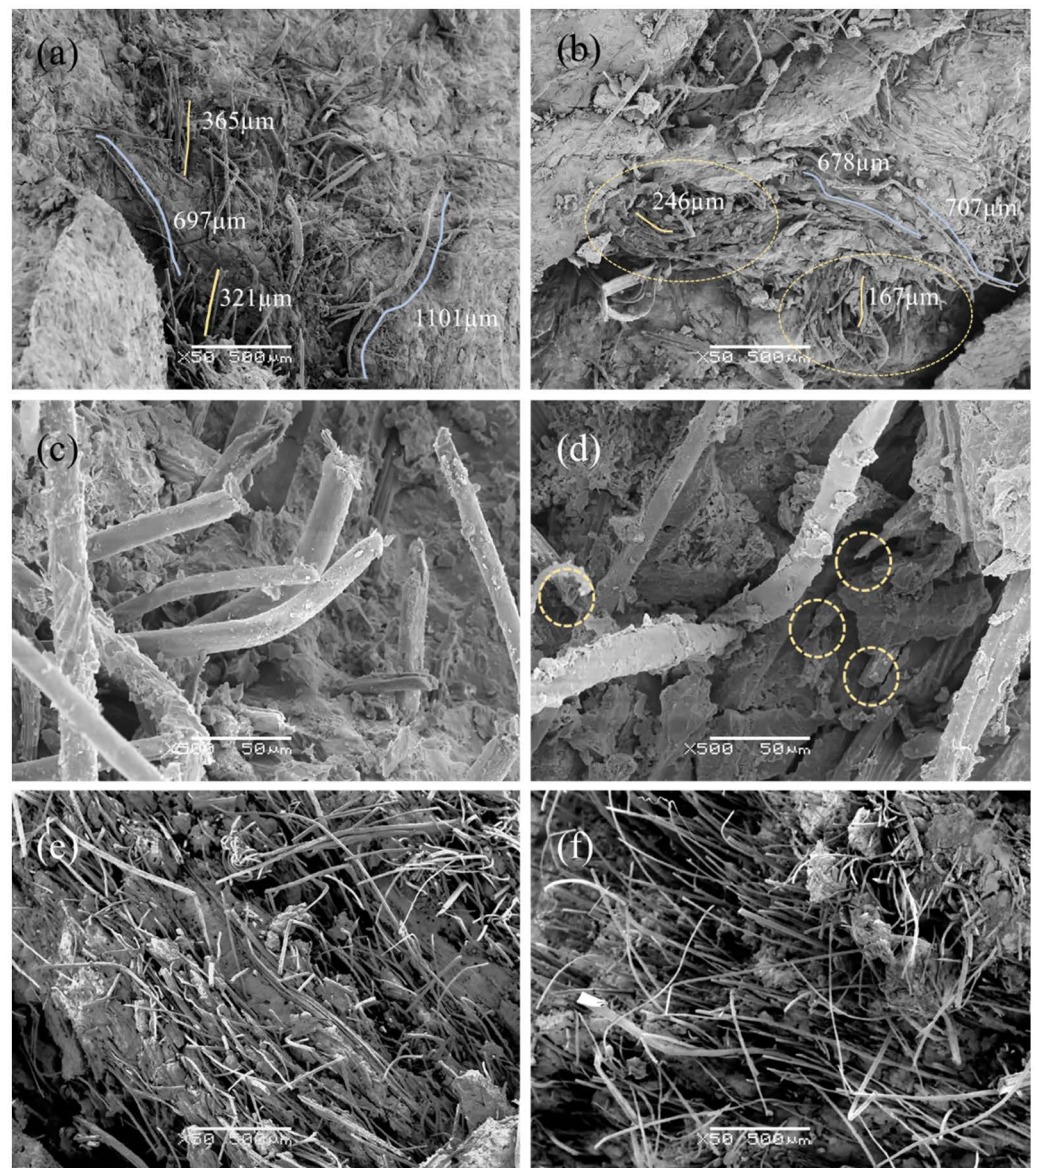
Figure 9. SEM micrographs of the fracture surfaces of the composites: (a) TW8; (b) TW8D; (c) TW8; (d) TW8D; (e) TW6L; and (f) TW6LD.

The loss of mechanical properties of the aged composites, mainly in absorbed energy and toughness, occurred due to the loss of adhesion and degradation of the vegetable fiber, as already explained. Both phenomena were more critical in the FRM than in the TRM due to the different distributions of the fibers. In the microimages of Figure 9 comparing the samples TW8 (Figure 9a) and TW8D (Figure 9b), the length of the fibers in the former are seen to be somewhat longer than those in the latter since most of the fibers in the aged samples were cut near the surface due to rupture. Therefore, the longer fibers generated more energy loss than the shorter ones through the pull-out mechanism of the fiber-cement interactions. Moreover, in Figure 9c,d, we could identify the differences between the fibers plucked from the unaged samples and the split fibers, indicated with a yellow circle, from

the aged samples. Therefore, the wet-dry cycles induced damage, leading to an increase in the number of fibers failing due to rupture, thereby decreasing the fibers' pull-out.

Nonetheless, regarding the TRM samples (see Figure 9e,f), the difference between the aged and unaged composites was insignificant since even after the accelerated aging, although properties were lost, a certain reinforcement effect was still maintained, which prevented breakage of the sample due to brittleness (see Figure 8a). Furthermore, longer fibers and the protrusion of a large set of fibers from the cement matrix were evident in TRM images with respect to FRM images. In fact, the fibers were dispersed randomly but homogeneously in the FRMs, while in the TRMs, the fibers were grouped in layers parallel to the surface, where a higher reinforcement density was obtained, which allowed for greater mechanical properties of this type of composite, mainly better energy absorption and toughness.

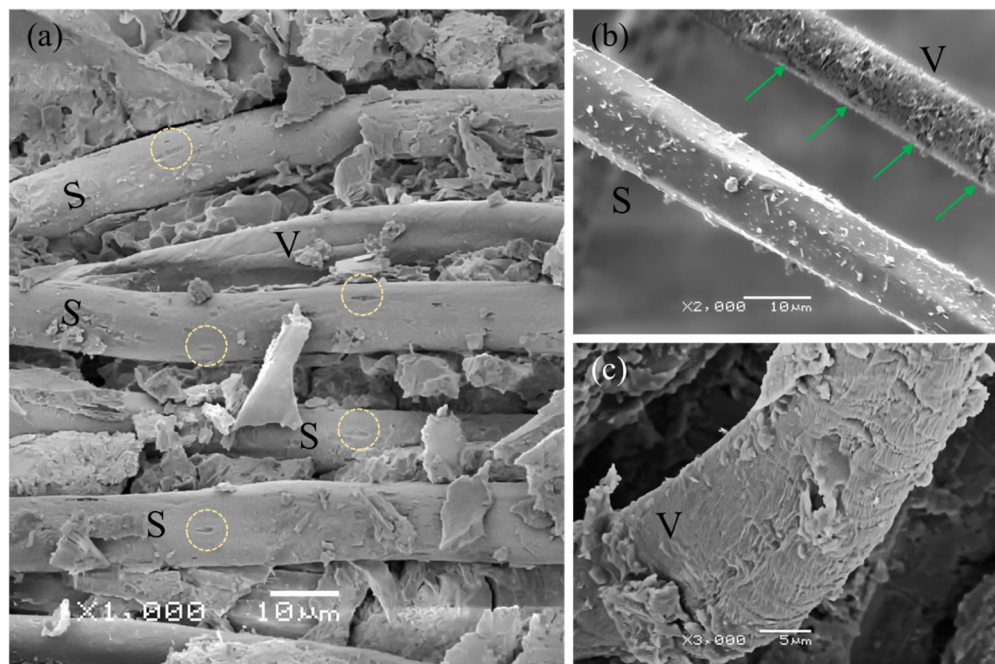
Figure 10. SEM micrographs of the fiber surfaces: (a) fibers from the broken section of an unaged sample; (b,c) fibers from the broken section of an aged sample.

In general, fibers in the unaged composites had clean surfaces whilst those in the aged composites appeared rougher and surrounded by precipitation products. In Figure 10a depicting the fibers from a broken section under unaged conditions, a set of synthetic

fibers (S) can be observed that are clearly distinguished by their almost cylindrical shape, with some extrusion marks as indicated by a yellow circle. A vegetable fiber (V) is also distinguished by being more oblong due to its more irregular and hollow section. After the accelerated aging procedure, Figure 10b, we observed that the synthetic fiber (S) seemed to have greater durability since the surface does not appear to have been affected and only some cement hydration products appeared. By contrast, in the vegetable fiber (V), some damage with superficial cracks appeared, indicated by green arrows. Figure 10c shows the surface roughness caused by the accelerated aging treatment in detail.
