## Case report

# Neurologic Dysfunction Associated With Mechanically Assisted Crevice Corrosion and Elevated Cobalt Ion Levels After Total Hip Arthroplasty

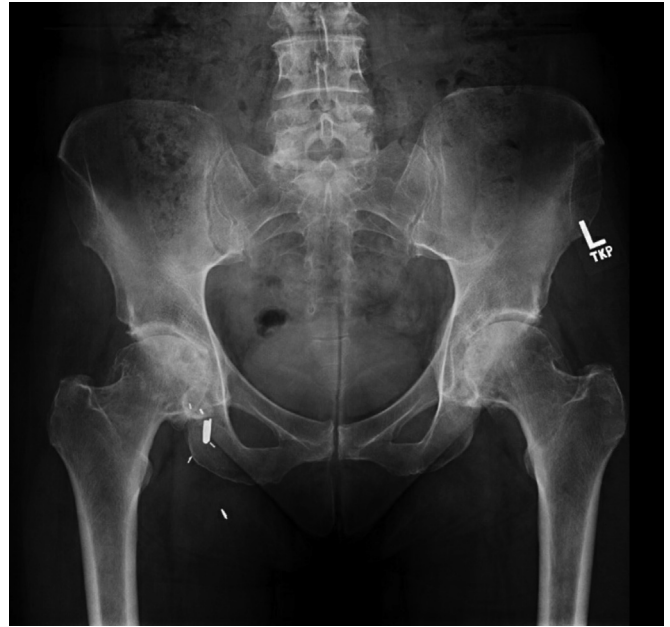
**Figure 1.** Preoperative pelvic radiograph 2 months after first-stage L-THA, February 2010. Note: Metallic objects seen in the right groin are surgical clips from a remote saphenous vein ligation procedure performed in 1988.

A 58-year-old woman who works as a pediatric intensive care unit nurse at a large academic medical center presented in 2009 with bilateral hip pain and pelvic radiographs consistent with advanced degenerative arthritis of both hips. Her past medical history was notable for longstanding hypothyroidism managed with levothyroxine. A corticosteroid injection was given with temporary relief in each hip. One year later, the hip pain worsened and was significantly impacting her quality of life. Pelvic radiographs demonstrated progression of her degenerative arthritis (Fig. 1).

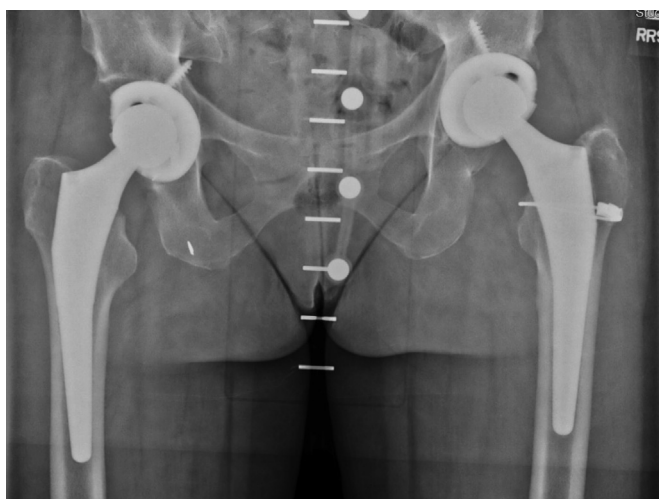
**Figure 3.** Postoperative pelvic radiograph after staged bilateral total hip arthroplasty, July 2013.

cementless bilateral total hip replacements (Fig. 3). She returned to work as a pediatric intensive care unit nurse.

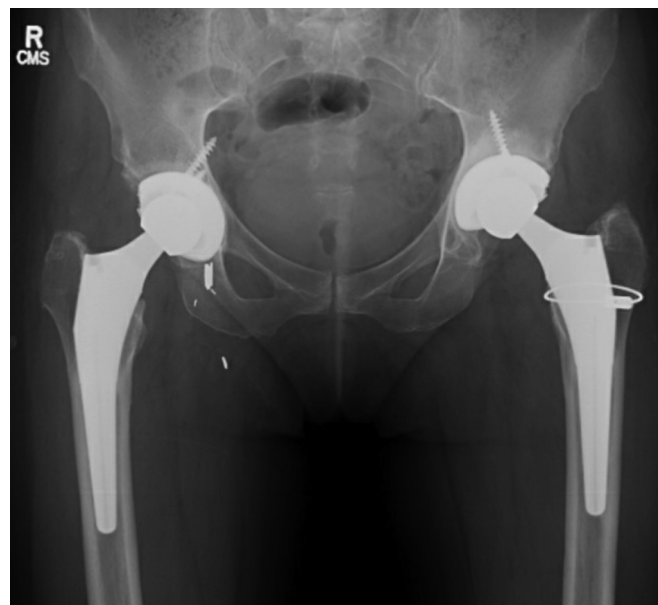
**Figure 4.** Postoperative pelvic radiograph 7 years after first-stage L-THA, March 2017.
