CASE REPORT

Intravestibular Stapes Prosthesis Protrusion Causing Post Stapedectomy Vertigo

J. P. Toirkens* and W. P. A. Kelders†

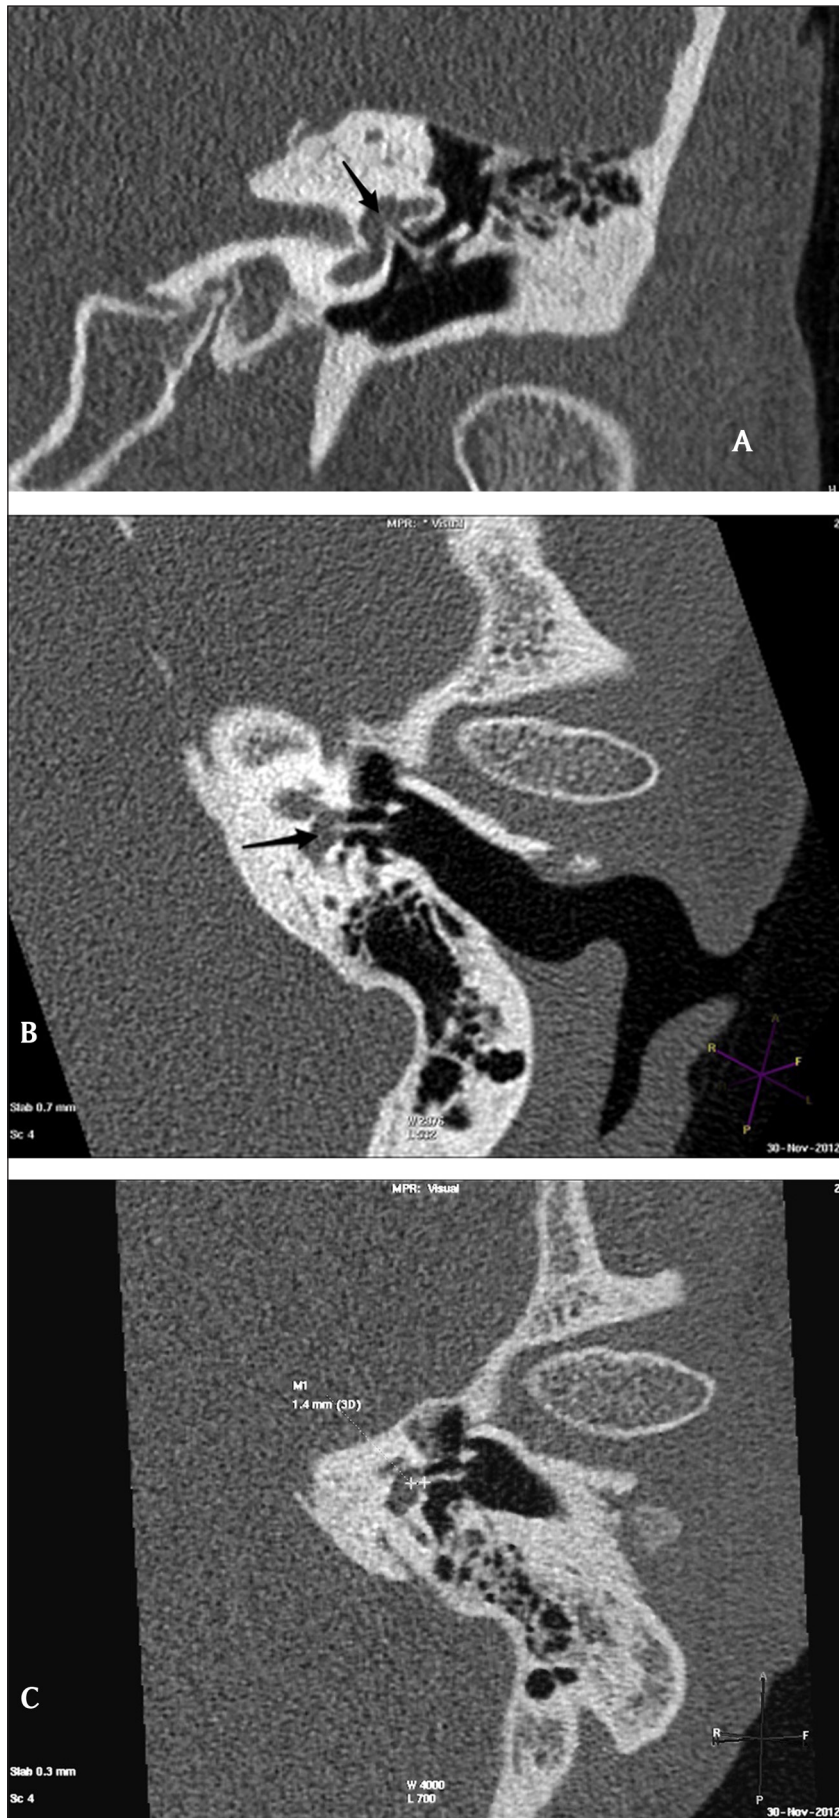
Figure 1: A) Para-coronal; B) Para-axial multiplanar reformats show stapes prosthesis protruding into the vestibule (arrow); C) measurement of protrusion depth.

A temporal bone high resolution CT (HR CT) was performed and showed migration of the stapes prosthesis into the vestibule (protrusion) (**Fig. 1**). Depth of protrusion was measured 14 millimeters from tip of the prosthesis to the oval window. The diagnosis of intravestibular stapes prosthesis protrusion related post stapedectomy vertigo was made and revision surgery was proposed.

HR CT imaging can frequently help to find the cause of the vertigo [5]. HR CT can demonstrate the position of the stapes prosthesis tip in relation to the oval window. 0.5–1 millimeter is the generally accepted limit for normal vestibular penetration [6, 7]. This limit has been established in cadaver studies and is related to the minimal distance from the stapes footplate in stapedotomy to the vestibular organs. Caution has to be taken not to make harsh conclusions out of near limit CT measurements because small cadaver case control studies have shown that precise measurement of the stapes protrusion until recently were not possible. Maybe last generation multislice CT systems can narrow the gap between multiplanar measurement and reality. Also the prosthesis material could have an effect on measurements (metal vs. plastic). Nevertheless HR CT can be of great use differentiating between possible other causes of post stapes surgery vertigo like granuloma (local soft tissue mass) or perilymphatic fistula (not visible).
