Radiolucent Skull Clamps for Intra-Operative Imaging: A Technical Note

Neil Haranhalli ¹, Hugo Zeberg ², Patrick Lasala ¹, David Altschul ³

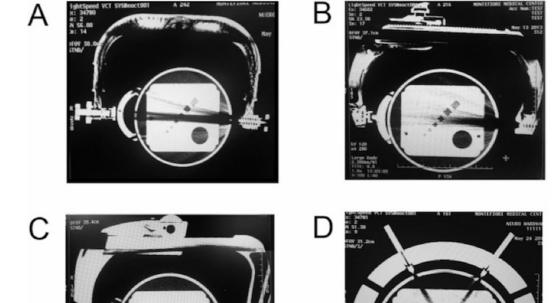
FIGURE 1: Four near-radiolucent frames in conventional CT

Figure.1 depicts the results of four near-radiolucent skull clamps. Both of the Mayfield clamps and the Doro clamp, although to a lesser extent, (Fig. *1A*-C) suffer from metal artifacts due to a spring in the one pinned arm. The Sugita frame (Fig. *1D*) has no spring, but pins connected to the rest of the head frame are not radiolucent and show artifacts along the lines from the pins. As observed in Fig. *1*, the artifacts are dominated by dark lines (originating from beam hardening and scatter as discussed above). The intensity of the X-ray was set to 120 kV.

Upper row (A and B), two Mayfield skull clamps (C). A radiolucent Doro skull clamp (D). A Sugita carbon fiber head frame. Note the dark streaks along the line of greatest attenuation originating from the metal objects adjacent to the pins

radiolucent. We observed that the major source of artifacts is the spring in the one pinned arm. The spring serves to provide a margin of error to the pressure delivered to the skull by tightening of the screw. The most obvious solution would be to remove the spring and replace this protective feature with another protective mechanism. An excellent alternative would be, instead of having a torque screw, to put this protective mechanism outside the frame in the form of a torque screwdriver. Torque screwdrivers are screwdrivers with components that guarantee to tighten to a prespecified torque, ensuring tightening that is sufficient, but not excessive. An insufficiently tightened pin is a surgical problem for obvious reasons, but excessive tightening can also be problematic. Wounds caused by pin-type head holder have been reported to be the source of air entry [15], particularly in the sitting position [16-17], and for epidural hematomas [18-19] and skull fracture [20]. In industry, torque screwdrivers are widely used as part of quality assurance and there is no reason why they cannot be employed in the medical field. Variable clean room torque screwdrivers that can exert torques between 0.02 and 406 Nm exist [21]. The standard Mayfield Torque Screw has a torque of 108.5 Nm and a reduced load 24.5 Nm torque screw exists for procedures in which lower pressure and less pin penetration is desired (Integra specifies the torque in lb, which is not a torque unit. We assumed lb./ft). A skull clamp must resist relatively high forces. A recent study measured the force exerted on a Mayfield head clamp using strain gages during brain surgery, a force range with a median of 5.5 N and a maximum of 151.87 N was measured [22]. There could be an additional advantage of having a variable preset torque screwdriver so that the torque could be adjusted for factors such as age and osteoporosis.

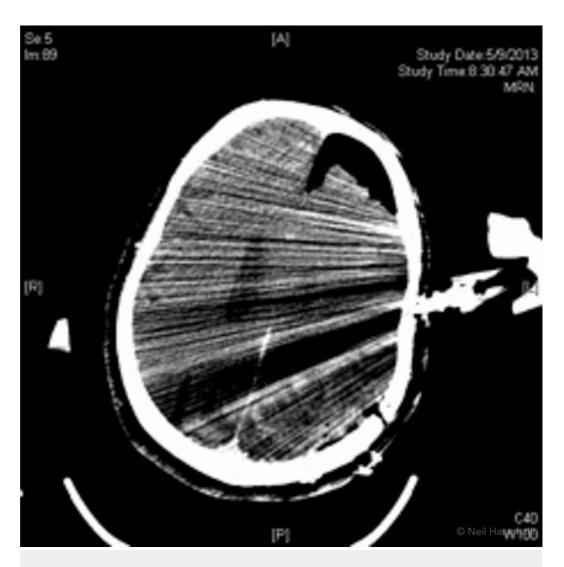
FIGURE 2: Intraoperative image demonstrating metal streak artifact

During surgery, a radiolucent Doro skull clamp was used (such as used in Figure 1 C) and a BodyTom scanner was done to assess the completeness of neoplasm removal. However, artifacts originating from the skull clamp used made such an evaluation impossible. As can be inferred from Fig. 2, which is similar to Fig. 1, there is a dark streak that comes from the spring on the one pinned arm. Moreover, the entire field of view is obscured by alternating black and white lines which are an expected difference [6, 8-11] when cone beam CT is used compared with conventional CT (Fig. 1). Another possible explanation could be patient motion, which is known to cause this type of artifact [2]. For the images rendered with conventional CT using a phantom, neither problems involving cone beam X-ray nor patient motion were present. Regardless of the cause, the image quality degradation was so severe that the medical utility was highly diminished.

Note the dark streak in the line of the right pin and the adjacent white streaks. Compared with Fig.1, virtually the entire field of view is obscured. The dark streaks are more prominent compared with Fig.1 due to the lateral parietal bone enhancing the metal streak artifact
