International Journal of Surgery Case Reports

Birmingham mid-head resection periprosthetic fractures: Case report

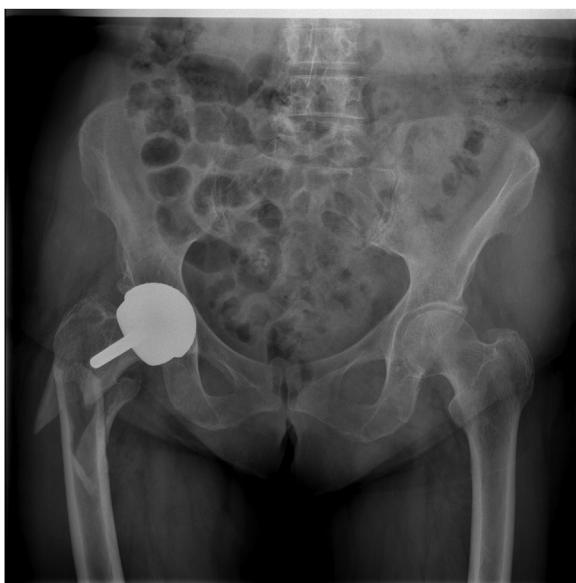
Fig. 1. Periprosthetic fracture.

We present the case of an 81-year-old patient from England with a history of arterial hypertension, atrial fibrillation anticoagulated with Warfarin, and obesity. She also took antihypertensive drugs and beta-blockers, but no bisphosphonates. She had no history of previous fractures due to fragility. She had previously undergone right total hip resurfacing arthroplasty due to osteoarthritis when she was 65. While on holiday, she fell down some stairs and was sent to A&E due to pain and functional deficit of the right hip. During the examination, it was discovered that her right lower limb was shortened and externally rotated. There were no distal neurovascular alterations. Plain radiographs revealed a periprosthetic fracture with a spiral pattern, which started in the cervical area and reached the subtrochanteric area (Fig. 1).

We present a case of periprosthetic fracture of a patient with a BMHR prosthesis. Olsen et al. [8] described two fracture patterns: transcervical vertical shear type and subcapital type. In our patient's case, the fracture pattern was different to those described, as the fracture started in the cervical area and reached the subtrochanteric area.

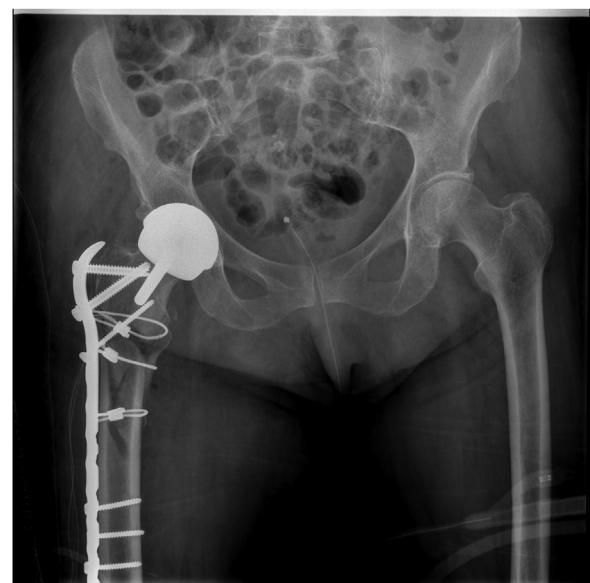
Fig. 2. Postoperative radiograph. Internal fixation with trochanteric plate and cerclages.

After the 4-day Warfarin washout period, the patient's fracture was surgically treated by means of open reduction and internal fixation with trochanteric plate and three cerclages. The prosthesis was not removed, as it was not mobilized. Postoperative radiographs revealed a satisfactory reduction of the fracture (Figs. 2 and 3).

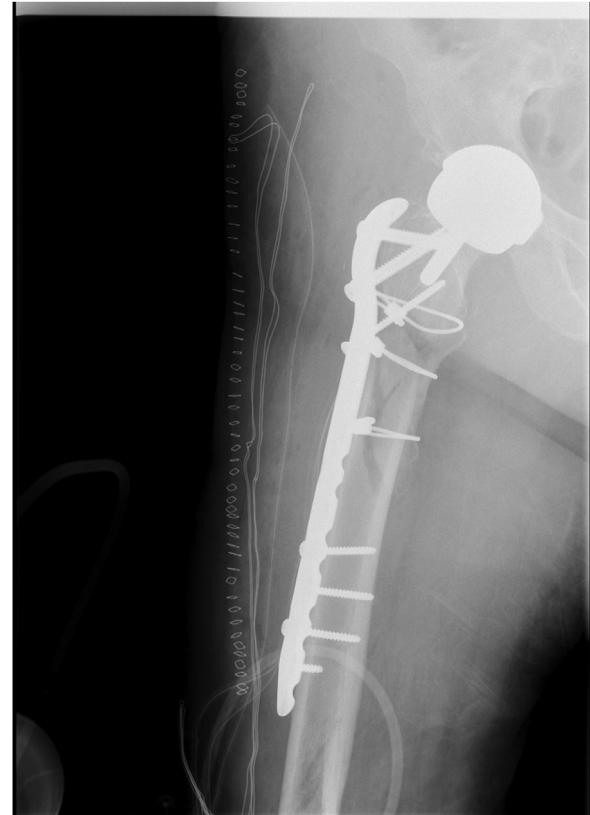
Fig. 3. Postoperative radiograph. Internal fixation with trochanteric plate and cerclages.
