Twiddler's Syndrome

Twiddler's syndrome refers to a rare condition in which a pacemaker or automatic implantable cardioverter-defibrillator (AICD) malfunctions due to coiling of the device in the skin pocket and resultant lead displacement. This image is the chest radiograph (CXR) of a 54-year-old male who presented to the emergency department with chest pain five months after his AICD was placed. The CXR shows AICD leads coiled around the device and the absence of leads in the ventricle consistent with Twiddler's syndrome. Patients with twiddler's syndrome should be admitted for operative intervention. [Clin Pract Cases Emerg Med. 2019;3(3):299-300.]

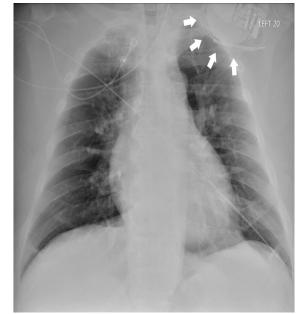
A 54-year-old male with an automatic implantable cardioverter-defibrillator (AICD) placed five months prior to arrival presented with sharp, left-sided chest pain for one day. He stated that his "pacemaker is moving." On physical exam, the vital signs were within normal limits, the patient was in no distress, and the left superolateral chest wall was tender to palpation. The electrocardiogram showed a normal sinus rhythm without ischemic changes. Chest radiograph revealed AICD leads wrapped around the device and absence of leads in the ventricle (Image).

Image. Anteroposterior chest radiograph revealing automatic implantable cardioverter-defibrillator leads wrapped around the device (white arrows) and absence of leads in the ventricle.

What is the major impact of the image(s)? The chest radiograph shows AICD leads coiled around the device and the absence of leads in the ventricle consistent with twiddler's syndrome.

How might this improve emergency medicine practice? *Patients with twiddler's syndrome should be admitted for operative intervention.*
