Effect of post etching cleansing on surface microstructure, surface topography, and microshear bond strength of lithium disilicate

Aim: This study assessed the effect of postetch cleansing on the surface microstructure, surface topography, and microshear bond strength (μ SBS) of lithium disilicate and the resin cement.

Setting and Design: *In Vitro* analytical study.

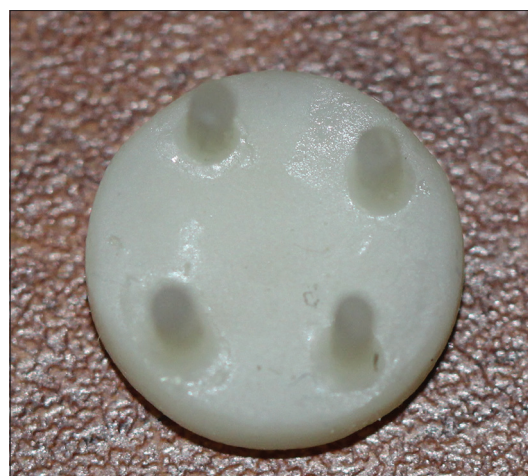
Figure 1: Specimen fabrication with resin cement cylinders on lithium disilicate discs

Following surface treatments, a silane coat was applied (Silane; Ultradent Products, Jordan) to all the discs with a microbrush for 60 s and gently air-dried. After silane application, 2 coats of adhesive (Single Bond Universal Adhesive; 3M ESPE, St. Paul, MN, USA) were applied, gently agitated and dried with a stream for evaporation of the solvent. Then, according to manufacturer's instructions, the adhesive was light-cured for 10 s. Four tygon tubes (Angiocath BD, Cundinamarca, Colombia) with a diameter of 0.9 mm and a height of 4 mm were placed on each surface-treated disc (4 tygons per ceramic disc; total $n = 60$) at a distance of 5 mm from each other and loaded with resin cement (RelyX Ultimate, 3M ESPE St. Paul, MN, USA). The samples were light-cured for 40 s at an intensity of $1,200\ \text{mw}/\text{cm}^2$ (Blue Dent Smart, BG Light, Bulgaria), according to the manufacturer's instructions. A sharp blade was used for the removal of the tygon tubes from the disc. This resulted with each ceramic disc having four resin cement cylinders [Figure 1].

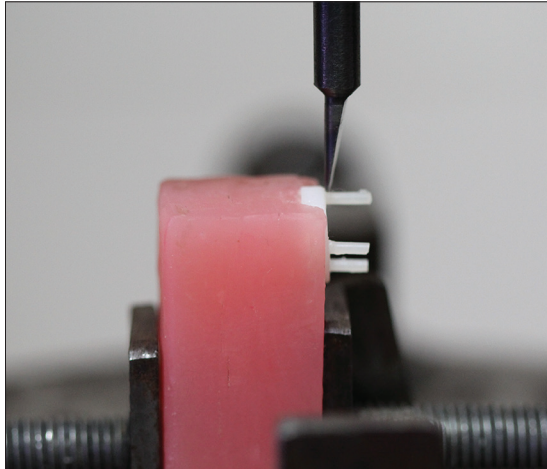
Figure 2: Microshear bond strength testing

dimension $40\ \text{mm} \times 15\ \text{mm} \times 15\ \text{mm}$ was constructed to stabilize the ceramic discs. This was then positioned in the universal testing machine (Instron, Instron Engineering Corporation, Massachusetts). A blade was positioned at an angle of 90° at the junction of the resin/ceramic interface [Figure 2]. A shear load was applied to each resin cement cylinder, at a crosshead speed of $0.5\ \text{mm}/\text{minutes}$, until specimen fractured.^[18] The values were expressed in MPa.^[19]

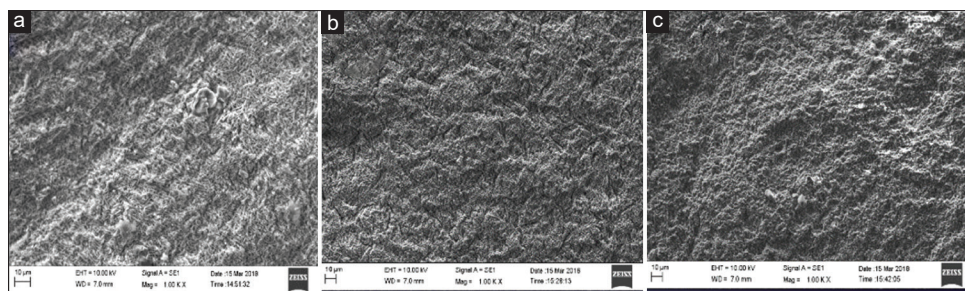
Figure 5: SEM images obtained from each experimental group ($\times 1000$): (a) Group HF, (b) Group HFP, (c) Group HFPU

The results of SEM analysis at $\times 1000$ and $\times 3000$ magnification are demonstrated in Figures 5 and 6,

respectively. Group HF showed needle-like structures with vitreous islands. Microsurface of Group HFP showed lesser vitreous islands and increased density of needle-like structures, giving a dry earth appearance suggestive of increased roughness. Group HFPU showed a uniform interlocked networks of needle-like structures suggestive of most dense etching pattern. From Group HF to Group HFPU, an increase in the density and the uniformity of etching pattern was noted.

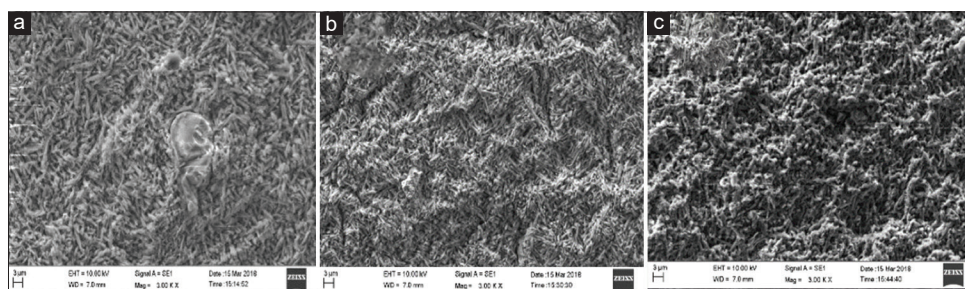
Figure 6: Scanning electronic microscope images obtained from each experimental group ($\times 3000$): (a) Group HF, (b) Group HFP, (c) Group HFPU

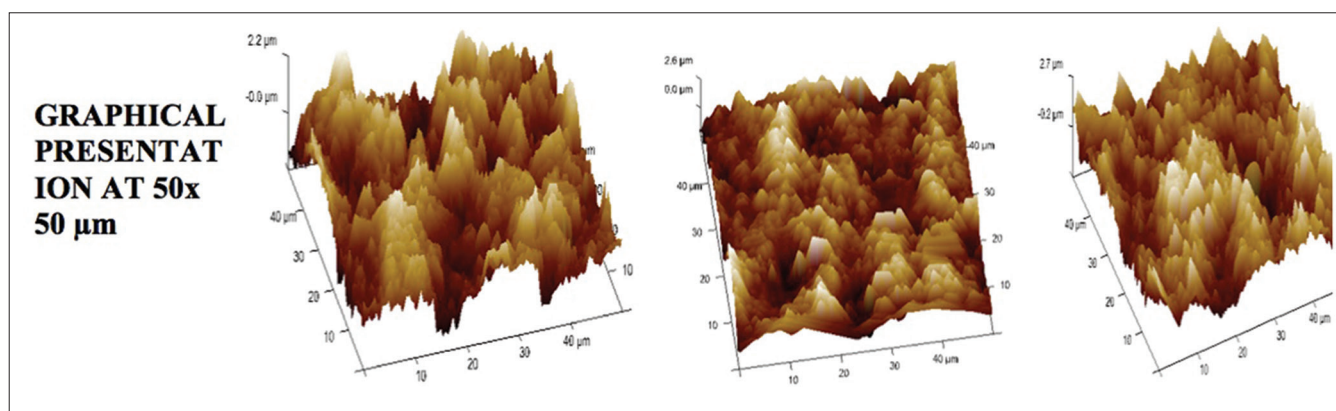
Figure 7: Atomic force microscope images of Group HF, Group HFP, HFPU

The AFM results are presented in Table 4 and Figure 7. Group HFPU showed the highest value of surface roughness (Ra, Rq, and Rmax) as compared to other two groups.

AFM analysis showed that the values of Ra (arithmetic roughness), Rv (maximum valley depth), and Rp (maximum peak height) were found to be highest for HFPU group, signifying that the surface roughness was maximum with the HFPU group; hence, it has the maximum surface area for bonding and hence the highest bond strength. Group HFPU showed an increase in bond strength of 28.48% and 15.89% over HF and HFP group, respectively.
