# The effect of a desensitizer and CO<sub>2</sub> laser irradiation on bond performance between eroded dentin and resin composite

**PURPOSE.** This study was aimed to evaluate effect of the desensitizing pretreatments on the micro-tensile bond strengths ( $\mu$ TBS) to eroded dentin and sound dentin. **MATERIALS AND METHODS.** Forty-two extracted molars were prepared to form a flat dentin surface, and then they were divided into two groups. Group I was stored in distilled water while group II was subjected to a pH cycling. Each group was then subdivided into three subgroups according to desensitizing pretreatment used: a) pretreatment with desensitizer (Gluma); b) pretreatment with CO<sub>2</sub> Laser (Ultra Dream Pluse); c) without any pretreatment. All prepared surfaces were bonded with Single Bond 2 and built up with resin composite (Filtek Z250). The micro-tensile bond test was performed. Fracture modes were evaluated by stereomicroscopy. Pretreated surfaces and bonded interfaces were characterized by scanning electron microscope (SEM). The data obtained was analyzed by two-way ANOVA ( $\alpha = 0.05$ ). **RESULTS.** For both sound and eroded dentin, samples treated with dese

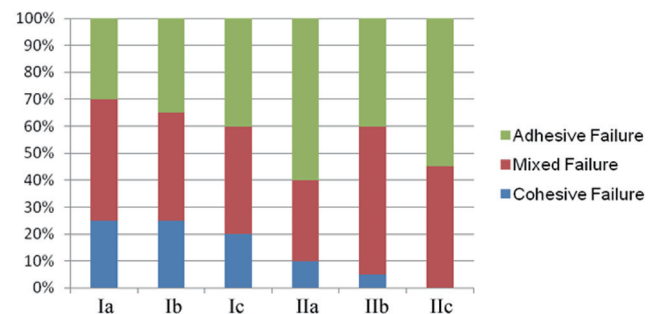
**Fig. 1.** Graphical presentation of the incidence (%) of failure modes for each group.

Group Ia: sound dentin treated with Gluma, Group Ib: sound dentin treated with CO<sub>2</sub> laser, Group Ic: sound dentin without any treatment, Group IIa: eroded dentin treated with Gluma, Group IIb: eroded dentin treated with CO<sub>2</sub> laser, Group IIc: eroded dentin without any treatment.

The failure mode percentages of the debonded specimens are shown in Fig. 1.

The overall failure types for specimens were "adhesive" and "mixed". However, more cohesive failures were observed in sound dentin groups (Group I) than in eroded dentin groups (Group II).

The artificial erosion process did not only negatively influence micro-tensile bond strengths, but also changed the failure pattern. Higher percentages of cohesive failures (Fig. 1) were observed in the eroded dentin groups. This type of failure has often been interpreted as evidence that bond strength of adhesive to dentin is stronger than the cohesive strength of dentin/RC. However, the nature of fracture is far more complex than that. It has been suggested that failure mode is affected by the material properties of all components of bonded joints, that is, the RC, hybrid layer, and dentin.<sup>24</sup> Thus, the presence of air bubbles can act as stress points in eroded dentin, which is softer and more porous than sound dentin, which would increase the likelihood of dentin cohesive fracture, especially in non-penetrated demineralized regions.

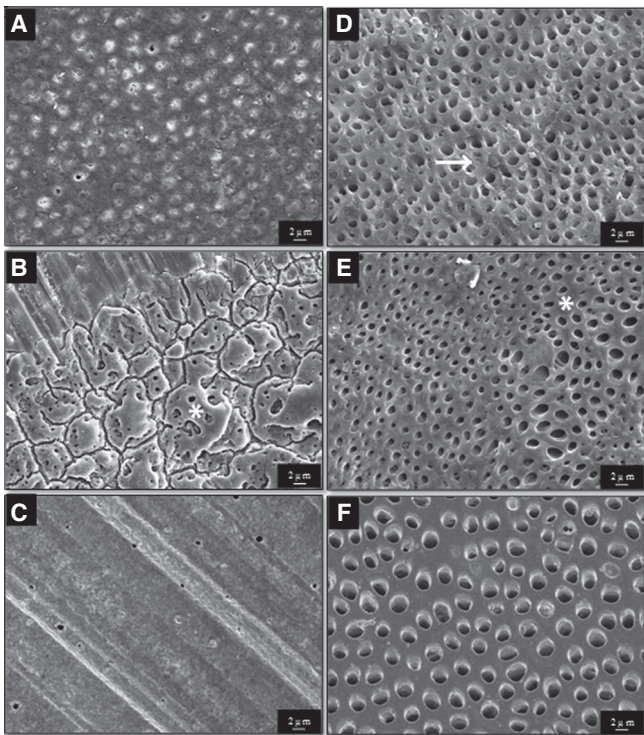
**Fig. 2.** Morphology of dentin surfaces under different pretreatment. (A) Group Ia: Dentinal tubules were completely or partially closed. (B) Group Ib: The irregular protrusions (asterisk) may be smear layer affected by laser irradiation. (C) Group Ic: Typical smear layer was observed. (D) Group IIa: Smear layer was entirely removed and dentin was demineralized, some tubules orifices were partially plugged (arrows). (E) Group IIb: Abnormal inter-tubular dentin was seen in laser affected spot (asterisk). (F) Group IIc: The smear layer is completely removed and dentinal tubules were opened. (Original magnification x1,000.)

Fig. 2 shows the microstructure of the dentin (sound/eroded) surface after desensitizing pretreatment.

diameter.<sup>14</sup> In the present study, SEM revealed that the smear layer was entirely removed and dentinal tubules were totally opened. After demineralization, peritubular dentin was apparent as some hydroxyapatite crystals only remain around dentinal tubules (Fig. 2D, Fig. 2E, and Fig. 2F). These surface changes induced by the artificial erosion process are in accordance with a previous report.<sup>8</sup>

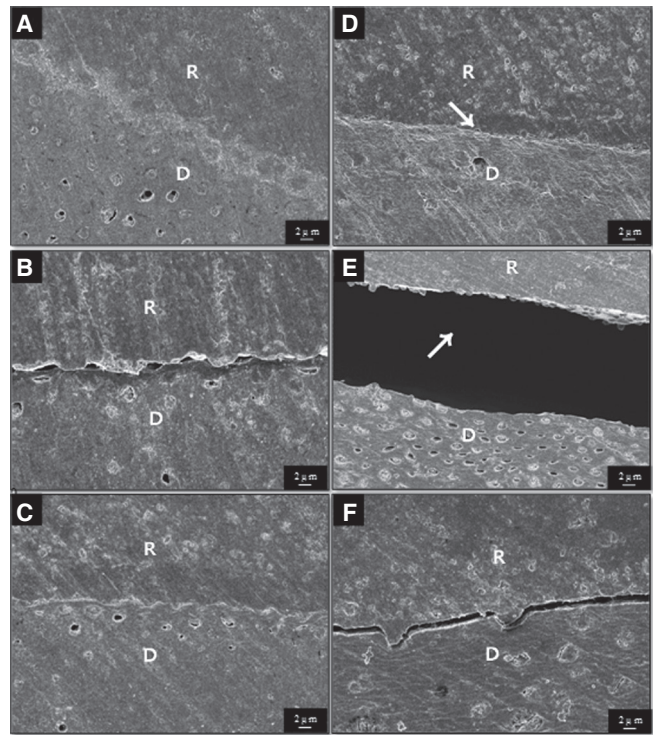
**Fig. 3.** Adhesive interface between resin composite and dentin. (A) Group Ia: A typical hybrid layer was hardly seen. (B) Group Ib: Debond area was apparently observed. (C) Group Ic: Adhesive layer bonded to dentin firmly, no debond area was observed. (D) Group IIa: Small cracks due to dehydration process were observed (arrow). (E) Group IIb: A big gap was observed and some resin tags (arrow) were remaining after debonding. (F) Group IIc: A small gap was observed between dentin and resin composite (Original magnification x1,000). R: Resin composite, D: Dentin.

Fig. 3 shows adhesive interface between RC and dentin. Fig. 3 (B, E, F) reveal that adhesive layers were not consistently bonded to dentin; gaps and debonded regions were observed in Group Ib, IIb and IIc, which concurred with the low micro-tensile bond strengths observed.
